Summary of Photographs

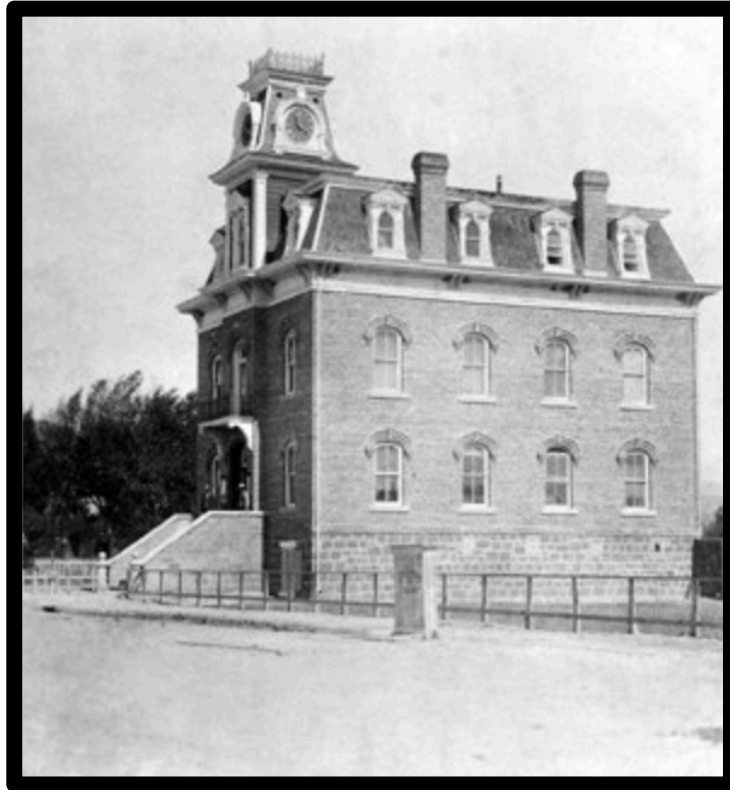
Beaver County Courthouse in Beaver, Utah. This photo was taken between 1890 and 1910 by Richard K.A. Kletting, architect. Notice the presence of chimneys.

Earthquake damage to this building is reported in the Deseret News on November 14, 1901: "In the earthquake at 9:30 last night, the Beaver county court house received a great deal of damage, the walls are cracked in about twenty-five places, and the roof is crushed in by the falling chimneys." Photo by Richard K.A. Kletting, architect.

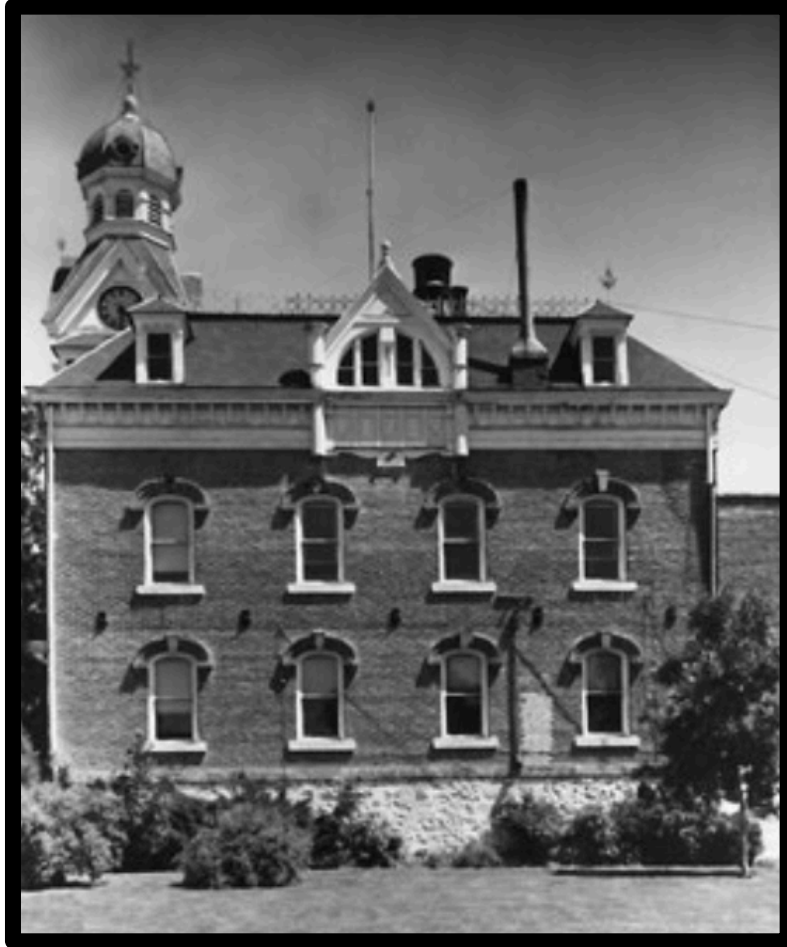
Beaver County Courthouse in Beaver, Utah. This photo was taken in 1968 by Kent Fairbanks. Notice the absence of tall brick chimneys. Remodeling has taken place since the time of the Kletting photo (taken between 1890 and 1910).

Although the description on the National Register of Historic Places attributes the courthouse remodeling to a fire in the late 1800's, the changes apparent in these photographs seem to reflect mitigation of the damage reported in the Deseret News on November 14, 1901: "In the earthquake at 9:30 last night, the Beaver county court house received a great deal of damage, the walls are cracked in about twenty-five places, and the roof is crushed in by the falling chimneys."

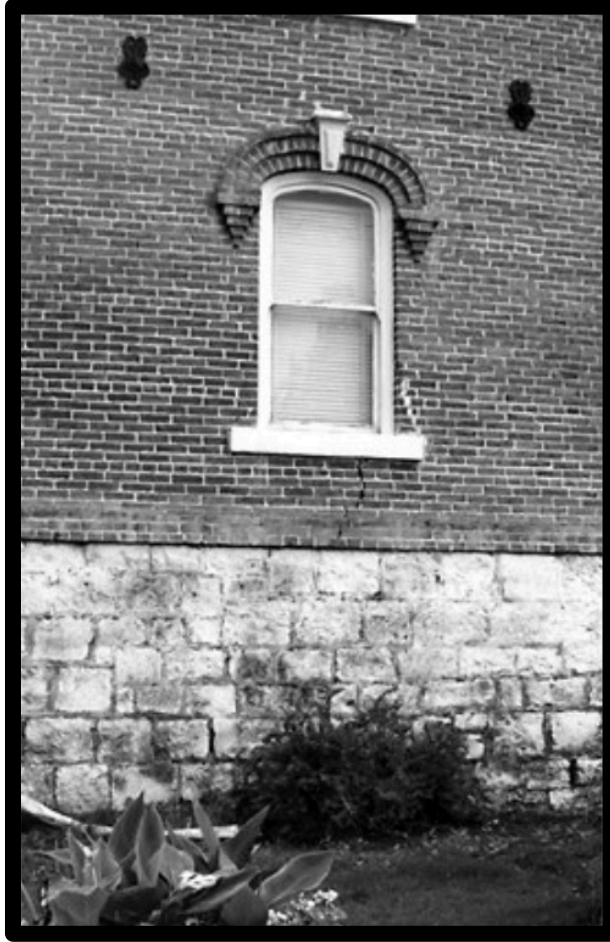
Close-up, taken in 1991, of one wall of the Beaver County Courthouse. Notice the crack beneath the window. The decorative elements are probably each one of a pair of "turnbuckles" on opposite walls connected by heavy wires in a retrofit effort to protect the building from further damage. Photo by Edith O'Brien.
