Summary of Photographs

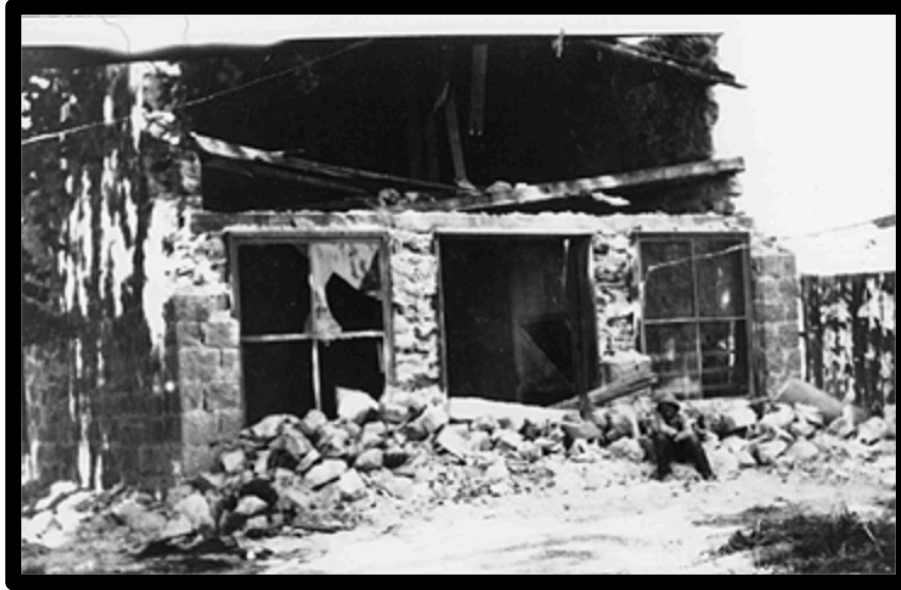
The paint shop on Main Street of Elsinore, Utah was badly damaged during the main shock of the 1921 Elsinore series of earthquakes. Its front wall was then thrown into the street by an equally strong earthquake two days later.

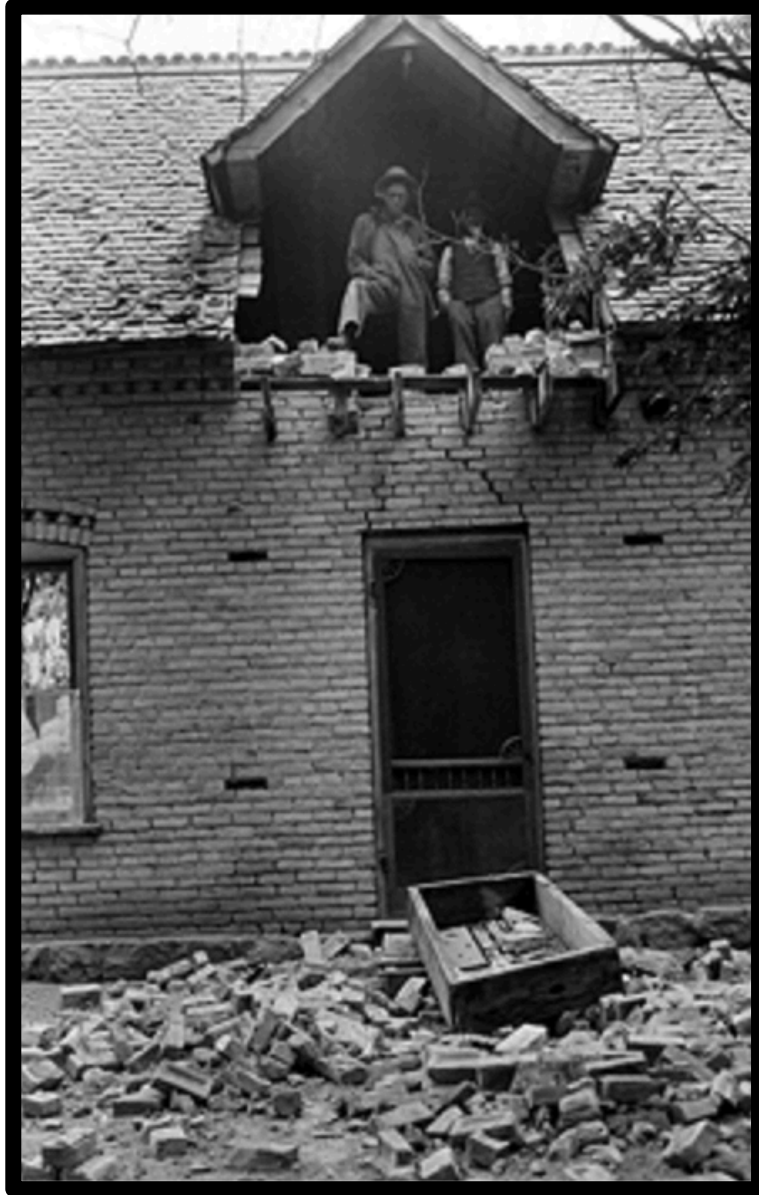
This is an example of damage to houses in Elsinore, Utah during the 1921 Elsinore series of earthquakes.

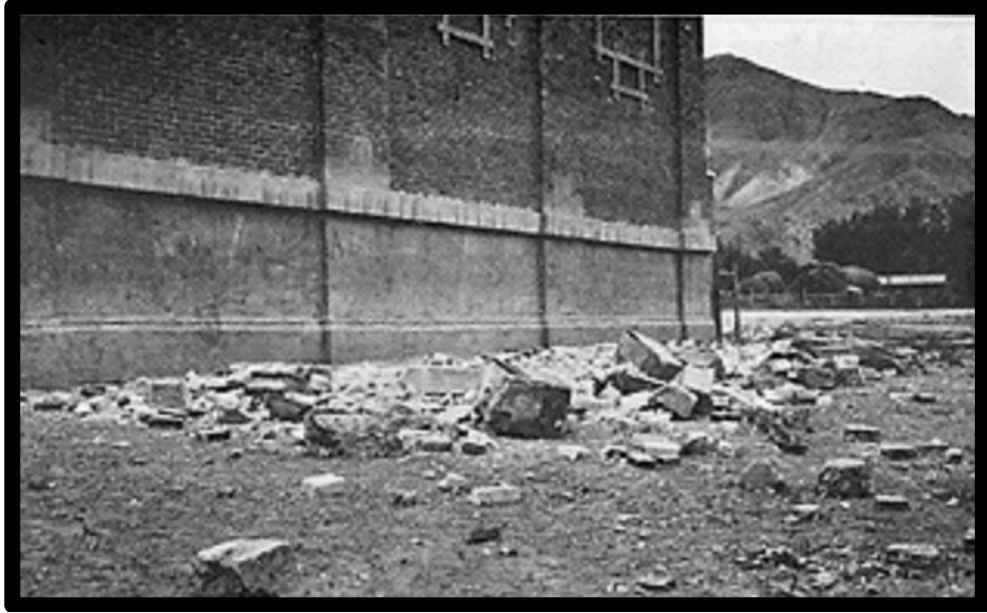
In Elsinore, Utah the fire wall (2-5 feet high) on three sides of the new two-story brick public school building was almost entirely thrown to the ground where children usually play. Photo from Bulletin of the Seismological Society of America (1921), vol 11, no. 3-4, plate 12.
