## Summary of Photographs

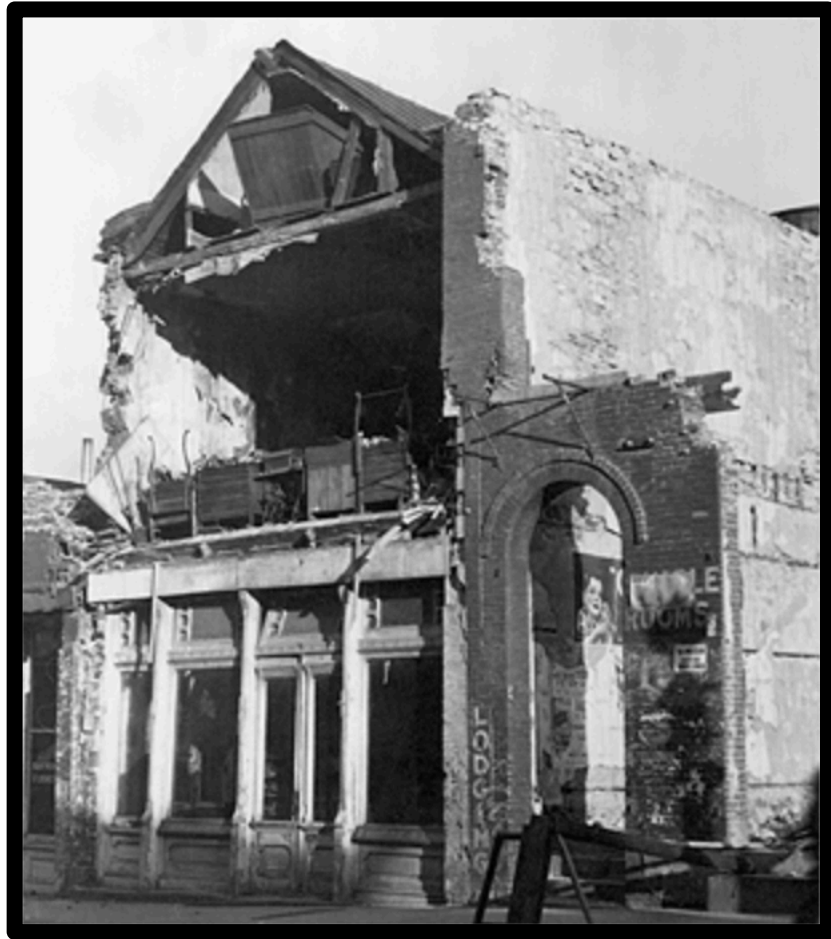
The front wall of the Headquarters Building on South Main Street in Helena, Montana, fell into the middle of the street during the main shock, killing one man. Photo by L.H. Jorud Photographer, Helena, MT.

Description: [Building on Main St.; Helena MT where 1 death occurred](#)  
Source: Montana Historical Society and MT Bureau of Mines and Geology  
[Info Categories:](#) B, P

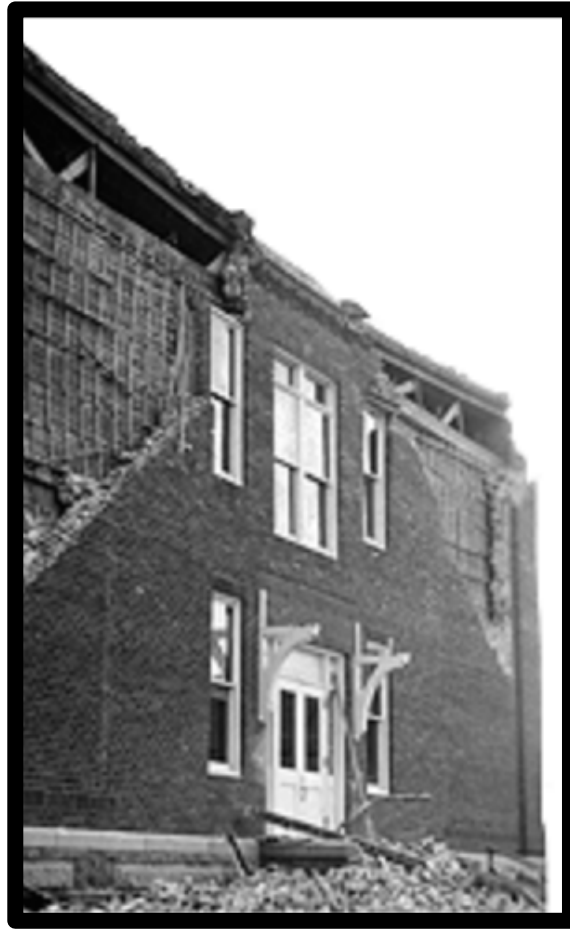
Bryant school in Helena, Montana, suffered increasing damage in the series of 1935 earthquakes which began October 12th. This photo shows the school after the main shock on Oct. 18th. Note that the fractures follow the mortar joints. Most of the remaining portion of the wall shown fell during the Oct. 31st aftershock (see next photo.) Photo published by MT Bureau of Mines and Geology in "Memoir 16, The Montana Earthquakes of 1935," by Harold W. Scott.

Description: [Bryant Elementary School; Helena, MT after October 18th](#)  
Source: MT Bureau of Mines and Geology  
[Info Categories:](#) B

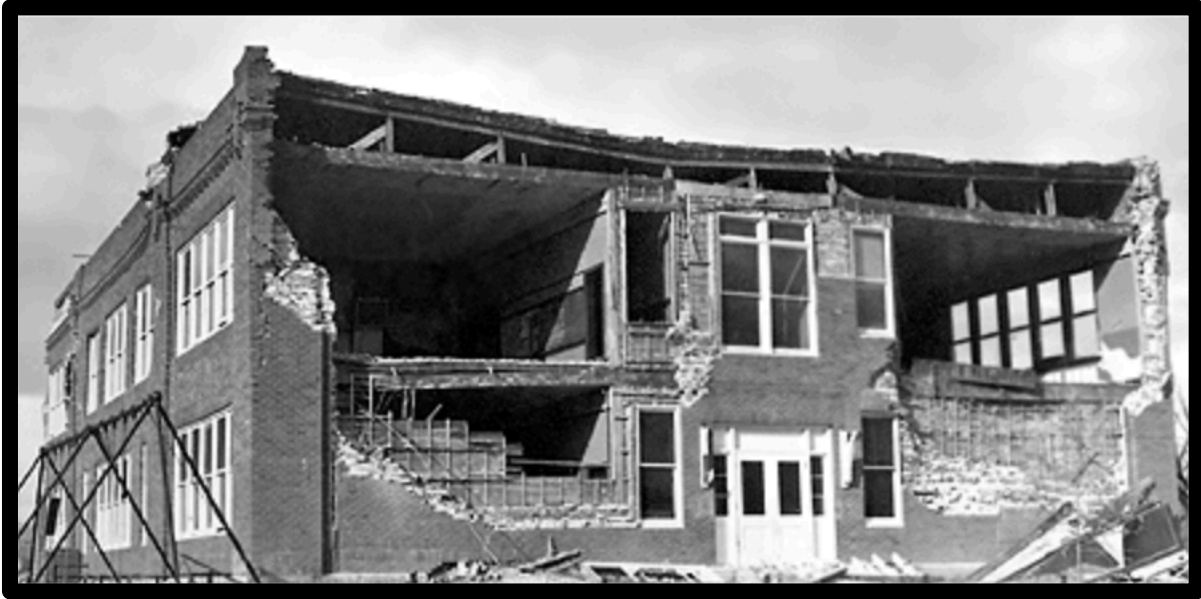
Bryant Elementary School was further damaged in the October 31st aftershock. Until reconstruction was completed, its 276 students attended school in the basement of Central school. Photo by L.H. Jorud Photographer, Helena, MT.

Description: [Bryant Elementary School; Helena, MT after October 31<sup>st</sup> aftershock](#)  
Source: Montana Historical Society and Montana Bureau  
[Info Categories:](#) B

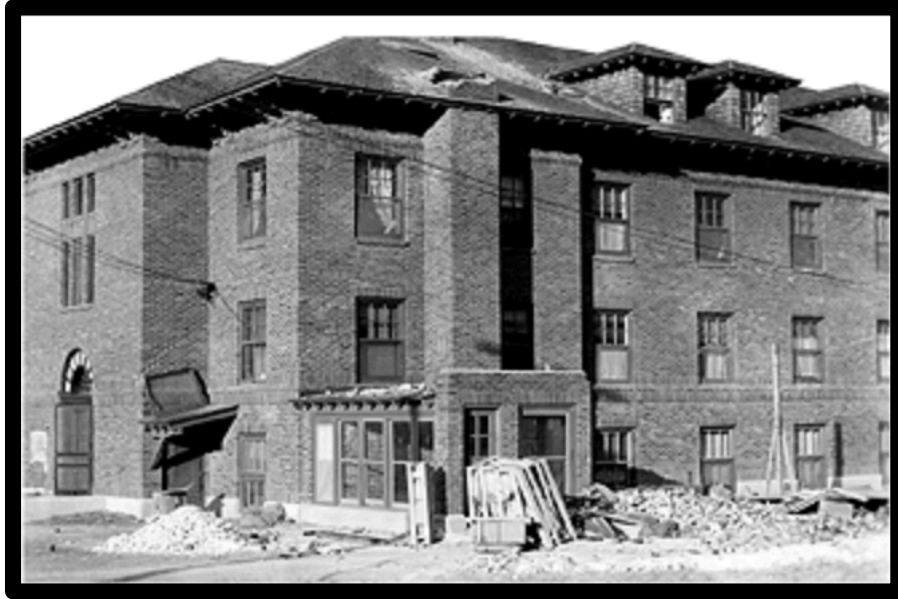
Intermountain Union College's Mills Hall. The October 18th earthquake caused \$20,000 (1935 dollars) in damage to several buildings on this college campus (located on site of present-day Capital Hill Mall). Most of the damage was repaired, and school resumed on October 29th. The aftershock on the 31st rendered the buildings uninhabitable. Soon after, the college was moved to Great Falls, Montana, and never reopened its doors in Helena. Photo by Knudsen and Son Photographers, Helena, MT.

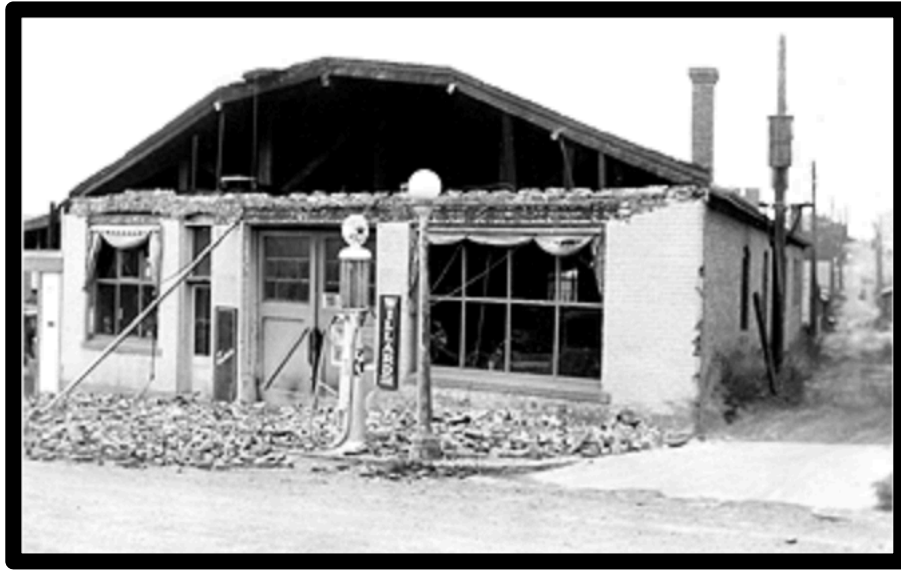
Walker's Garage in Helena, Montana. Photo by Knudsen and Son Photographers, Helena, MT.

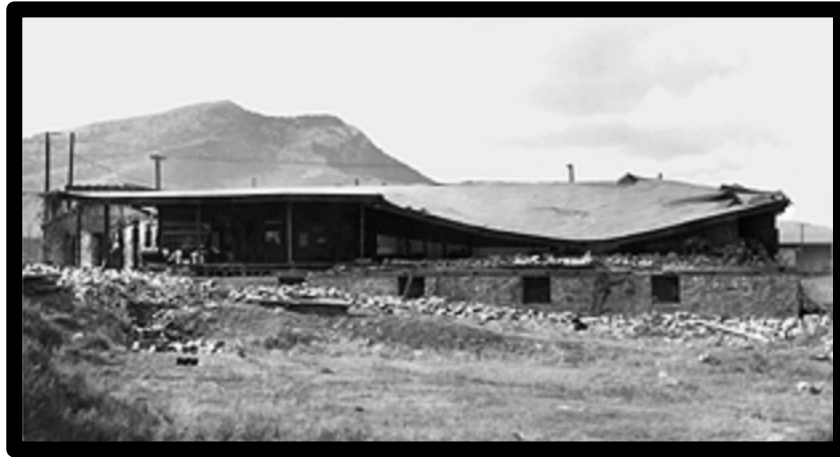
H. Earl Clark Filling Station on Helena Avenue had its walls shaken out, leaving the roof sagging on its supports. Several cars in the garage were badly battered. Photo by Knudsen and Son Photographers, Helena, MT.

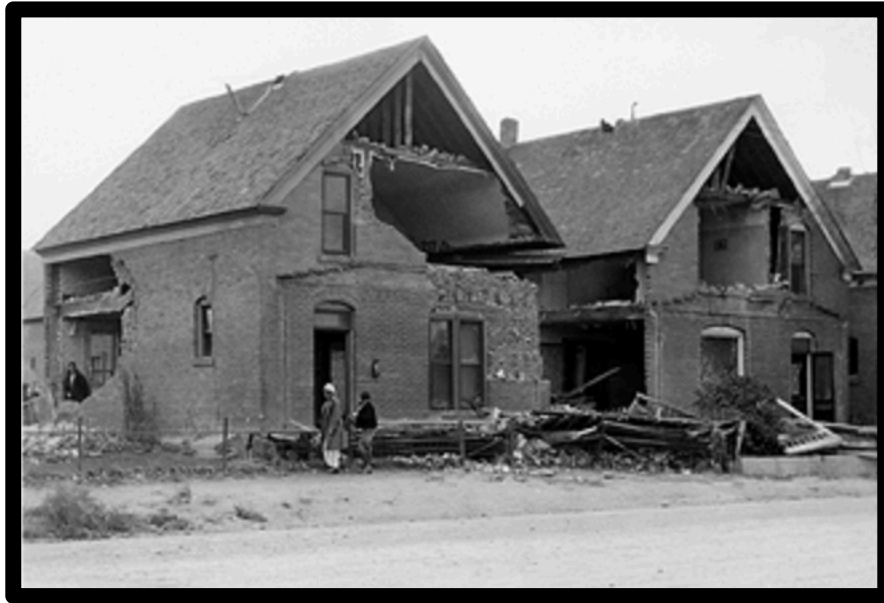
"Charles Purdy and his wife and two small children were buried alive when the front porch of the house at left, collapsed, at 1717 Boulder Ave. Purdy fought his way free and then dragged out his wife, seriously injured, and the youngsters. Neighbors next door suffered almost equal damage." [The Helena Independent newspaper; 10/22/1935]. Photo by Knudsen and Son Photographers, Helena, MT.

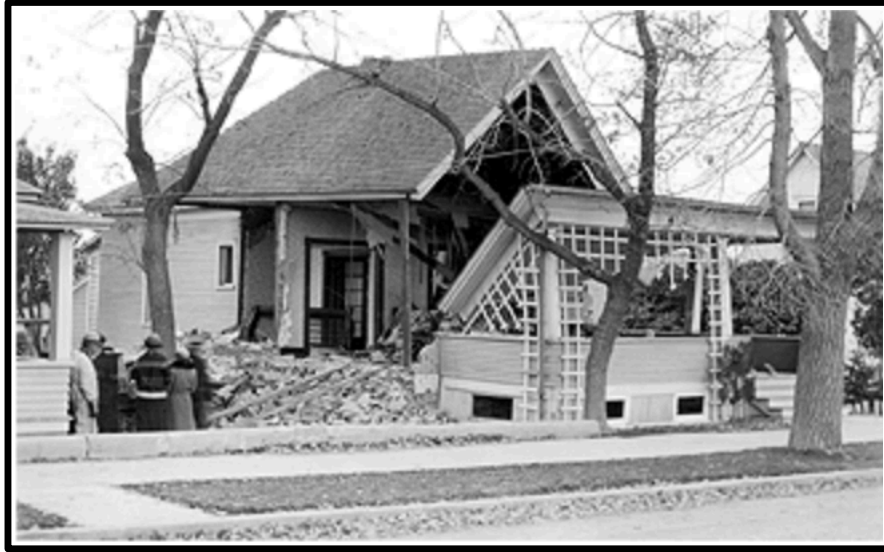
The W.J. Wilson home at 1502 Boulder Avenue in Helena, Montana, had its front brick walls pulverized. The porch roof dropped down and furniture was thrown out into the yard during the tremor. [Information from The Helena Independent newspaper, 10/20/1935]. Photo by Knudsen and Son Photographers, Helena, MT.

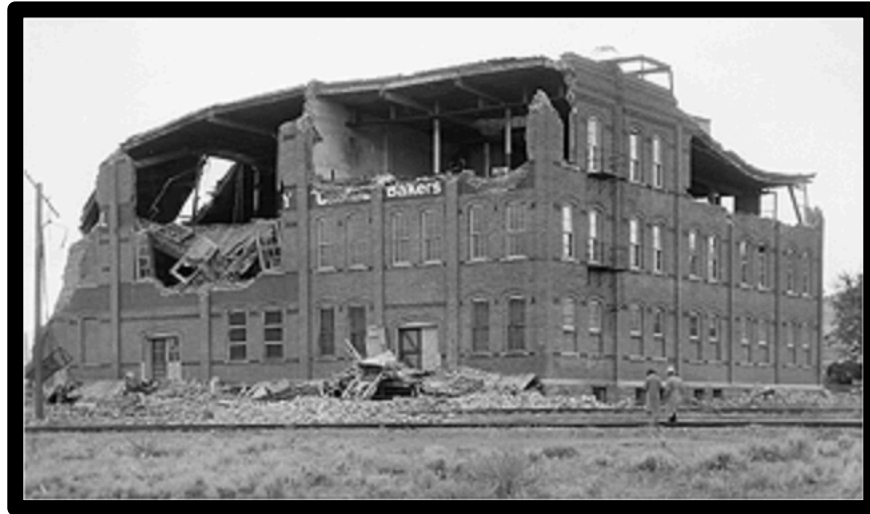
The National Biscuit Company's warehouse on Boulder Avenue in Helena, Montana, was initially damaged in the October 12th foreshock. The main shock on the 18th shook out its rear wall, allowing the roof to settle and crash through the structure in many places. [Information from The Helena Independent newspaper; 10/19/1935]. Photo by Knudsen and Son Photographers, Helena, MT.

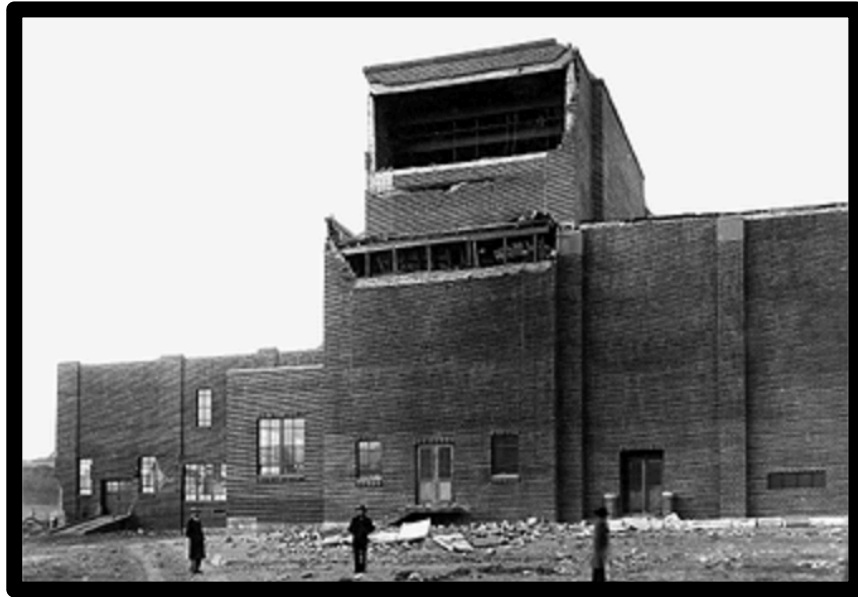
The new \$500,000 (1935 dollars) Helena High School was the pride of the community when it was dedicated in early October 1935. Two weeks later, the north wing, housing the auditorium and shops, was severely damaged in the main shock. Although modern and fireproof, no earthquake resistance had been built into the building. Helena had not been recognized as an active seismic zone. Photo published by MT Bureau of Mines and Geology in "Memoir 16, The Montana Earthquakes of 1935," by Harold W. Scott.

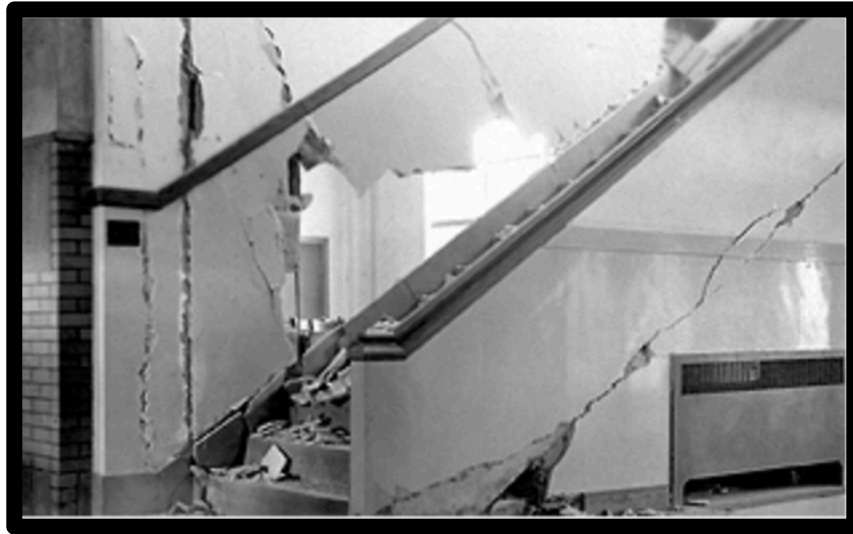
Stairwell and tile partition walls inside the new Helena High School were shattered. This photo was taken after the October 31st aftershock. Photo published by MT Bureau of Mines and Geology in "Memoir 16, The Montana Earthquakes of 1935," by Harold W. Scott.

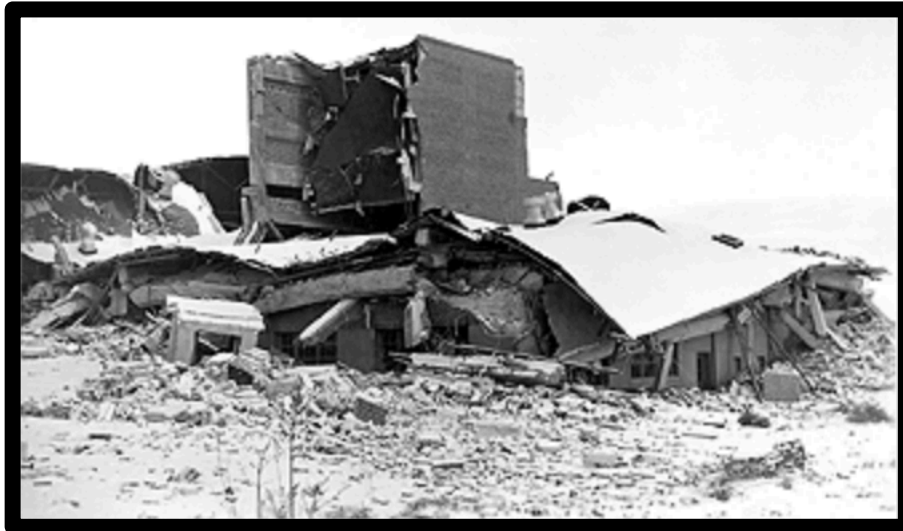
The north wing of Helena High School collapsed during the October 31st aftershock. 25-30 men survived in that building without injury due largely to their foreman who shouted reminders not to run outside. This was a lesson learned as a result of the main shock. The people who had been injured or killed in the main shock were all running out of their buildings and were hit by falling walls, etc. Photo published by MT Bureau of Mines and Geology in "Memoir 16, The Montana Earthquakes of 1935," by Harold W. Scott.

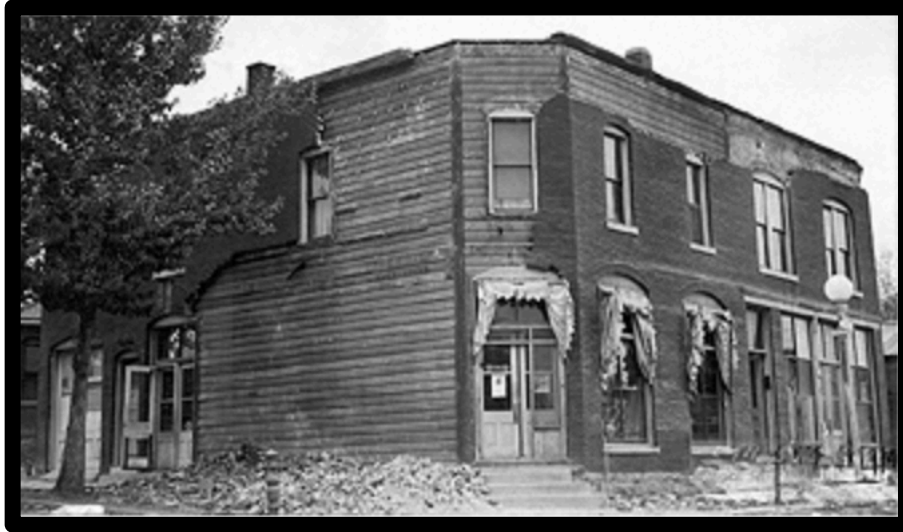
Brick veneer walls typically peeled off the wooden frames. Notice that in this building the chimneys still stand and the windows are not broken. Photo published by MT Bureau of Mines and Geology in "Memoir 16, The Montana Earthquakes of 1935," by Harold W. Scott.

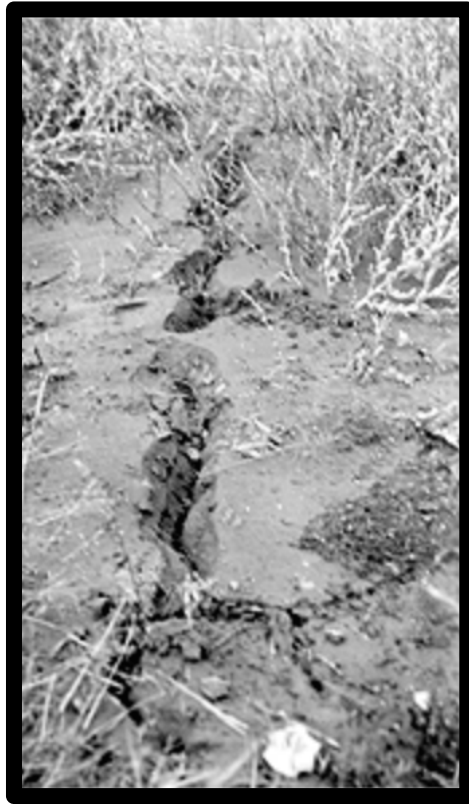
Ground cracks appeared south of Lake Stanchfield, and water flowed from them for about two hours. Photo published by MT Bureau of Mines and Geology in “Memoir 16, The Montana Earthquakes of 1935,” by Harold W. Scott.

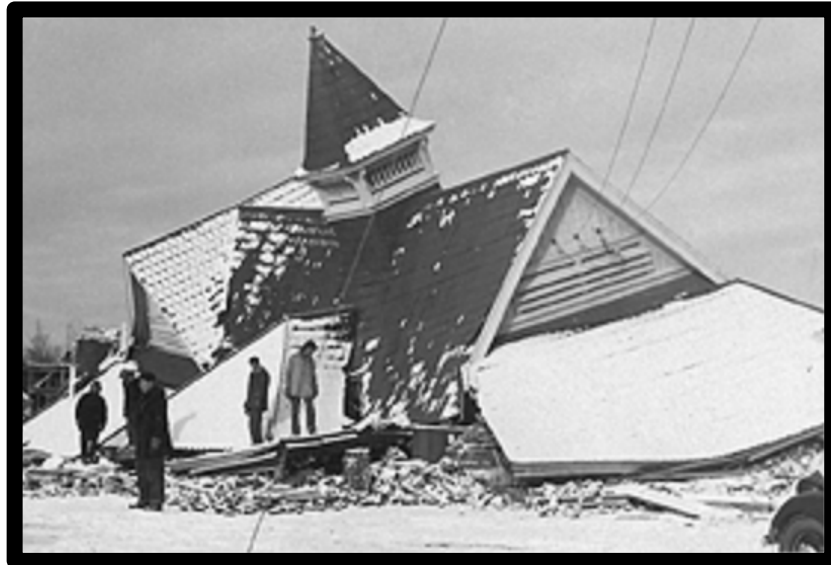
The heavy frame roof of this building fell to the ground when the masonry walls failed. Photo published by MT Bureau of Mines and Geology in "Memoir 16, The Montana Earthquakes of 1935," by Harold W. Scott.

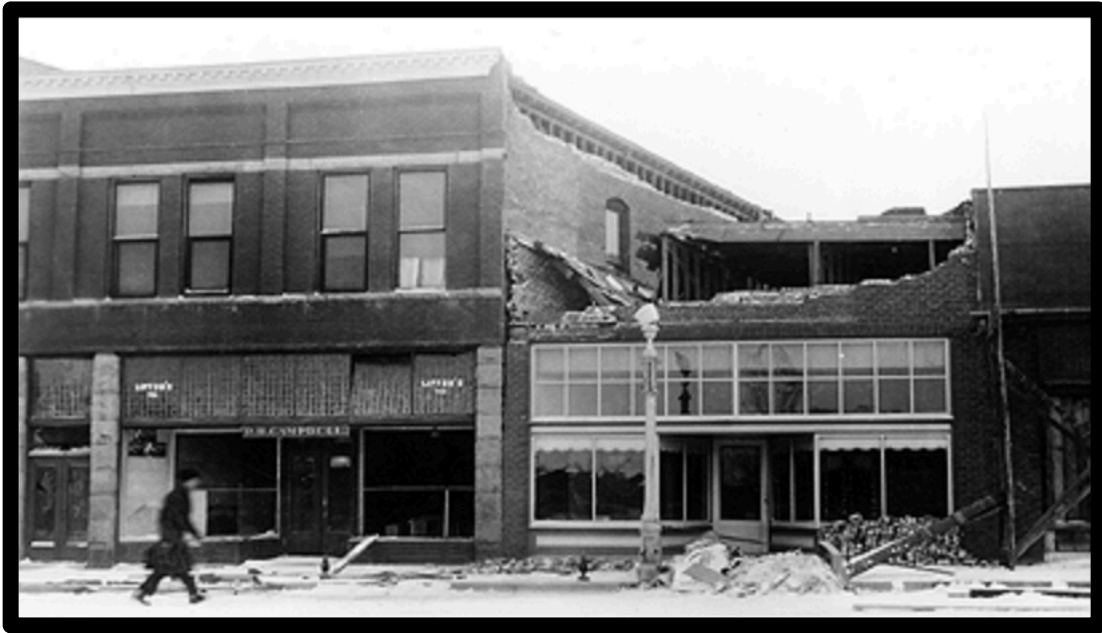
The business district near the Northern Pacific Depot suffered severe building damage during the main shock on October 18th. Photo from MT Historical Society collection.

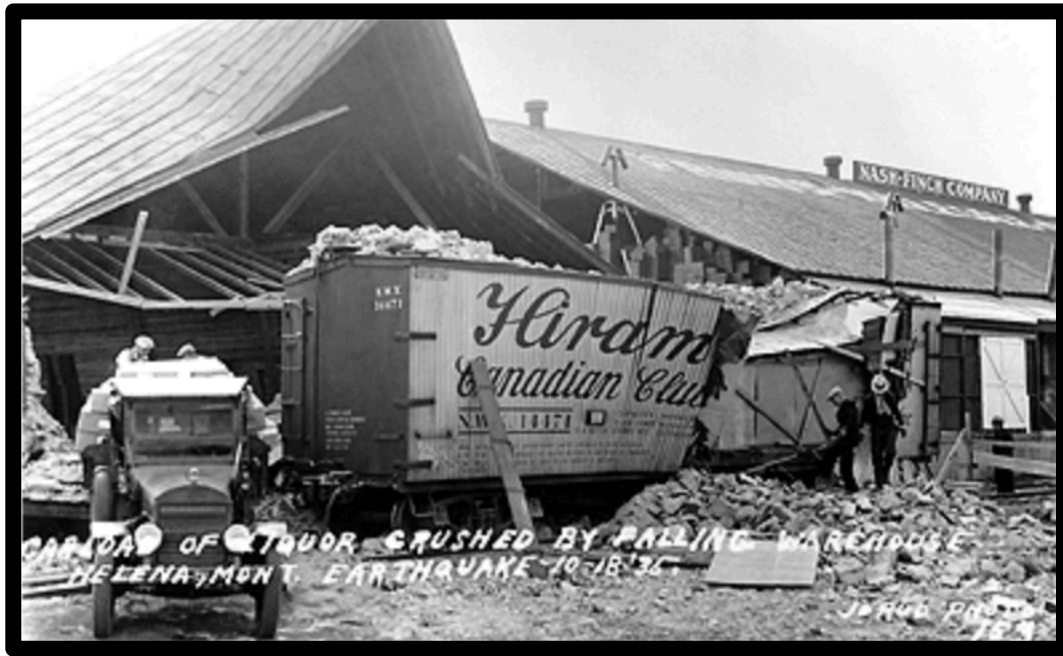
The warehouse roof of Christie Transfer and Storage fell in, pushing the walls out. One wall tore open a freight car of liquor being unloaded. Photo by L.H. Jorud, Helena, MT; from MT Historical Society collection.

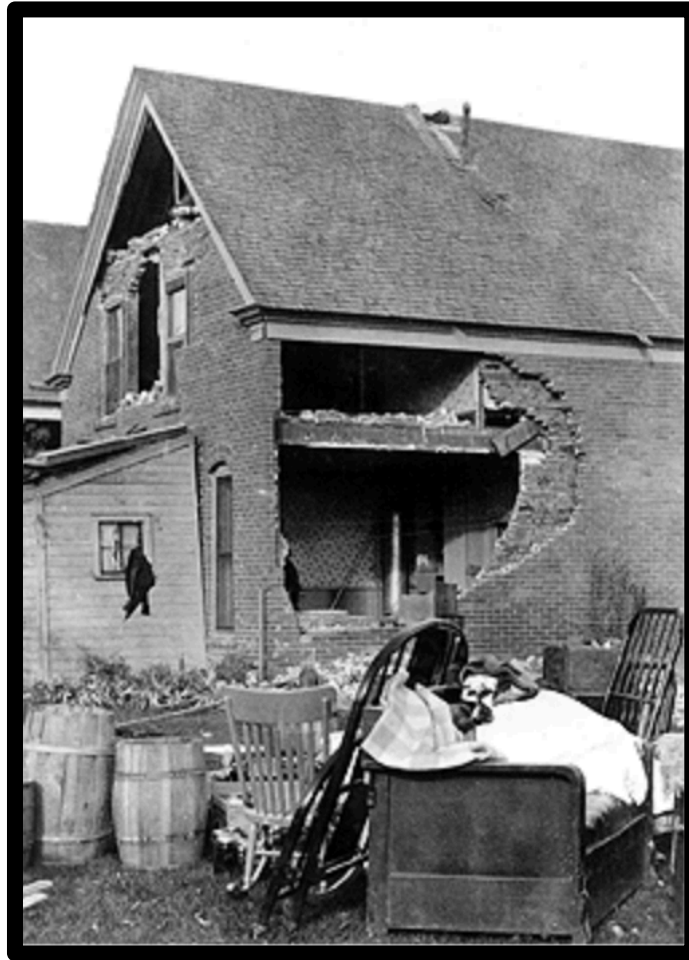
80% of Helena's 3000 homes were damaged, but the majority could be repaired at moderate cost. 500 were left homeless, at least temporarily. 29 homes were totally destroyed. Photo from MT Historical Society collection.

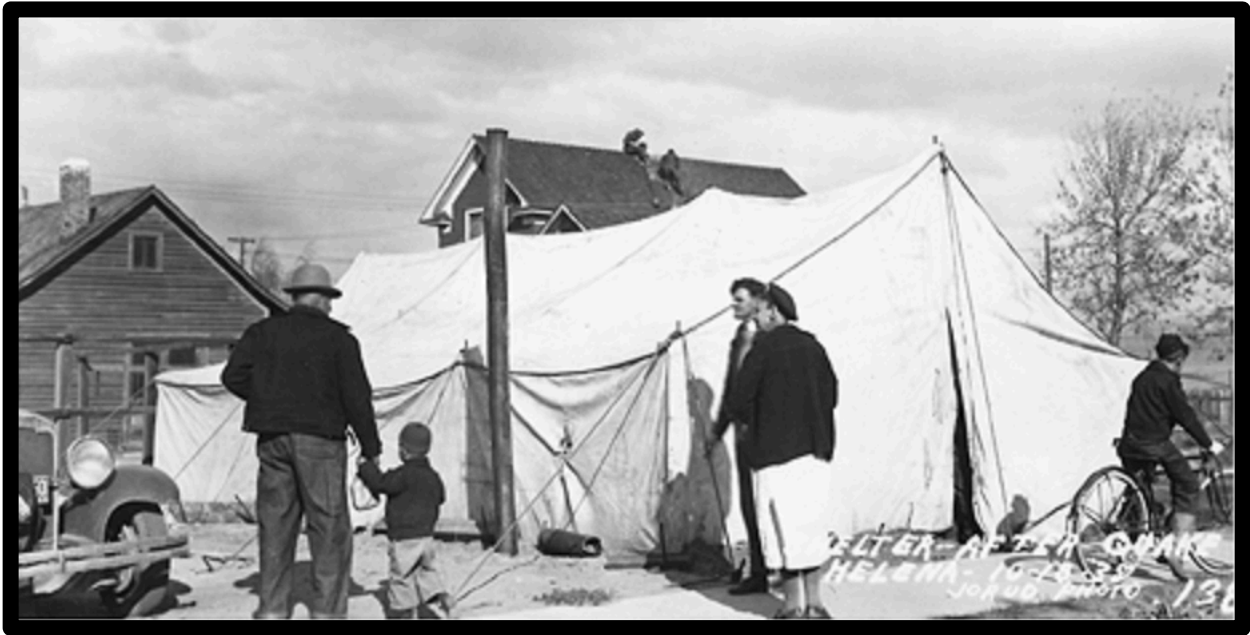
For nearly two weeks, many people lived in tents all over town. Some had no choice due to heavy damage to their homes. Others simply feared being inside during aftershocks. Photo by L.H. Jorud, Helena, MT; from MT Historical Society collection.

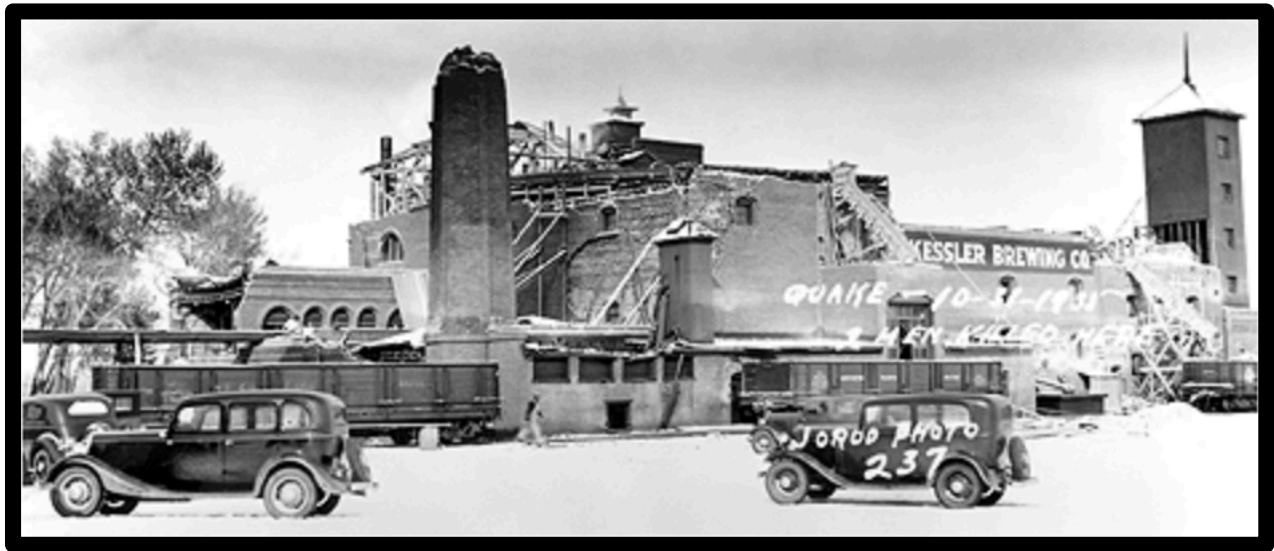
Two brickmasons on a work crew from Salt Lake City, Utah, were killed during the October 31st aftershock. They were removing a brick tower at the Kessler Brewing Co. when the ground shaking caused the bricks to tumble down. Photo by L.H. Jorud, Helena, MT; from MT Historical Society collection.

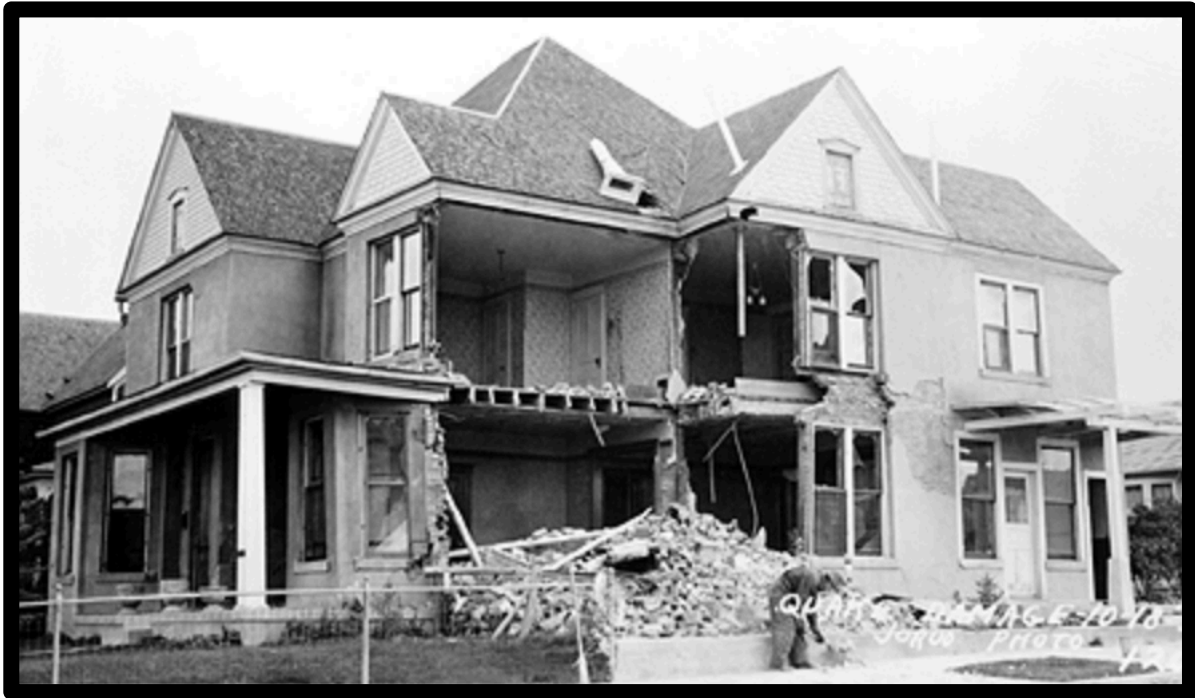
This residence at 1601 Lyndale Avenue, Helena, Montana, illustrates the typical partial failure of a brick bearing-wall dwelling. Photo by L.H. Jorud, Helena, MT; from MT Historical Society collection.

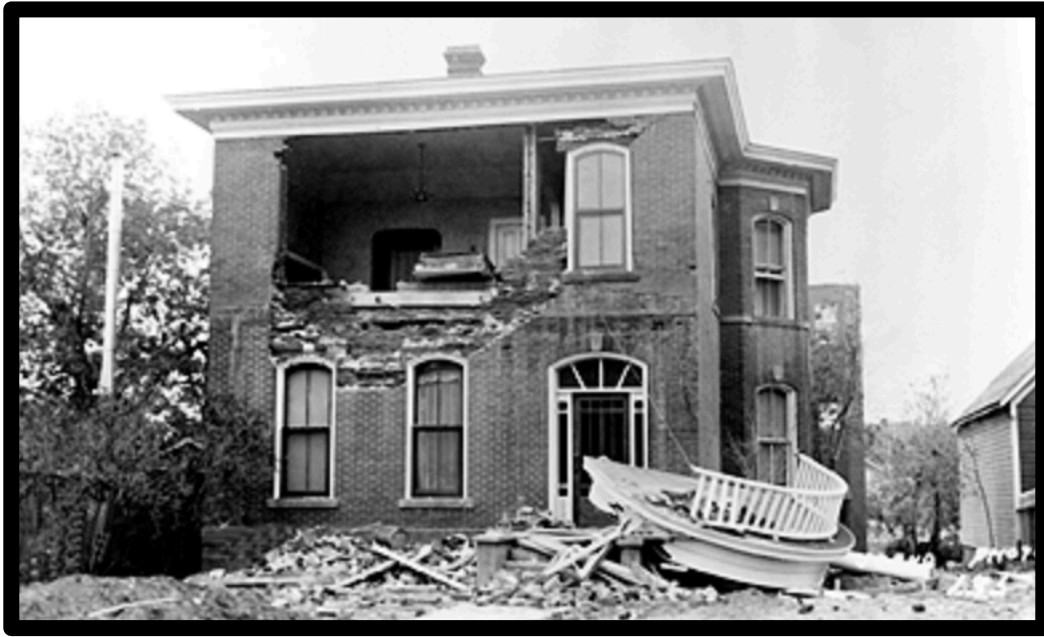
The balcony was ripped off the Fisher Apartments in Helena, Montana. Photo by L.H. Jorud, Helena, MT; from MT Historical Society collection.

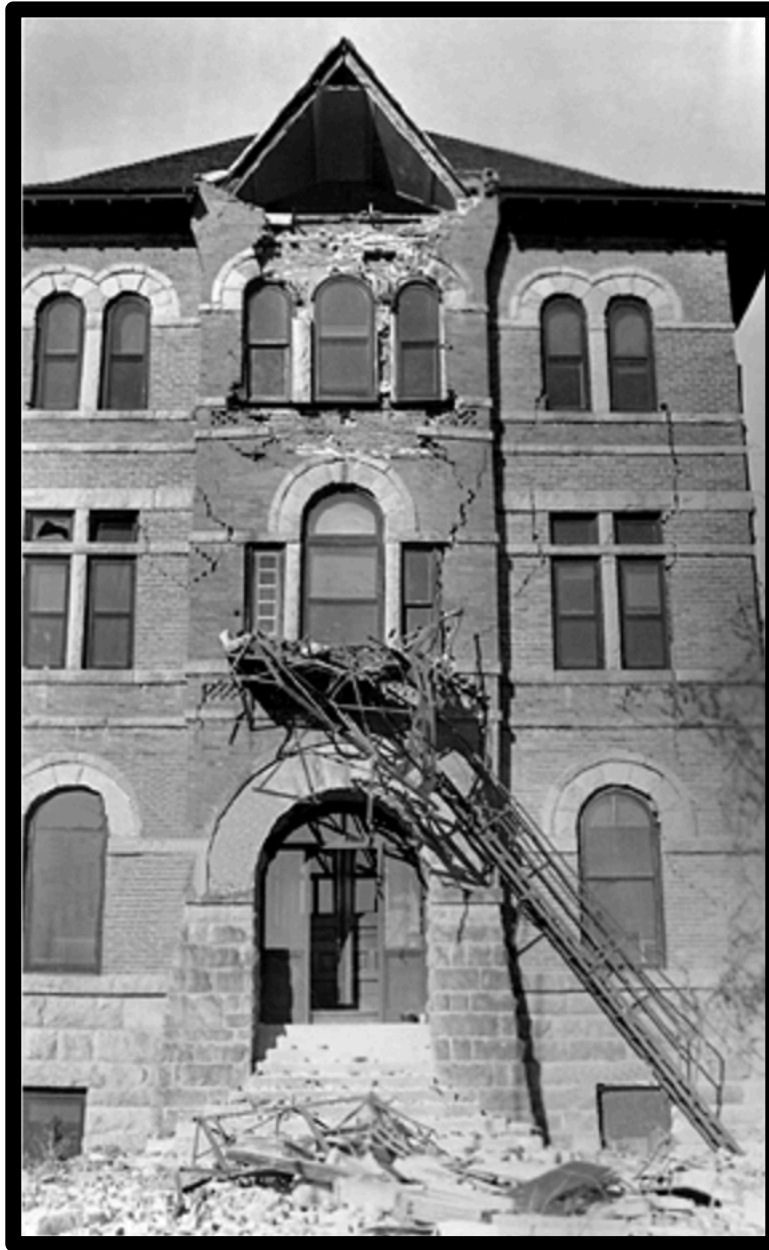
The upper brick walls of this dormitory of the Montana Deaconess School were severely damaged. The children (mostly orphans) it housed were uninjured. They were transferred to safer quarters at a neighborhood dance hall. Luckily, no one tried to exit this building during the earthquake! Photo by L.H. Jorud Photographer, Helena, MT.

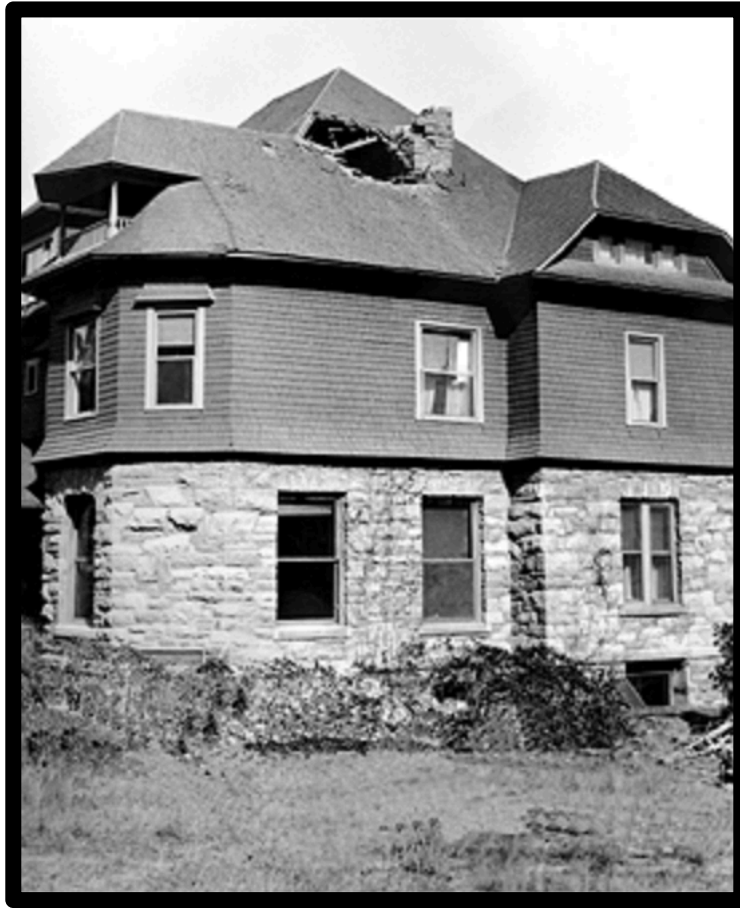
During an aftershock on October 23rd, the chimney on the Quigley home in Helena, Montana, fell through the roof of the home and nearly destroyed all of the furniture in the living room, including an expensive piano. Photo by L.H. Jorud Photographer, Helena, MT.

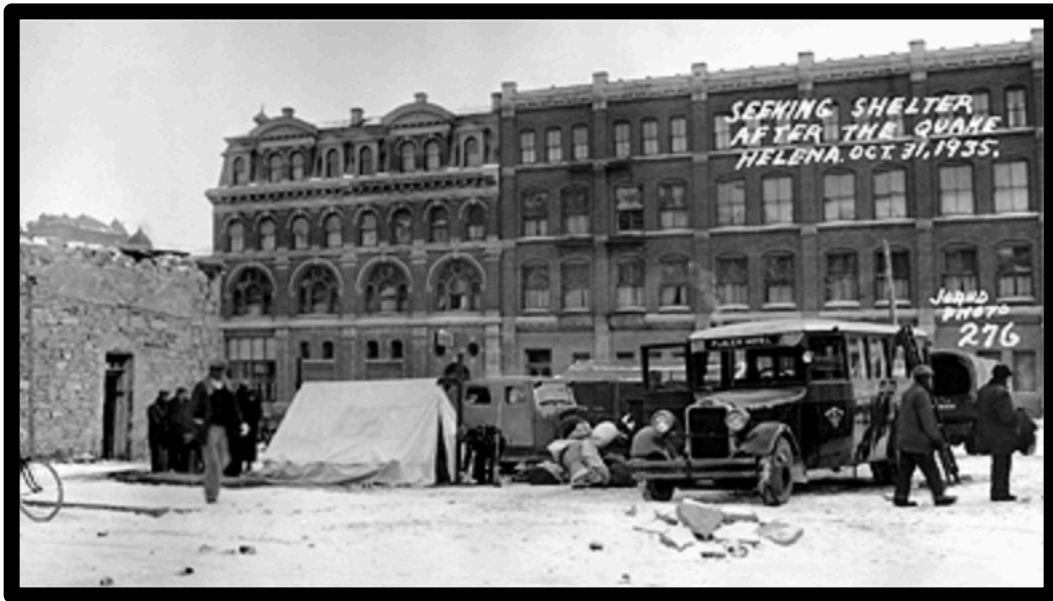
City Hall was severely damaged in the main shock forcing the Helena fire department and police department into temporary headquarters. The police department operated out of a tent and the "Black Maria" (vehicle belonging to the Placer Hotel). Photo by L.H. Jorud Photographer, Helena, MT.

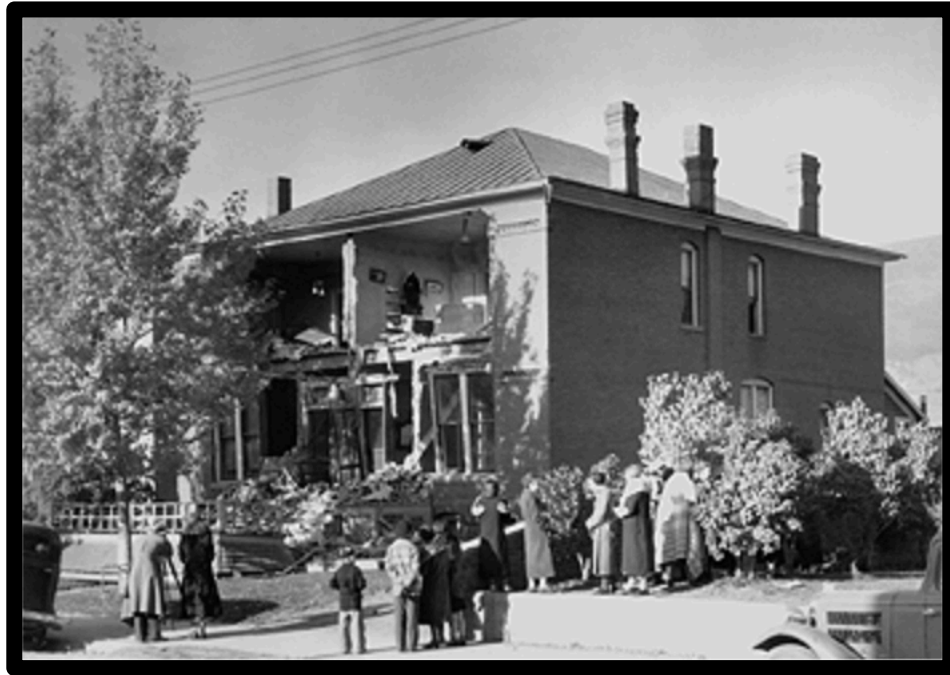
A two-story duplex on Rodney Street in Helena, Montana, was seriously damaged with porches and fronts dumped into the yard. Photo by Edward Reinig, Helena, MT.

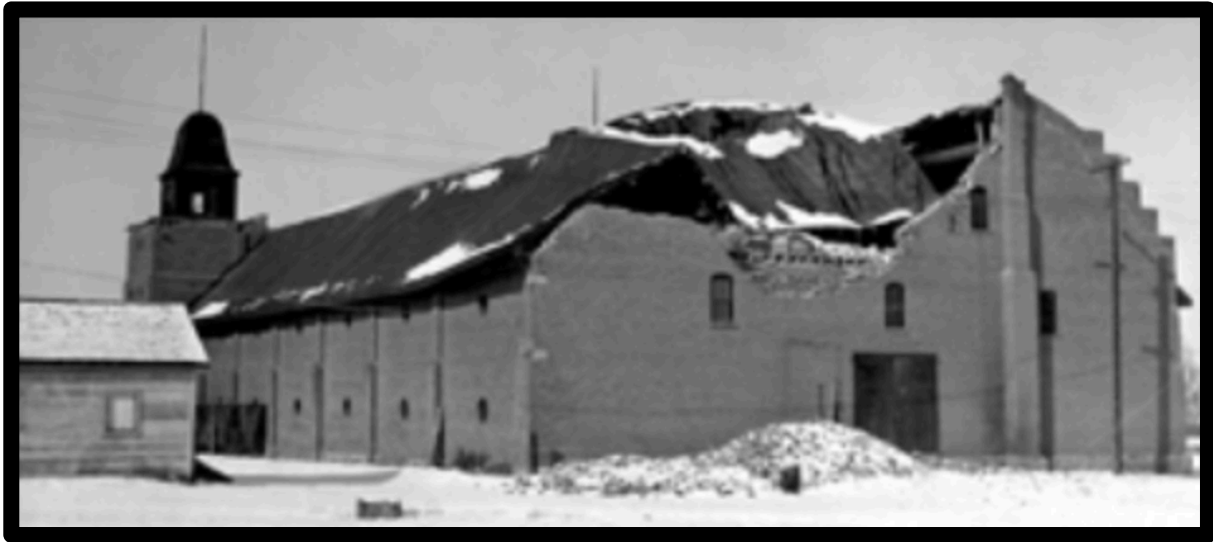
The U.S. Armory building on Warren Street in Helena, Montana, was severely damaged. Major Sol Peterson suffered severe head lacerations when he was caught in the collapse as he attempted to run outside.
