## Summary of Photographs

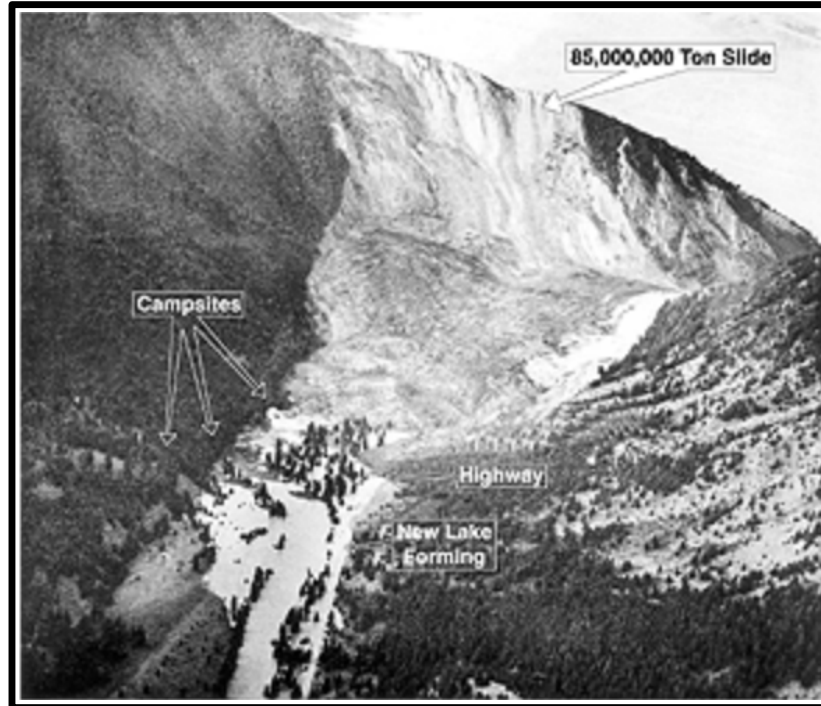
The Madison Canyon landslide, six miles below Hebgen Dam, was the most devastating result of this earthquake. Nearly half of a mountain fell to the canyon bottom, covered part of Rock Creek campground, blocked State Highway 287, and dammed the Madison River, causing Earthquake Lake to form. Twenty six people were killed by this landslide, but only seven bodies were found. The remaining 19 are presumed buried under the landslide. This photo was taken the day after the earthquake.

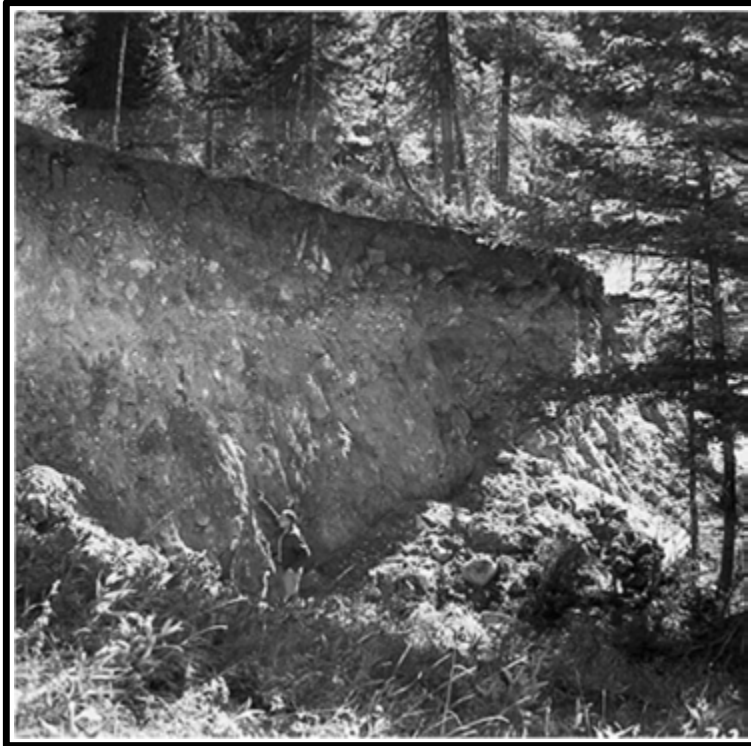
Several new fault scarps formed during the earthquake. The largest was the Red Canyon scarp located north of Hebgen Lake. It is 14 miles long with a maximum height of 21 feet. Photo #116 from J.R. Stacy Collection, U.S. Geological Survey.

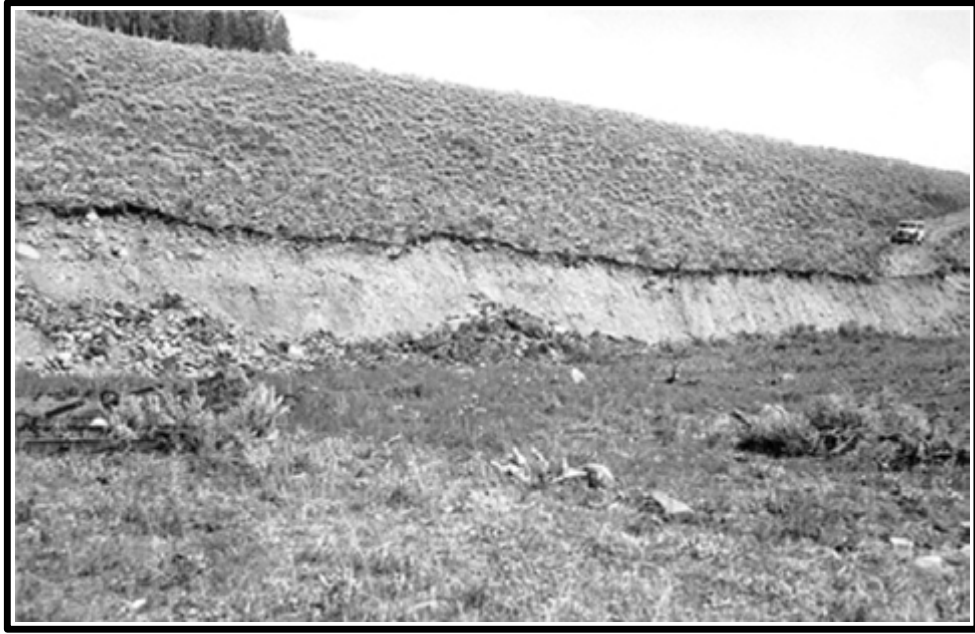
Red Canyon fault scarp crosses the access road to Blarneystone Ranch. Photo #5 from J.B. Hadley Collection, U.S. Geological Survey.

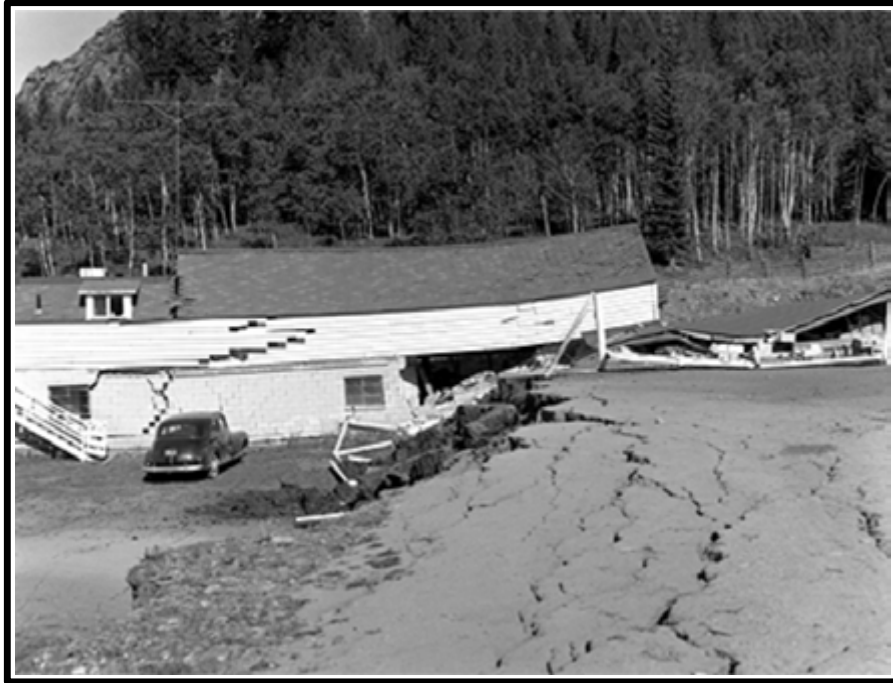
The remnants of the old Red Canyon fault scarp were hidden by sand and gravel deposits when softwater tycoon, Emmett J. Culligan, built his "Blarneystone Ranch" across it. When the fault was reactivated in this earthquake, the earth dropped 10 -12 feet beneath the ranch, collapsing the storage shed portion on top of the scarp and severely buckling the domestic quarters that were attached. The shed portion was built of unreinforced concrete blocks. The domestic quarters had a wood frame structure on top of concrete blocks. The caretaker family climbed out of windows to escape the building after the earthquake. Photo #17 from I.J. Witkind Collection, U.S. Geological Survey.

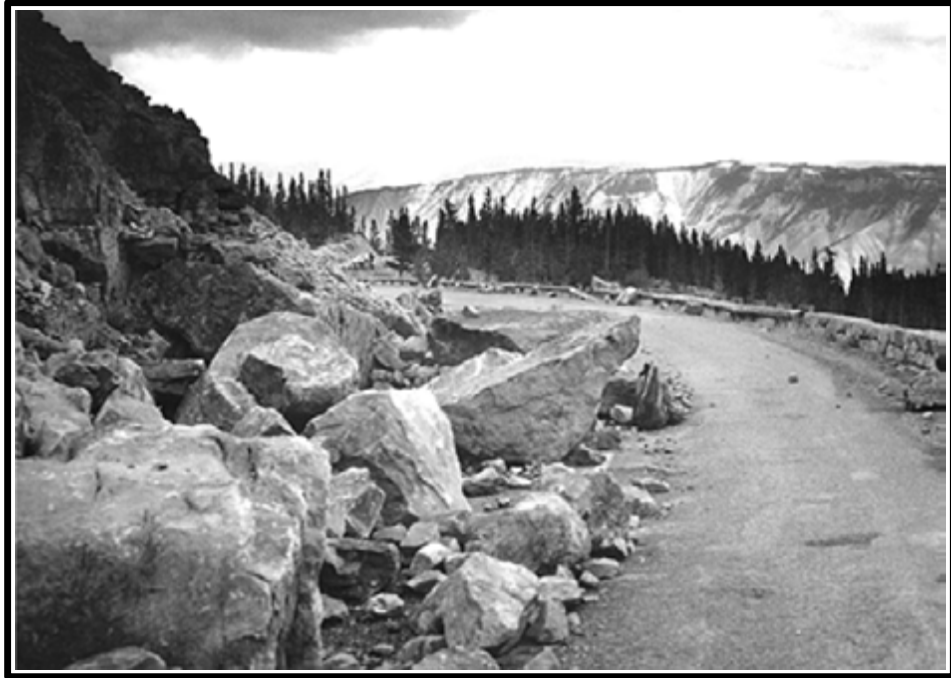
The earthquake caused rockfalls and landslides throughout the northwest section of Yellowstone National Park. This one blocked the road at Golden Gate Canyon. A later slide just missed five park workers. Photo by Haynes, Inc. for the Deseret News.

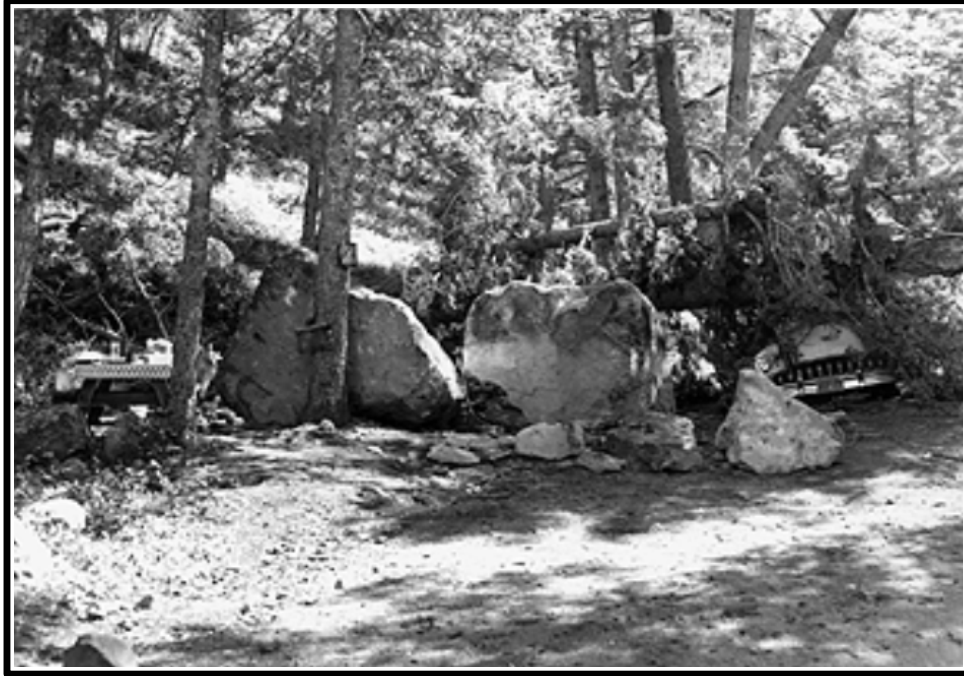
Two people died at Cliff Lake Campground, 15 miles southwest of the Madison Canyon landslide, when a large boulder bounced over the picnic table and landed on their tent. Their three sons, sleeping a few feet away, were not injured.

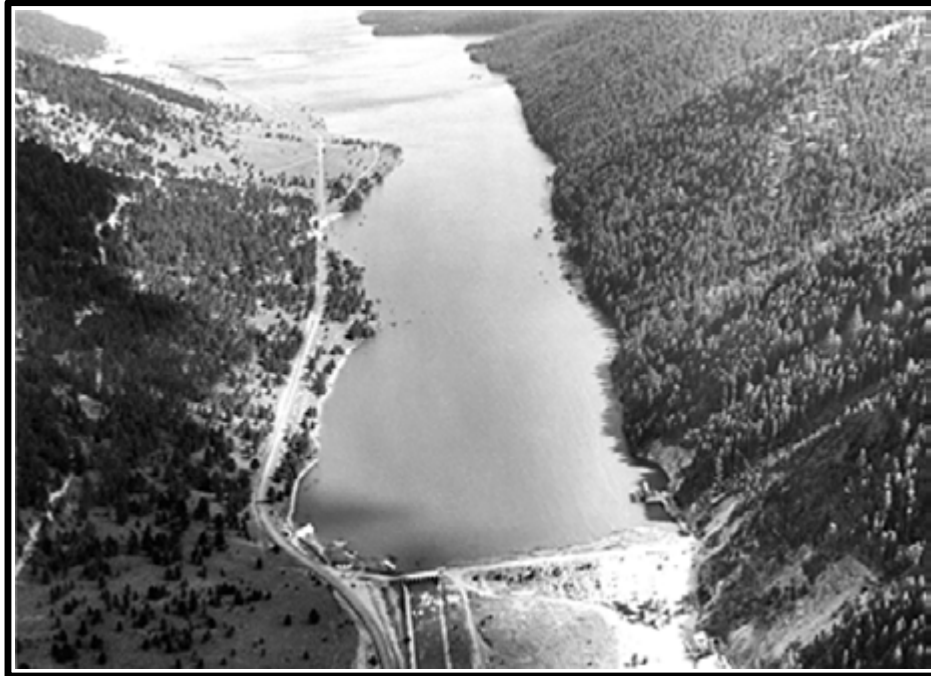
The Hebgen Lake Dam is an earth-fill, concrete core dam that was built on the Madison River in 1914. It survived the intense vibrations of the earthquake as well as the repeated waves (seiche) which overflowed from Hebgen Lake. These waves were caused by the sudden down-dropping and tilting of the lake bottom during the earthquake. Notice the newly-formed Hebgen fault scarp to the far left and the small landslide (upper third of photo) that dropped part of Highway 287 into Hebgen Lake.

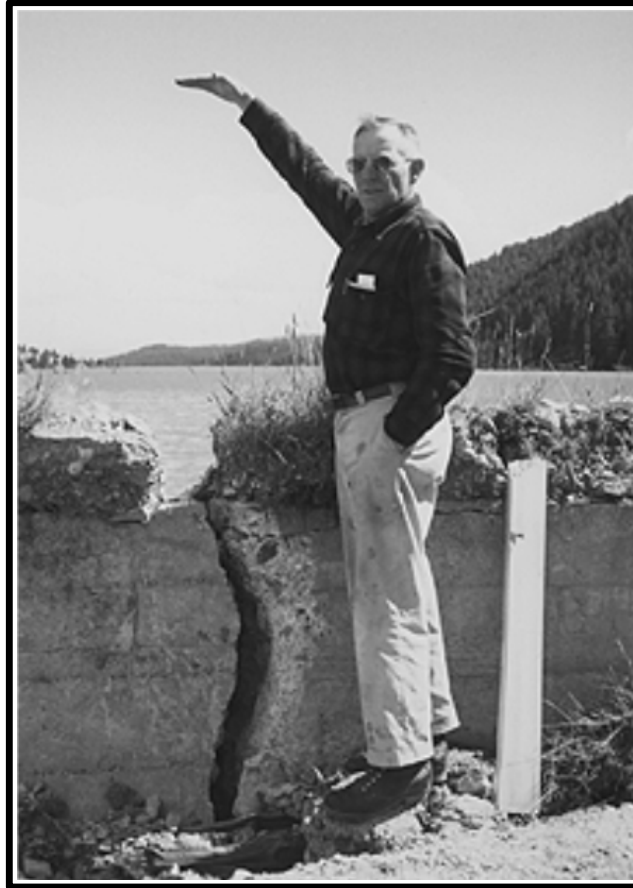
George Hungerford, dam caretaker, observed 3-4 foot surges of water overtopping the dam. With each surge water flowed an estimated 10 minutes before withdrawing. The earthquake also caused the earth-fill to drop leaving the concrete core wall exposed. Its sod covering remained in place. The largest of the 16 cracks in the wall was 3 1/2 inches wide. Despite all of this the dam held. Photo by Dick Engstrom, Montana Power Company.

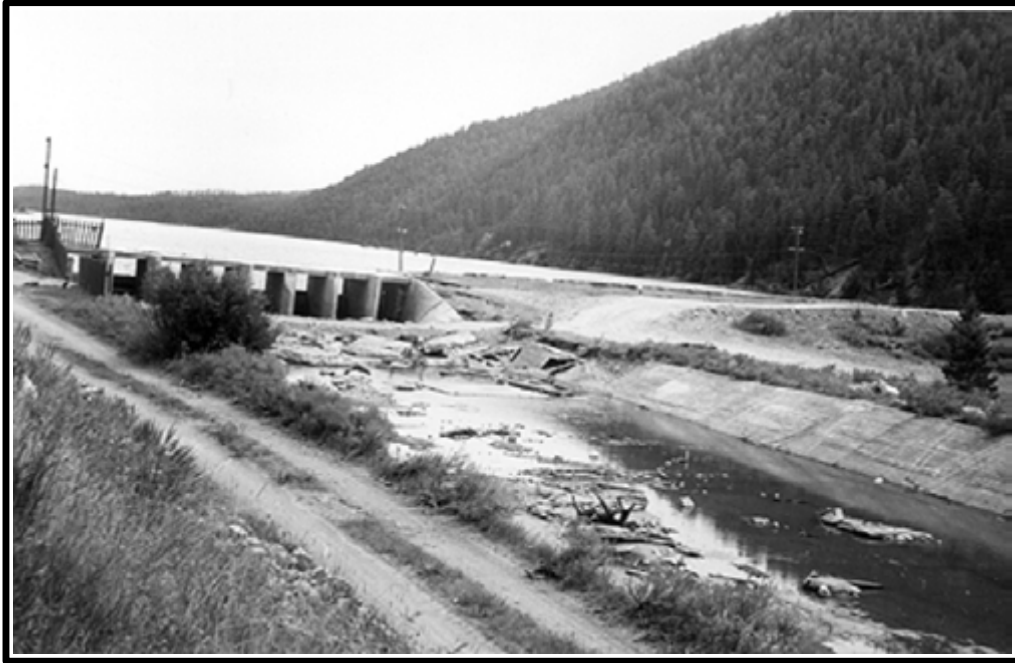
The spillway of Hebgen Dam was damaged by the ground shaking. Water flowing down the spillway further eroded some of the concrete slabs.

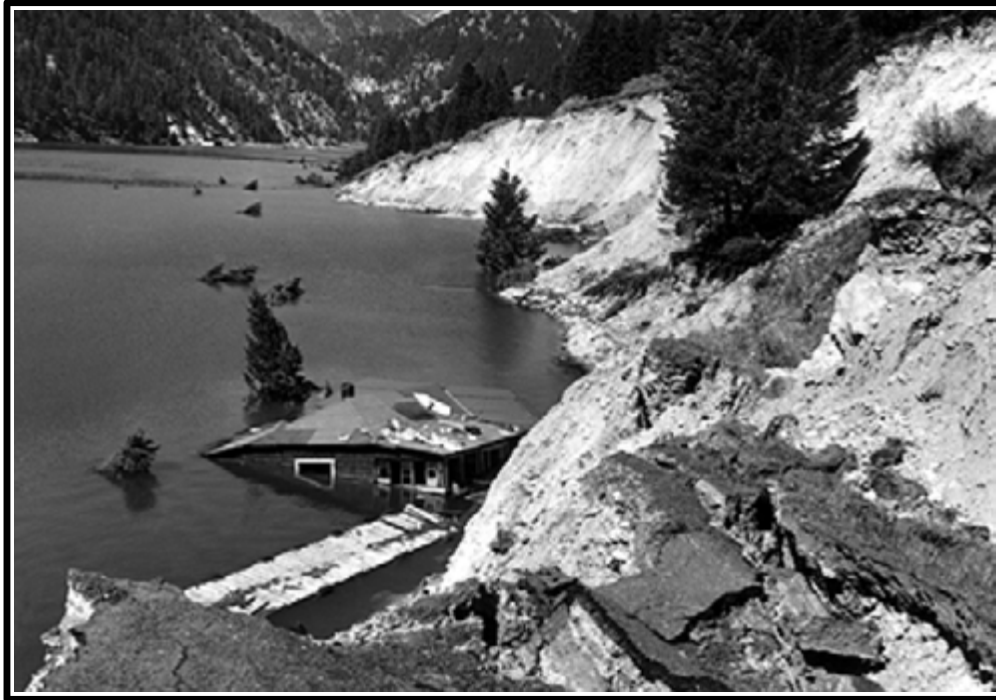
The north shore of Hebgen Lake was submerged when the rock on which it rests dropped down adjacent to the new Hebgen fault scarp. The main residence at Hilgard Lodge dropped off its foundation into the lake and floated to this location.

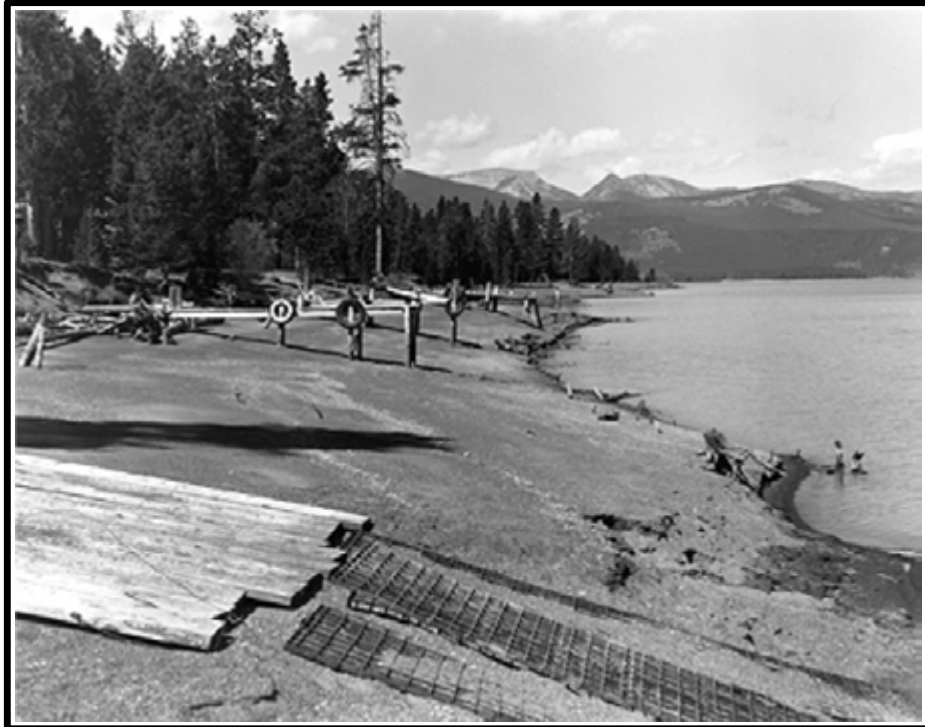
Northward tilting of Hebgen Lake submerged the north shore and left these boat docks high and dry along the south shore. This down-dropping of the lakebed caused the waves that overtopped the dam 4 times and continued oscillating 11 1/2 hours. Photo #53 from I.J. Witkind Collection, U.S. Geological Survey.

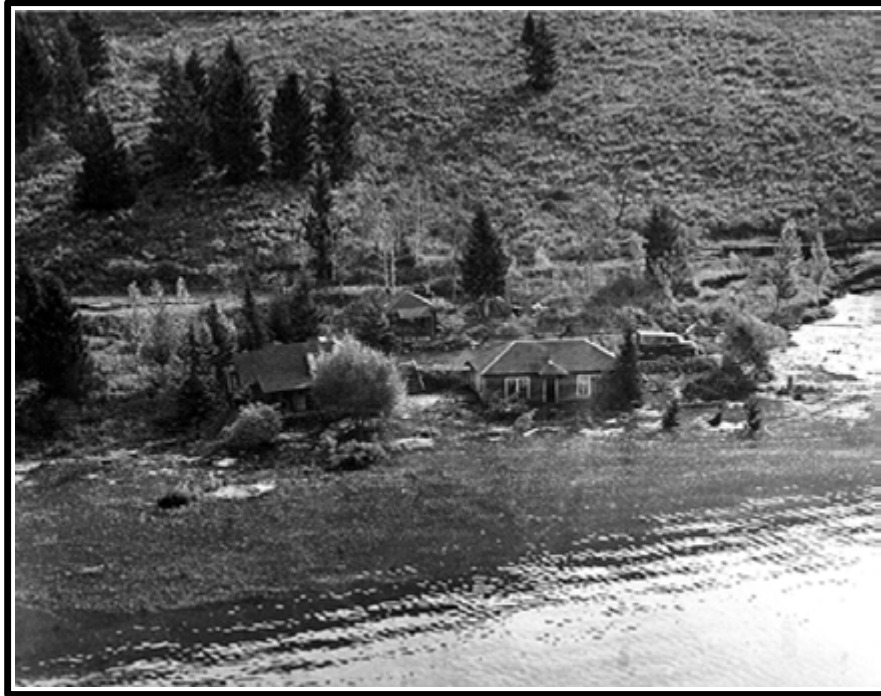
Hebgen Lake surrounded these units of Hilgard Lodge on its northeast shore when the basin beneath the lake dropped (subsided) over a large area during the earthquake.

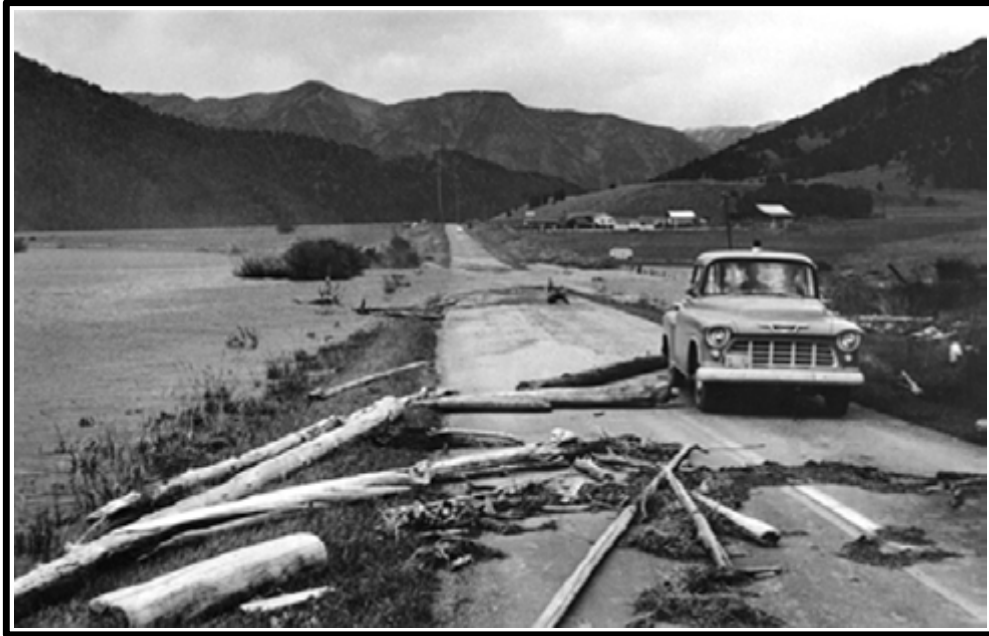
Driftwood was thrown up onto the road by the seiche (oscillatory waves) in Hebgen Lake.

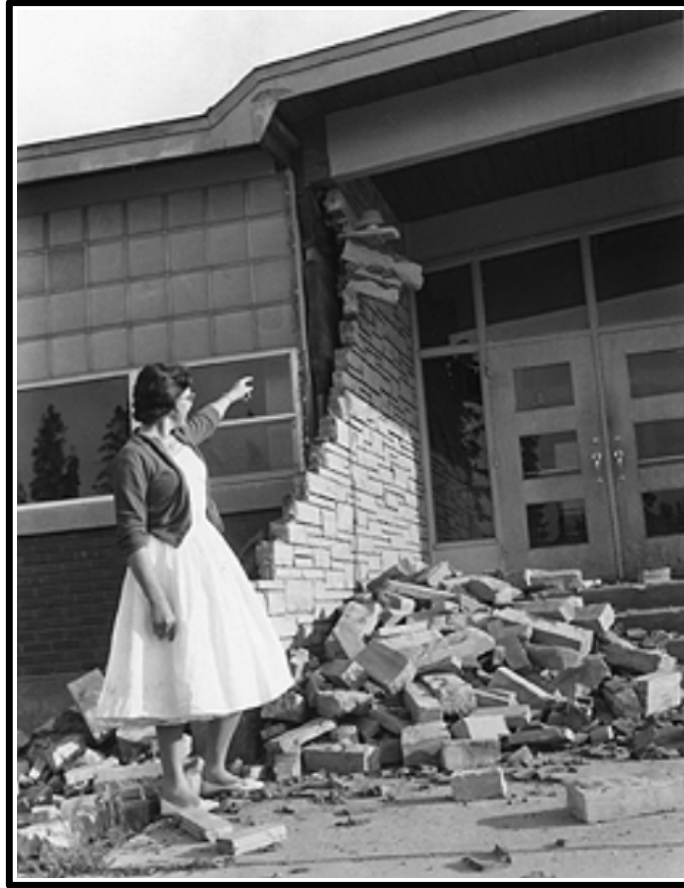
The stone firewall at the front entrance to the West Yellowstone Public School collapsed during the ground shaking. Photo by Conrad, Salt Lake Tribune.

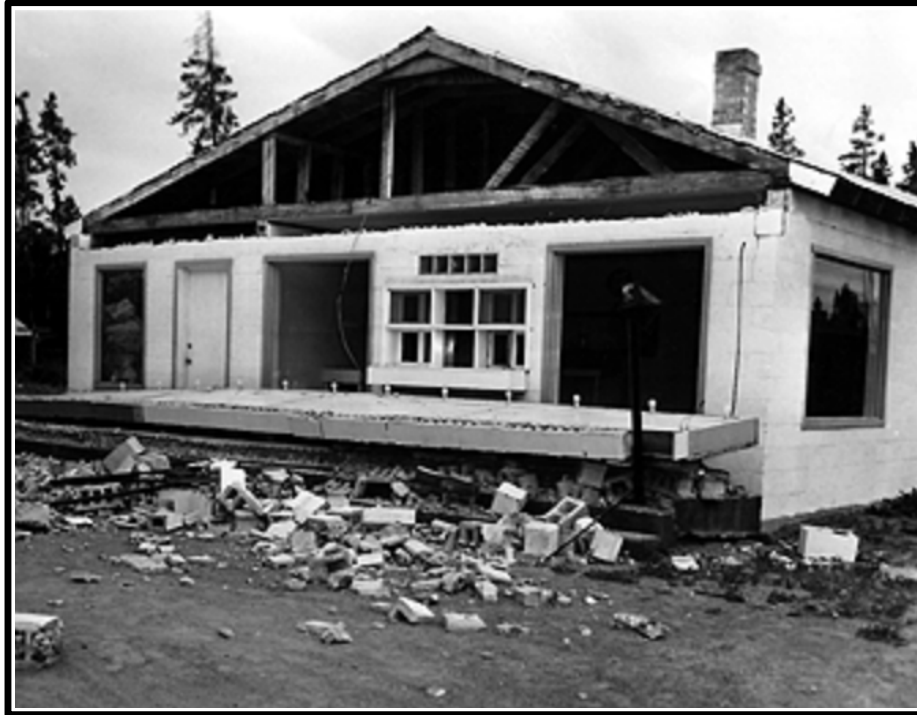
The unanchored gable fell from the front of the Arctic Circle store in West Yellowstone, eight miles from the epicenter.

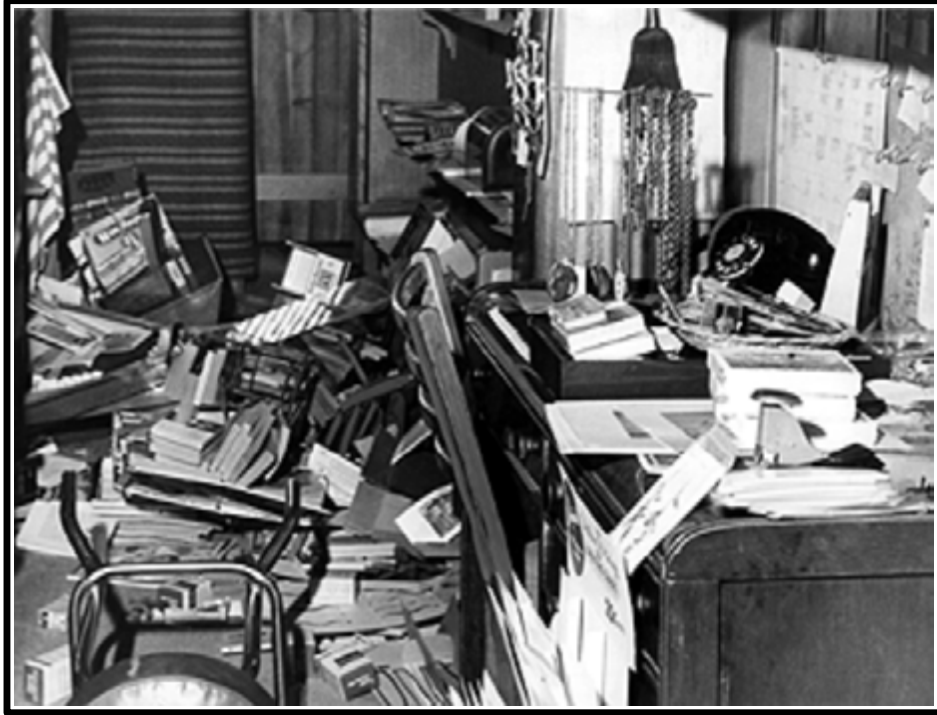
Ground shaking tossed merchandise and furnishings in offices, stores, and homes in West Yellowstone, 8 miles from the epicenter.

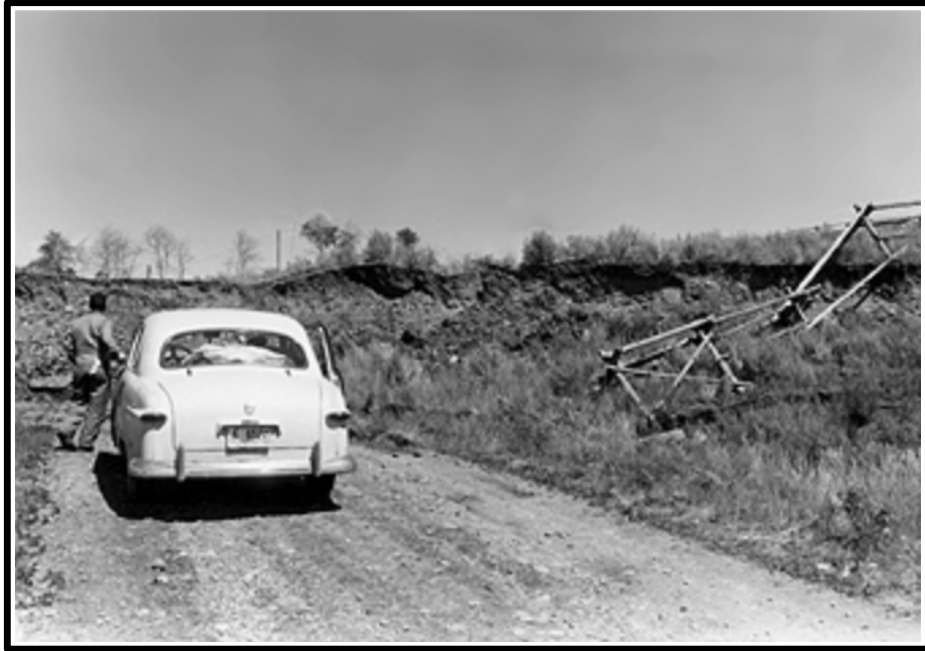
Evacuating the area after an earthquake may not be easy! Asplary of the Red Canyon fault scarp lifted a 10-foot wall across the road. Photo by Carl Hayden, Salt Lake Tribune.

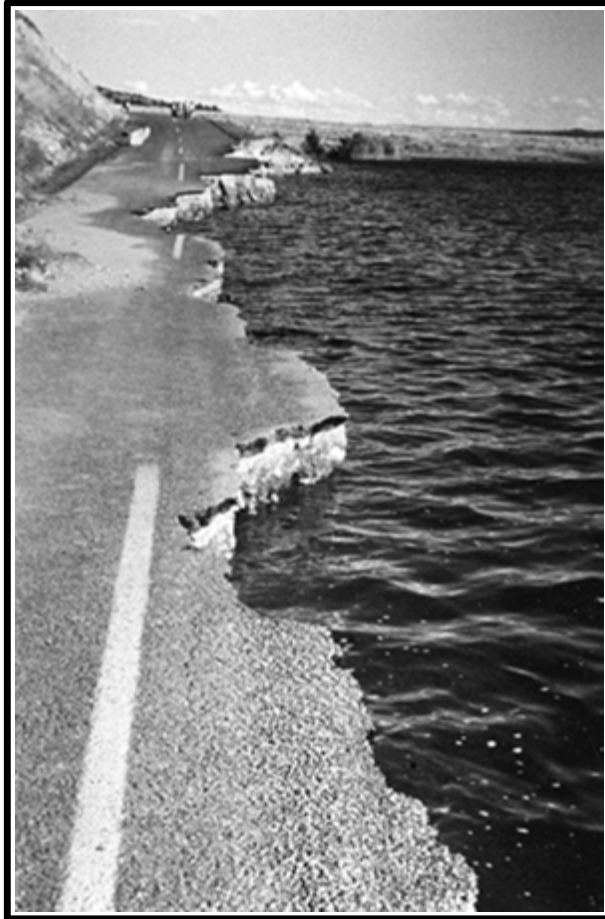
Four small landslides dropped portions of Highway 287 into Hebgen Lake, blocking the exit route for people in the Madison Canyon above the landslide. Photo #116 from I.J. Witkind Collection, U.S. Geological Survey.

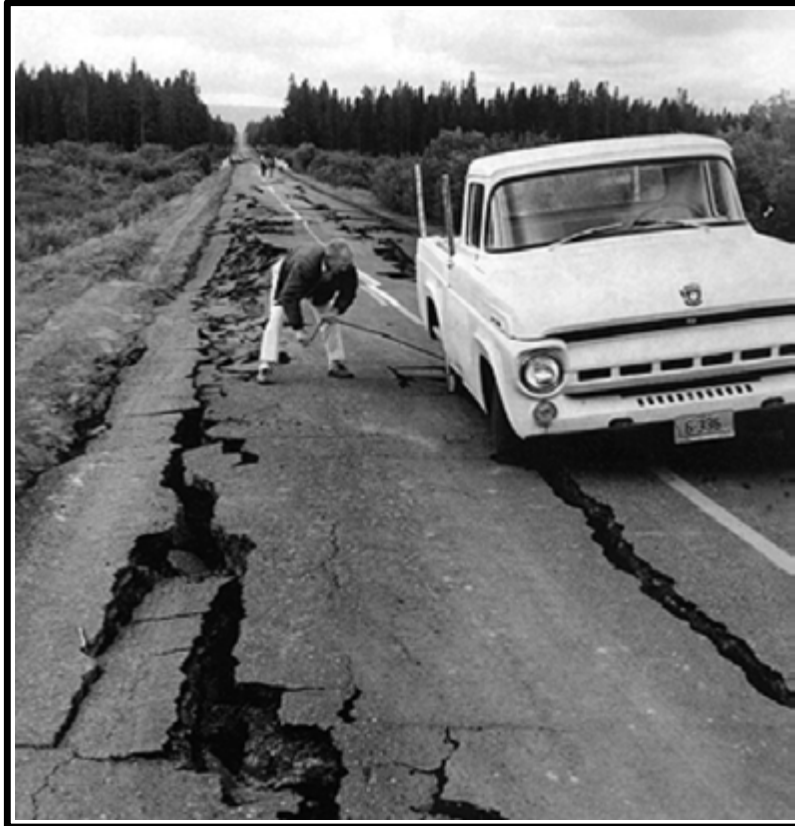
Ground shaking caused roadbeds to settle and crack, hampering safe driving. This highway is U.S. 91 between West Yellowstone and Hebgen Lake. Photo by Ray Jones, Deseret News.

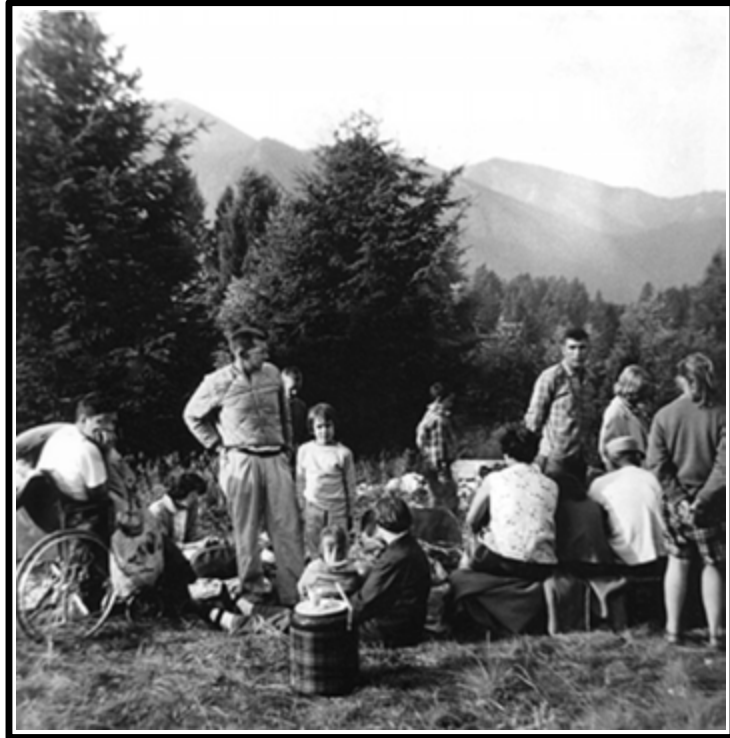
Campers in Madison Canyon wait for rescue after their usual exits are blocked by the enormous Madison Canyon landslide to the west and smaller landslides to the east that dropped parts of the highway into Hebgen Lake. The man in the wheelchair is Henry Bennett of Arizona. During the earthquake, rising water swept him out of his sleeping bag.

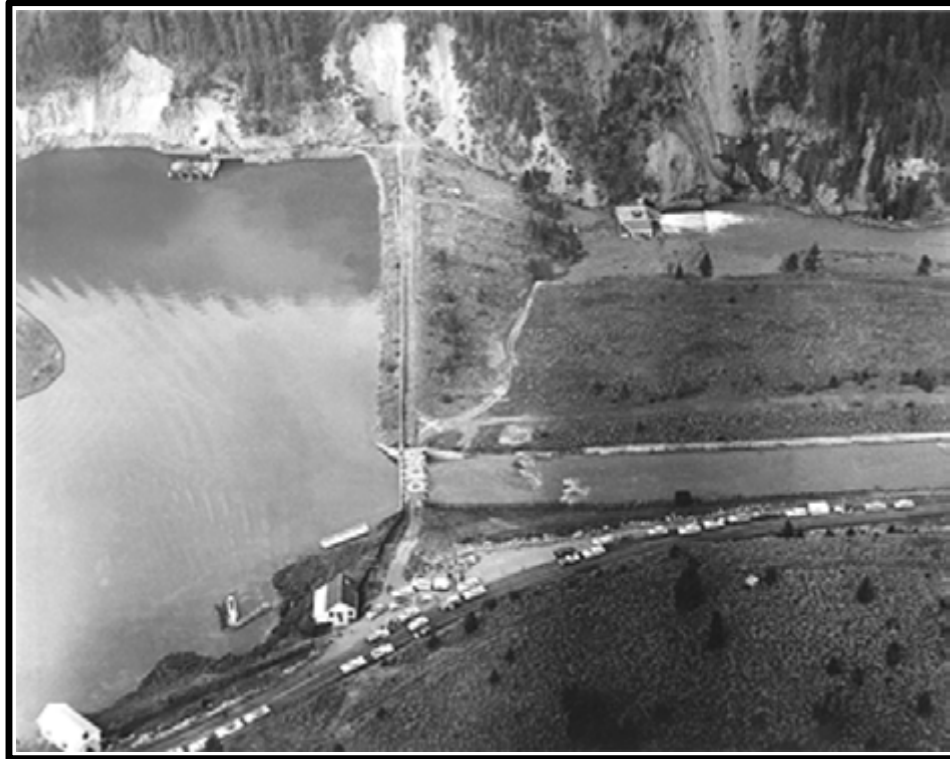
Chalked messages on Hebgen Dam tell those flying over that the dam is OK, but that people need help (SOS) to get out of the canyon. Photo by J.M. Heslop, Deseret News.

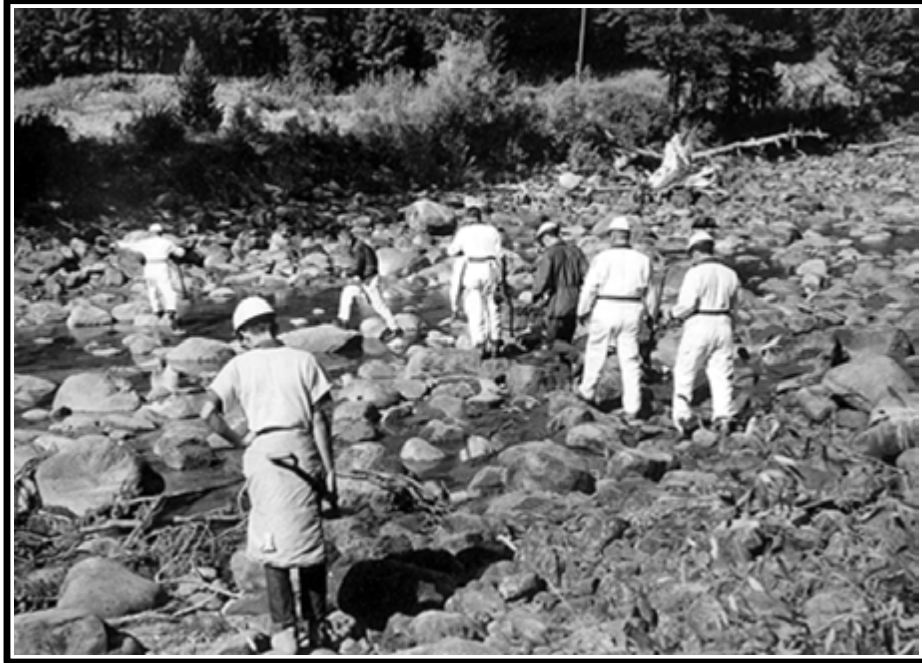
Rescuers search the rocky bed of the Madison River and the area adjacent to the huge landslide for victims and personal belongings that may give some clue to the identities of those buried by the landslide. Photo by Larry Finnegan, Deseret News.

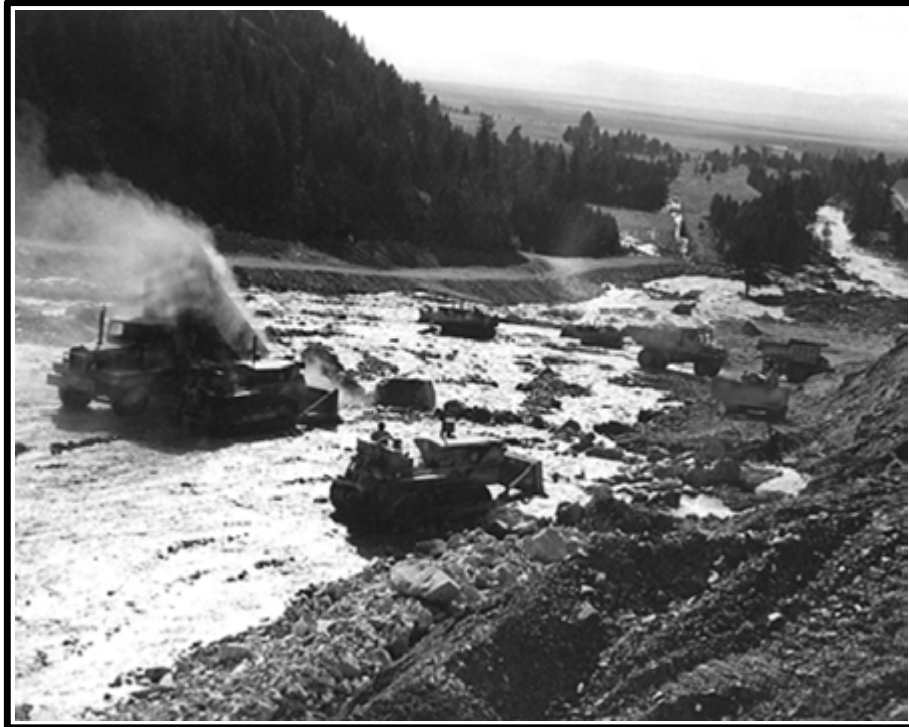
The Army Corp of Engineers race to complete a spillway at the top of the Madison Canyon landslide. It was feared that the newly forming "Earthquake Lake" would break through the landslide-dam and cause devastation downstream. Photo by United Press International.
