Summary of Photographs

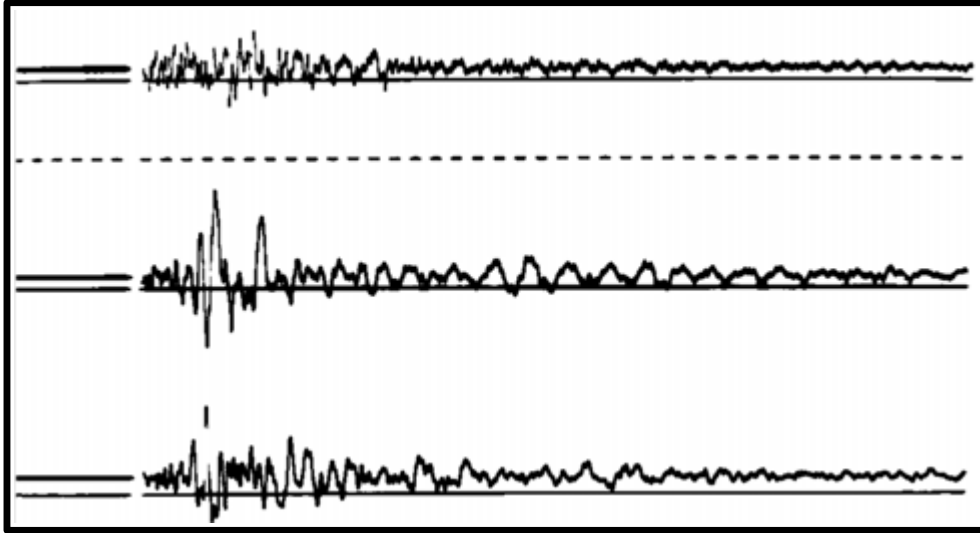
These strong-motion recordings of the vertical (.06g), north-south (.10g), and east-west (.13g) ground accelerations during the Cache Valley earthquake provide engineers with useful data in designing buildings resistant to earthquakes. The instrument itself was owned by the U.S. Coast and Geodetic Survey and located at Utah State University.

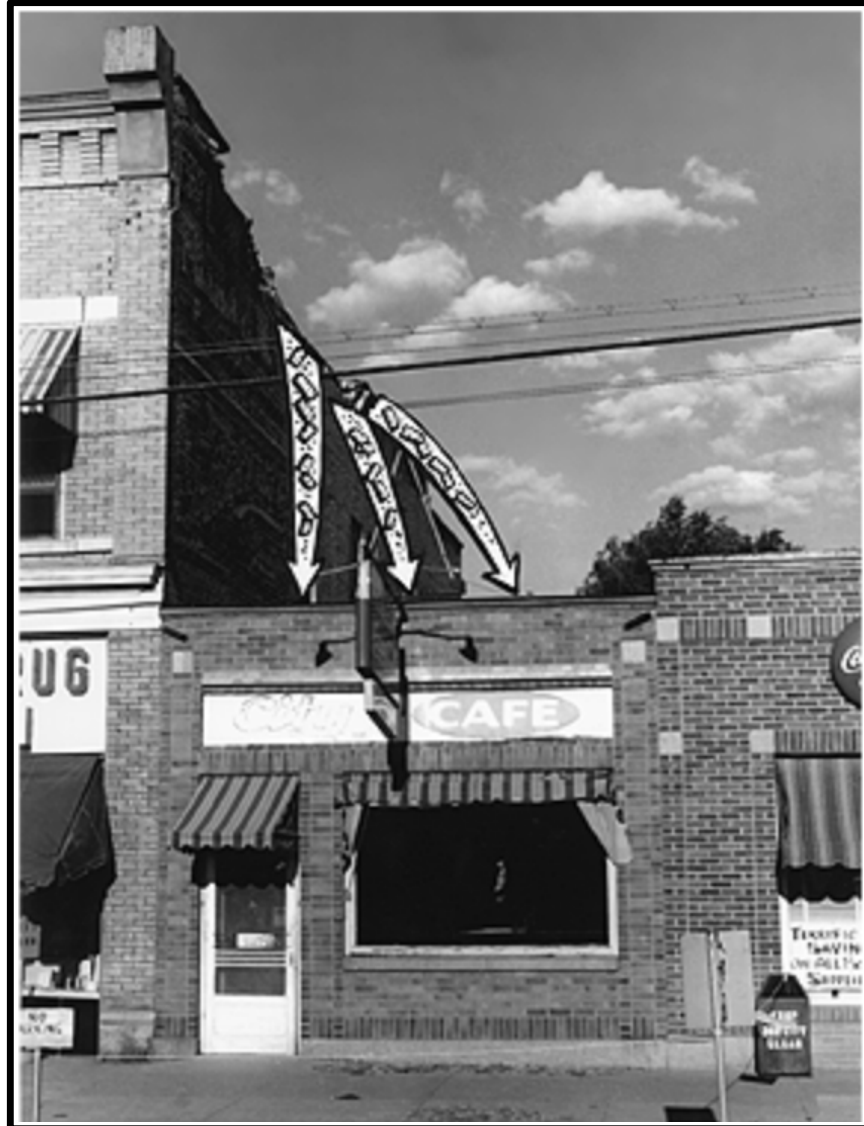
Arrows show path of bricks that tumbled from the parapet of the Lewiston Drugstore onto the roof of the City Cafe in Lewiston, Utah. Luckily this cafe in Lewiston, Utah, was not open when ground shaking caused part of a brick parapet of an adjacent building to fall through the roof. Photo by Ray G. Jones.

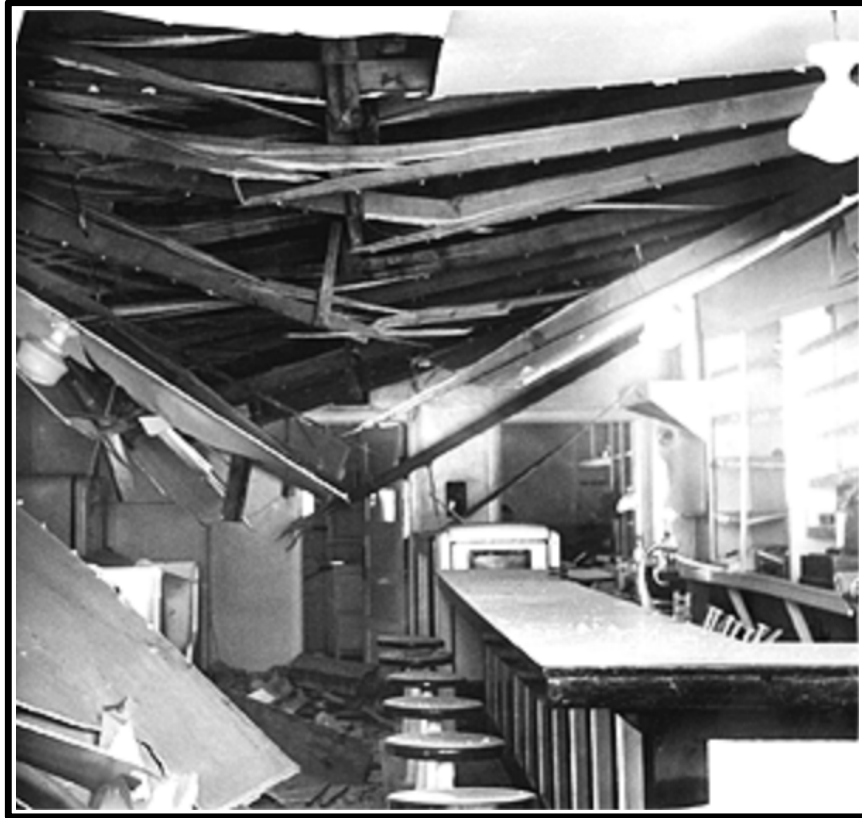
Luckily this cafe in Lewiston, Utah, was not open when ground shaking caused part of a brick parapet of an adjacent building to fall through the roof.

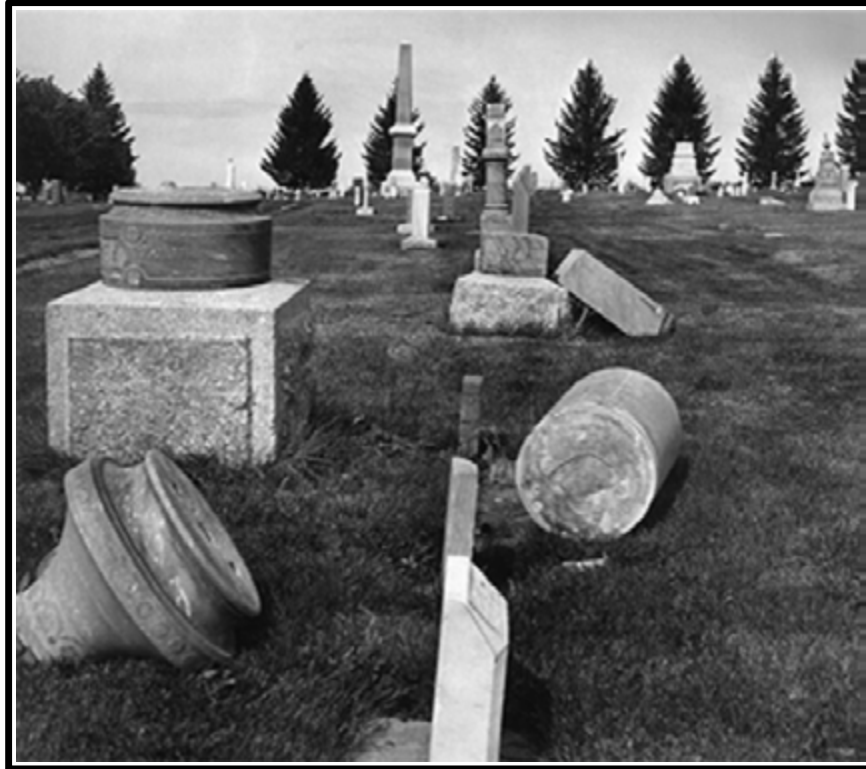
Many headstones in the Richmond, Utah, cemetery toppled or were twisted during the ground shaking.

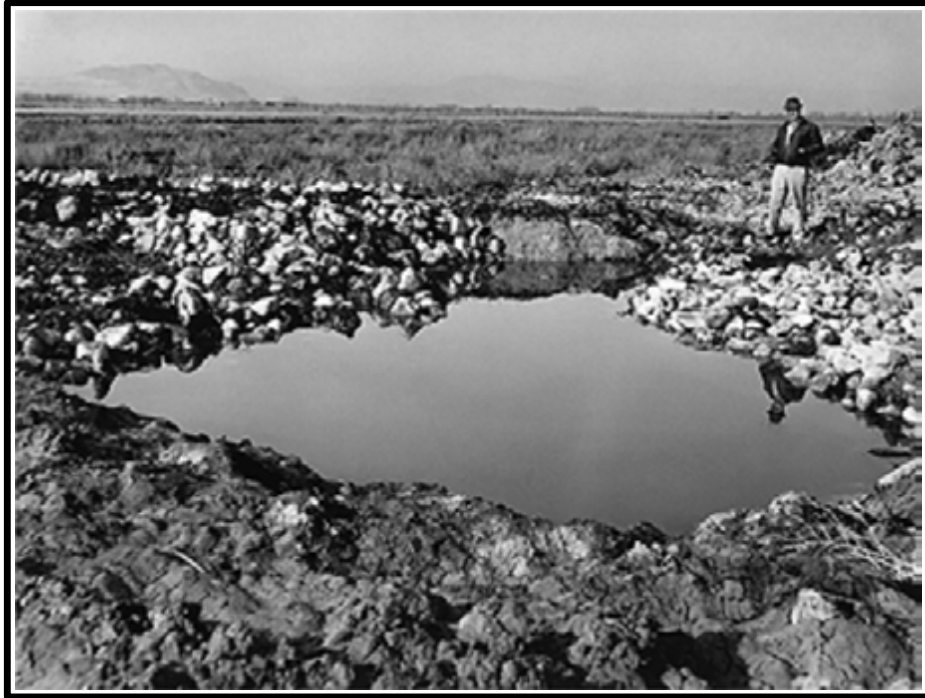
This "waterhole" on the Logan-Cache Airport property is one of the springs in the Logan area that was regenerated during the earthquake.

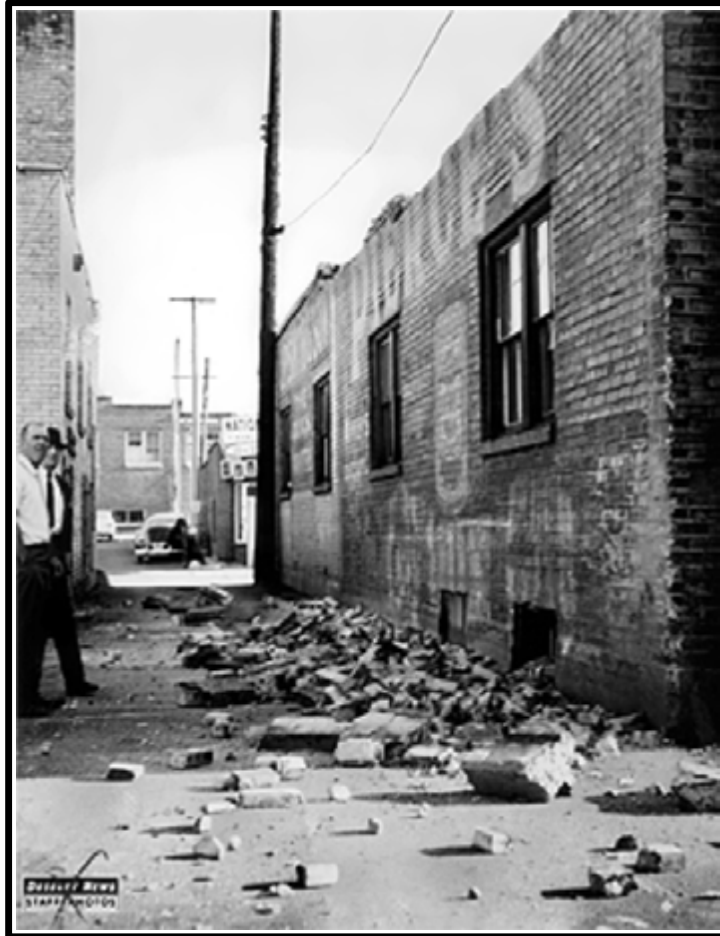
An alley in Logan, Utah, is littered with bricks that fell from a 40 foot length of wall of the Smith Printing company. Photo by Chris Nielsen.

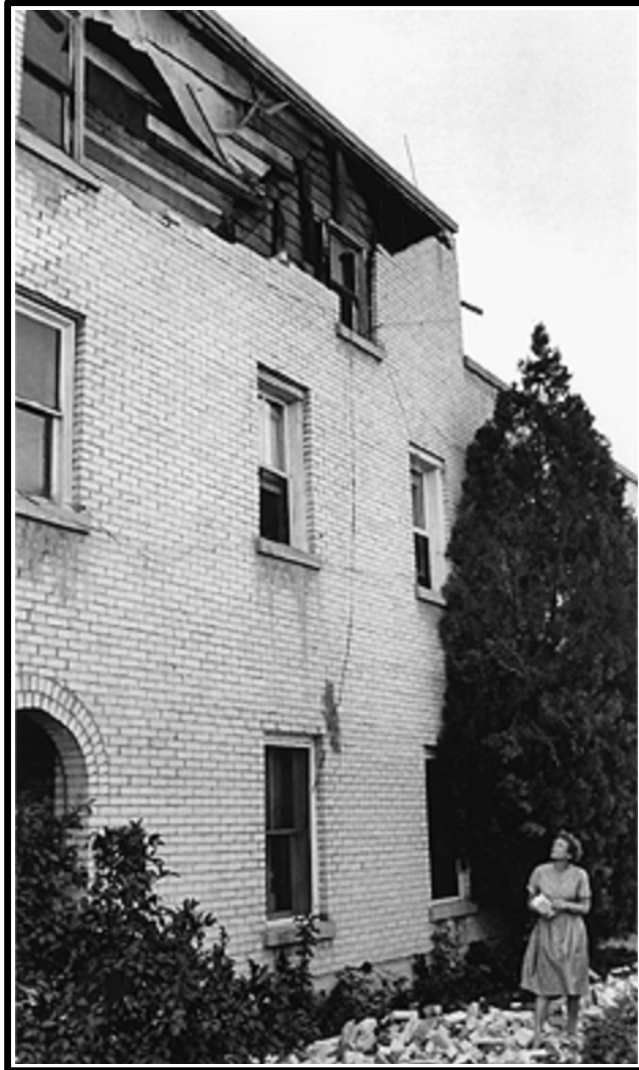
Brick veneer fell from the Astle Apartments in Logan, Utah.

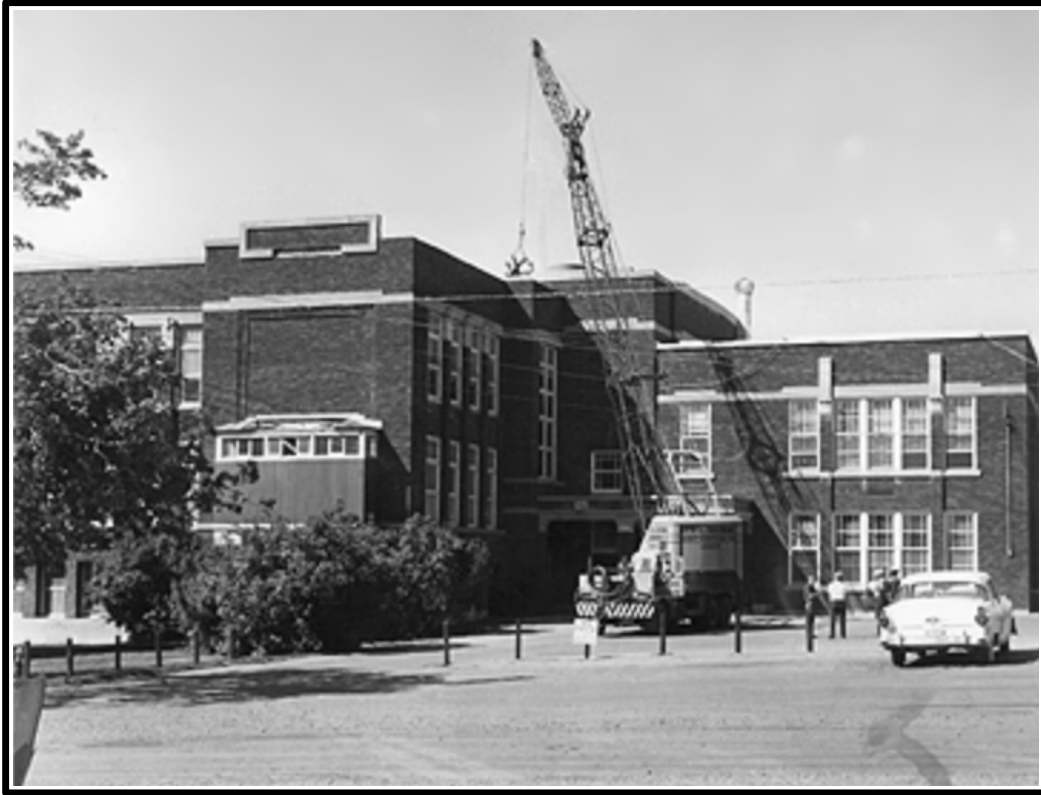
At North Cache High School in Richmond, Utah, cranes are used to remove the heavy (150 pounds per square foot) capstones that were loosened during the earthquake.

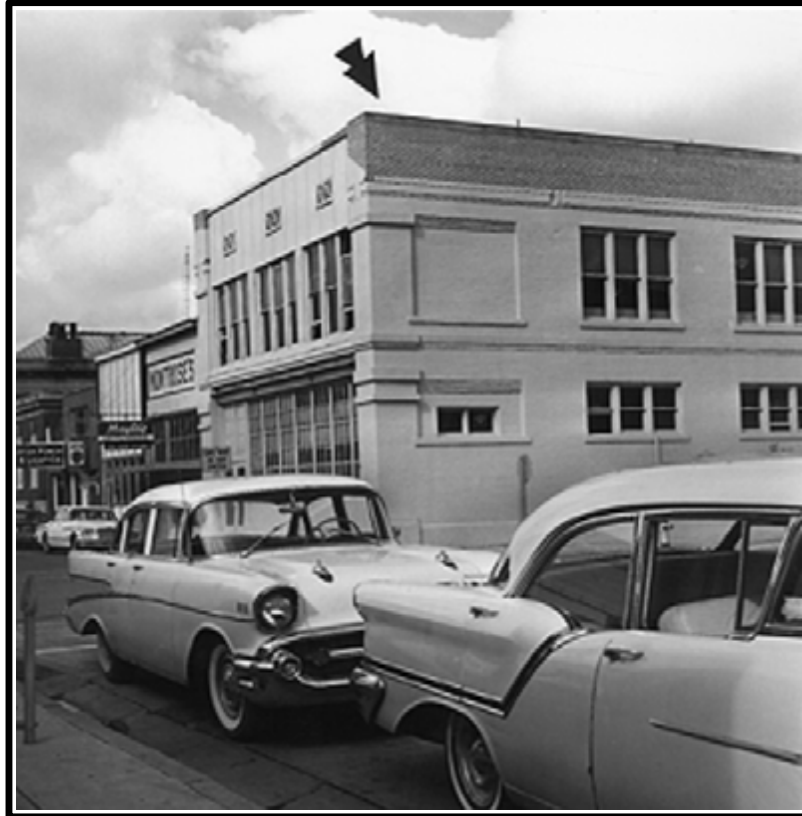
Logan Junior High School was severely damaged by the earthquake, but was repaired and allowed to reopen within two weeks. A reinforced concrete bond beam was cast around the walls at the roof line, and steel tie rods were installed. Structural engineers reported that this work would make the school more safe than it was before the earthquake. This photo shows the brick replacing the original loosened parapet wall.

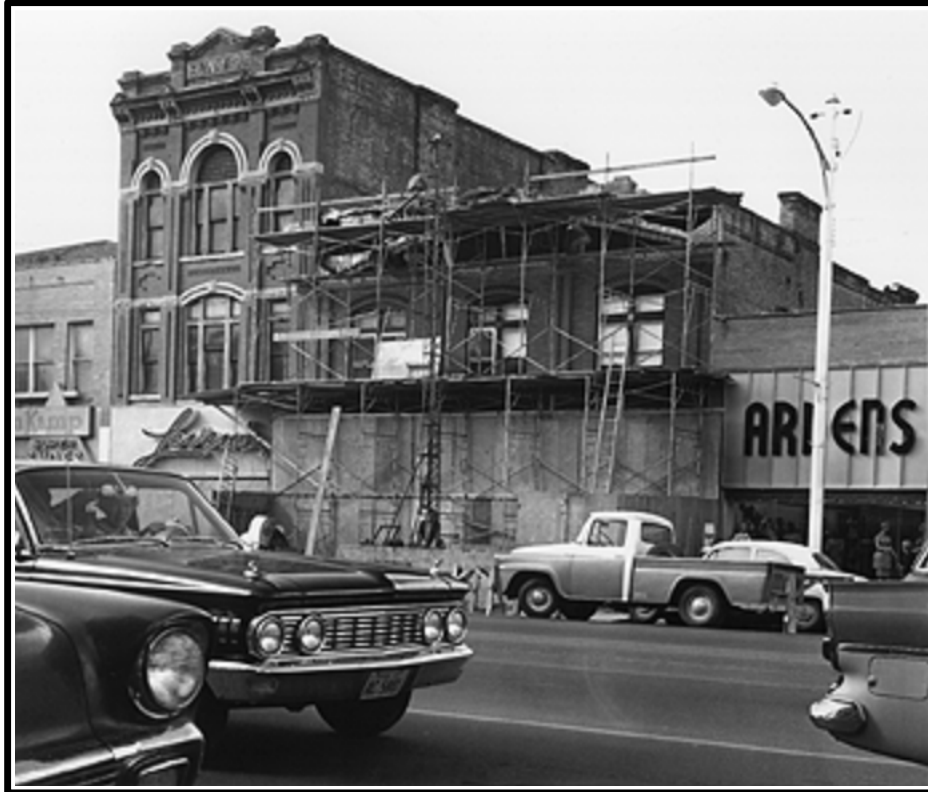
Three weeks after the earthquake, scaffolding is moved along Main Street in Logan, Utah, as workmen repair buildings.

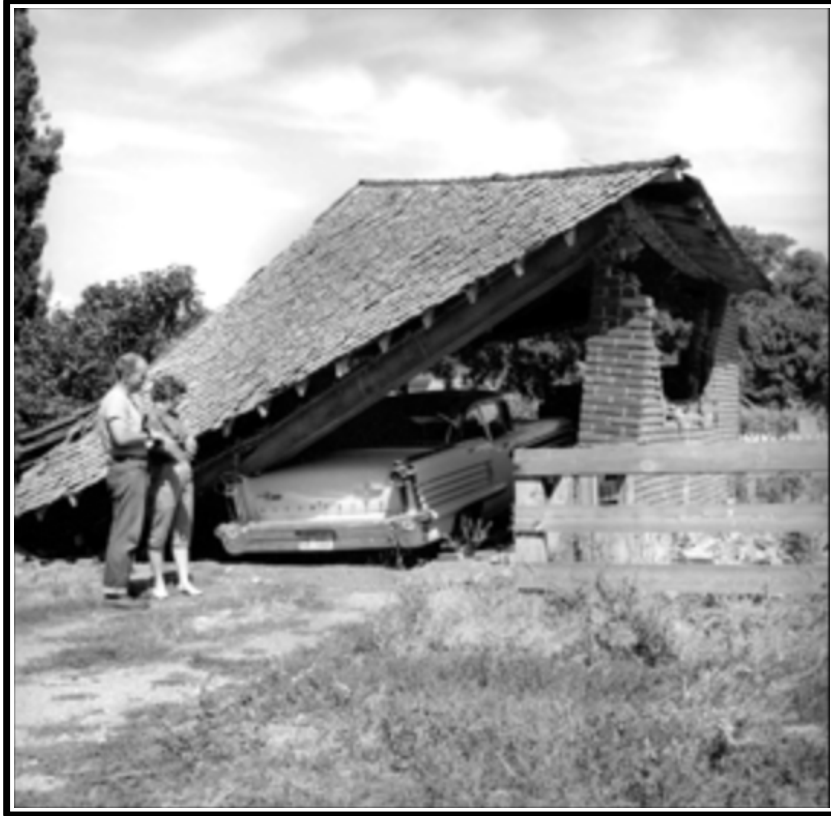
In Richmond, Utah, this brick garage collapsed onto a car. However, when workmen lifted the roof, the owner was able to drive the car out.

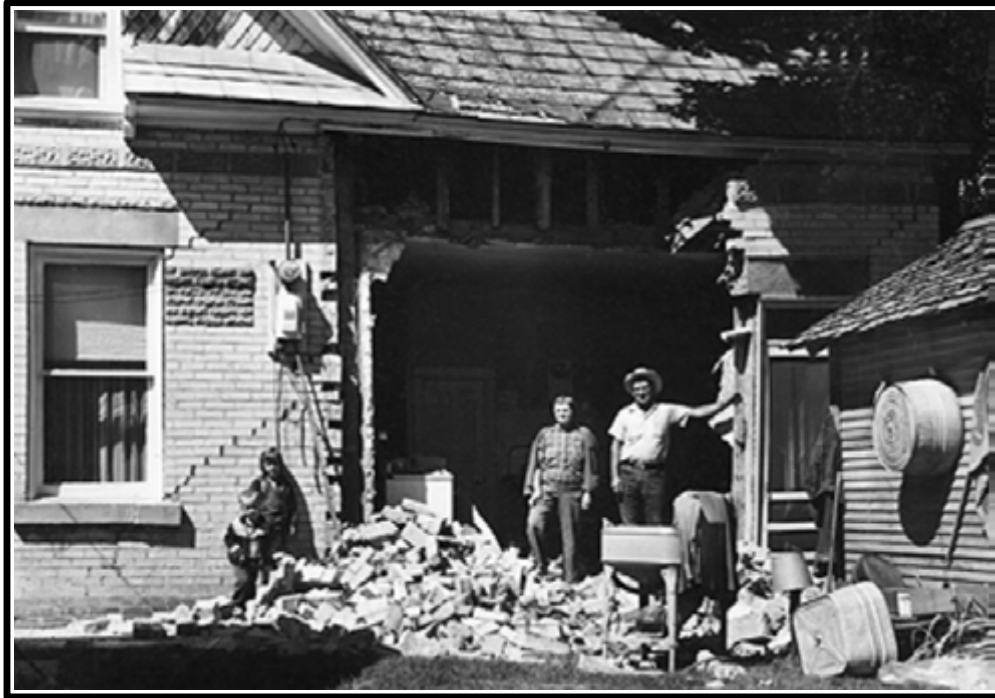
One wall of this brick home in Richmond, Utah, collapsed.

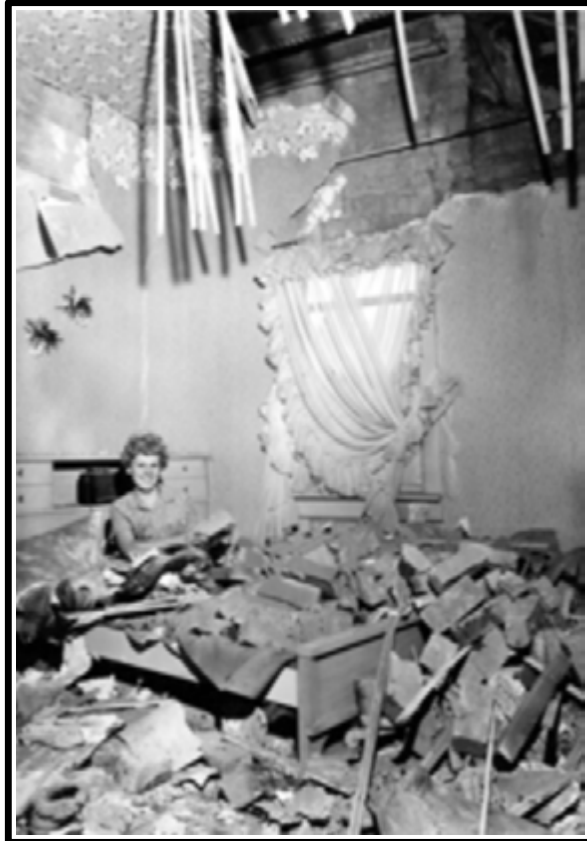
This young woman was in bed when the east wall of her home crashed inward. She escaped with only a bruise, but does not remember how she managed to move so quickly. Richmond, Utah.

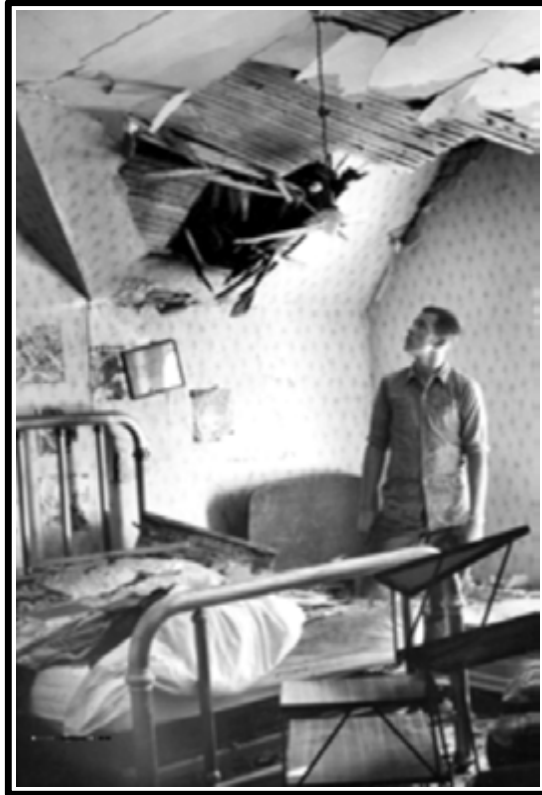
In Richmond, Utah, this young man was just getting out of bed when bricks began falling on him. Luckily, he was not hurt.

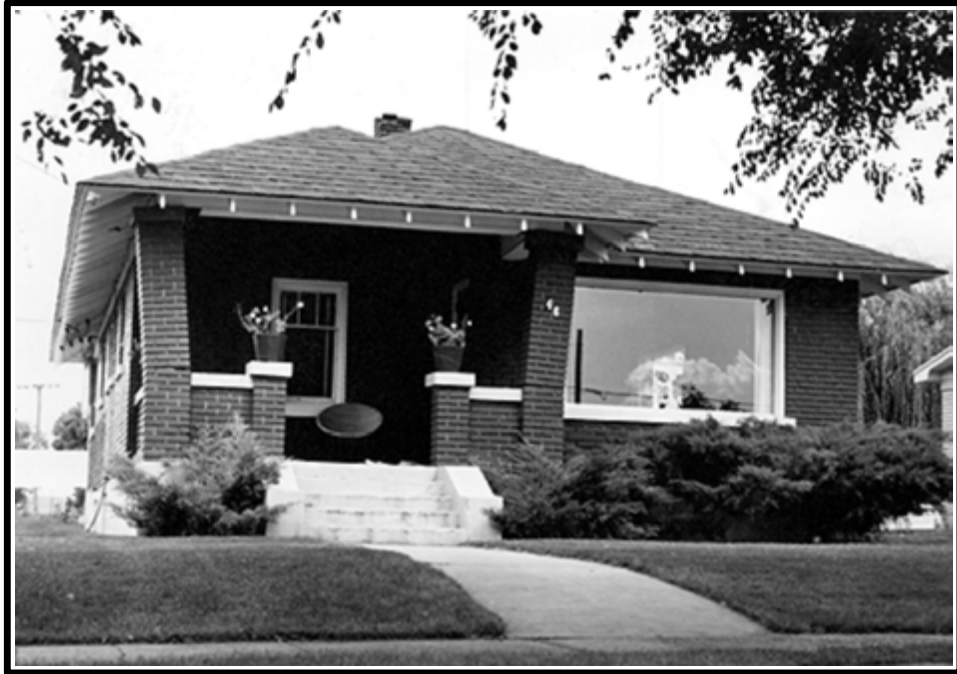
Brick porch columns on this home in Richmond, Utah, were cracked and tilted by the ground shaking.

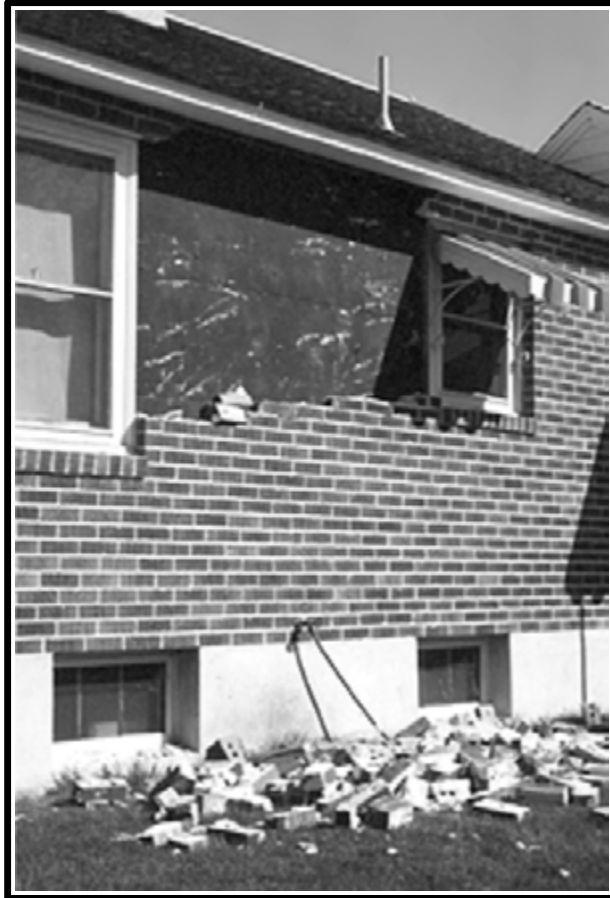
Brick home damage in Richmond, Utah.

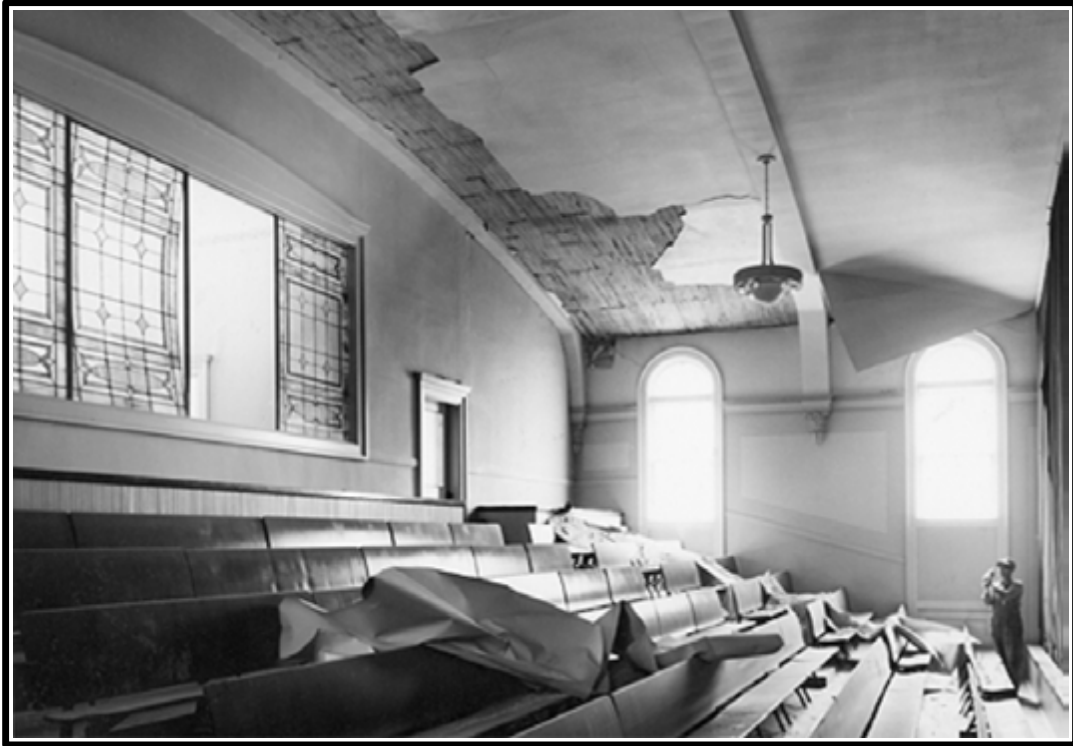
Plaster was knocked from the ceiling onto the seats in the Benson Stake Tabernacle in Richmond, Utah.

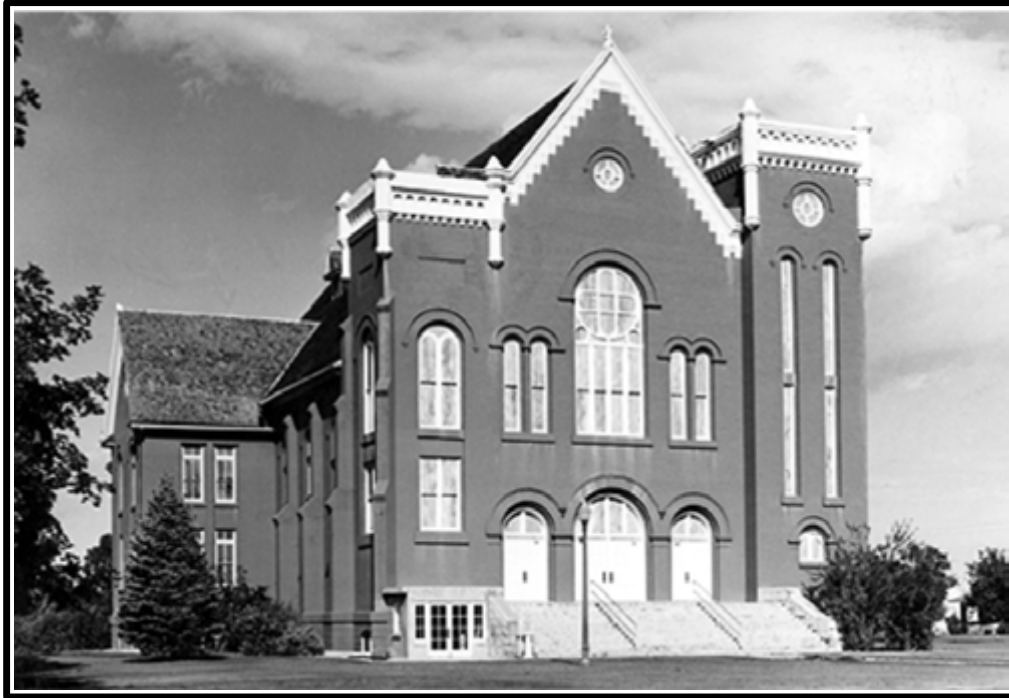
This photo of the Latter-Day Saints' Benson Stake Tabernacle in Richmond, Utah, was taken before the earthquake. Compare with the following photograph of the same building during demolition after being severely damaged by the earthquake.

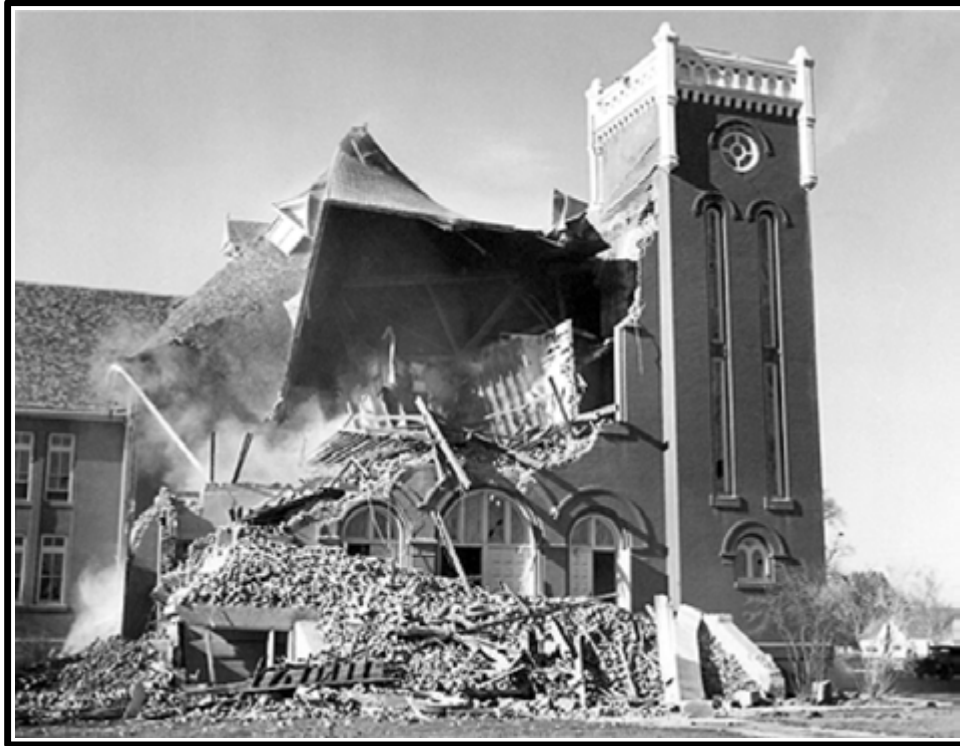
The fifty-eight year old Latter-Day Saints' Benson Stake Tabernacle in Richmond, Utah, was torn down after the earthquake due to severe structural damage.

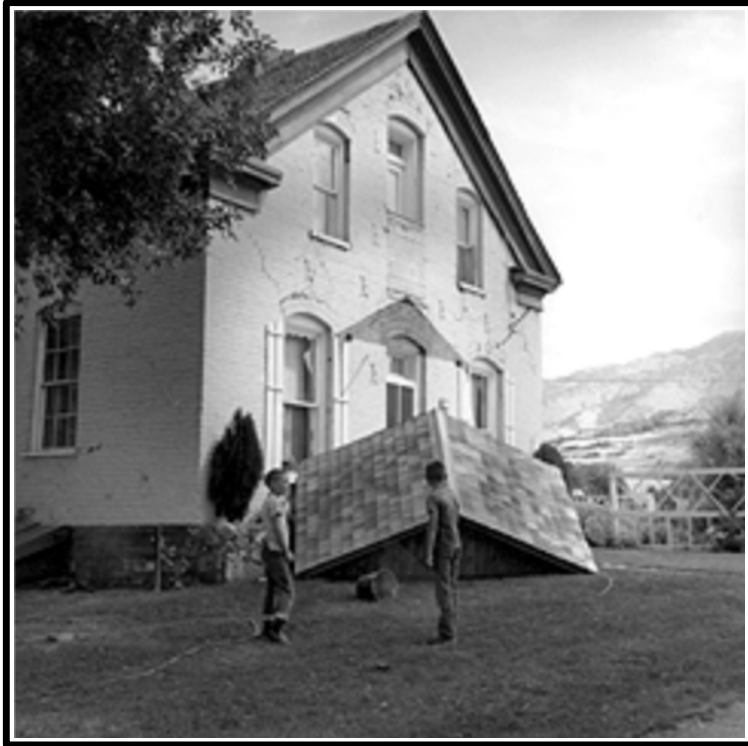
This historic home (once a school house) in Richmond, Utah, had recently been refurbished when the earthquake made it uninhabitable. The family moved out, and the home was eventually torn down. Photo by Ralph Collins.

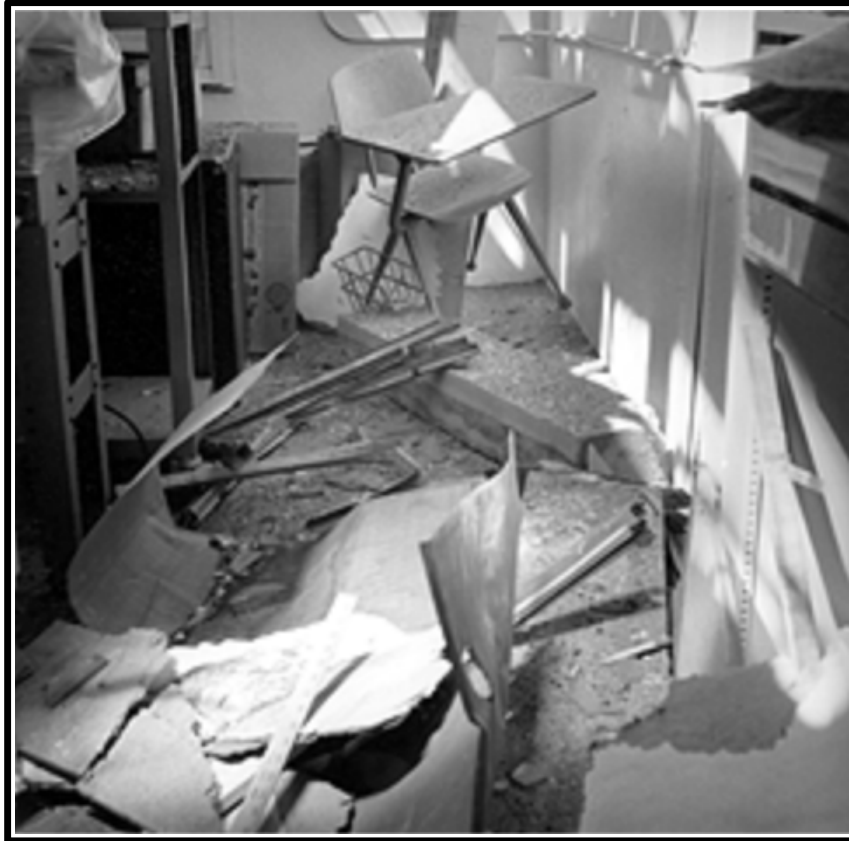
Bricks and plaster rained onto these desks in North Cache High School during the earthquake. Luckily the quake hit at 6:30 a.m. before school opened. Photo by Ralph Collins.

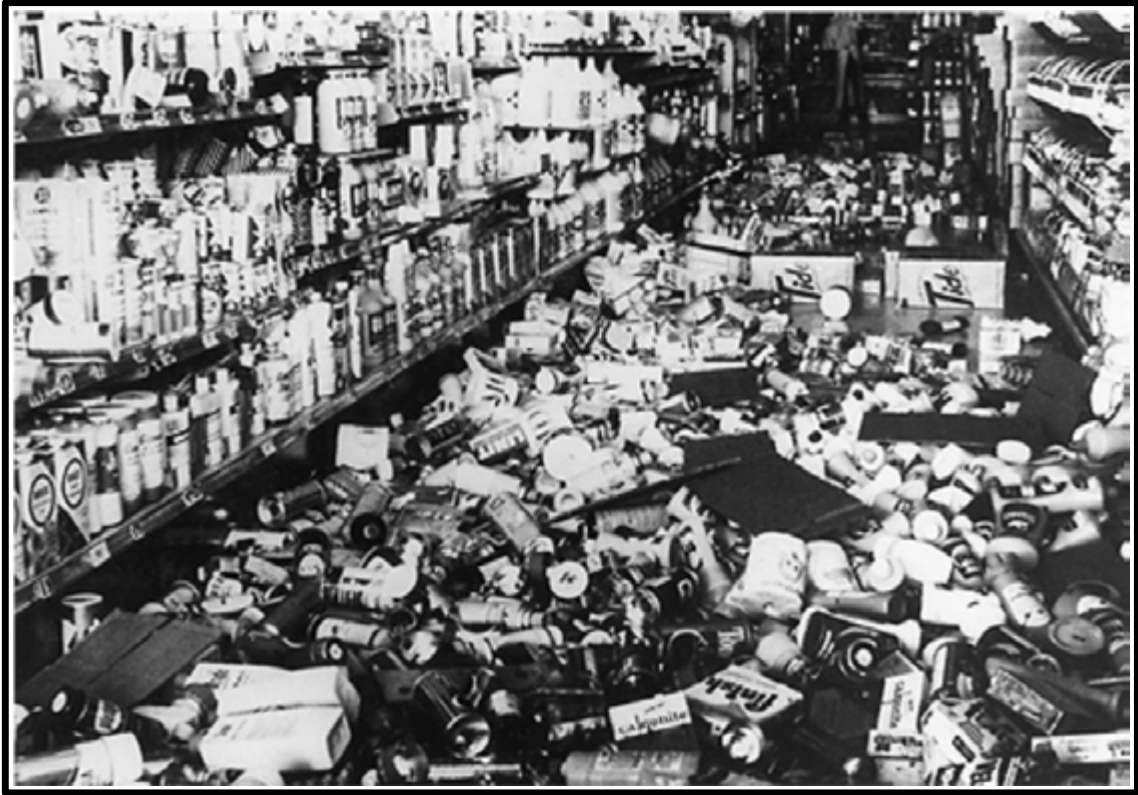
Grocery stores in Cache Valley required several hours of clean-up after the earthquake. Photo from Herald-Journal, Logan, UT.

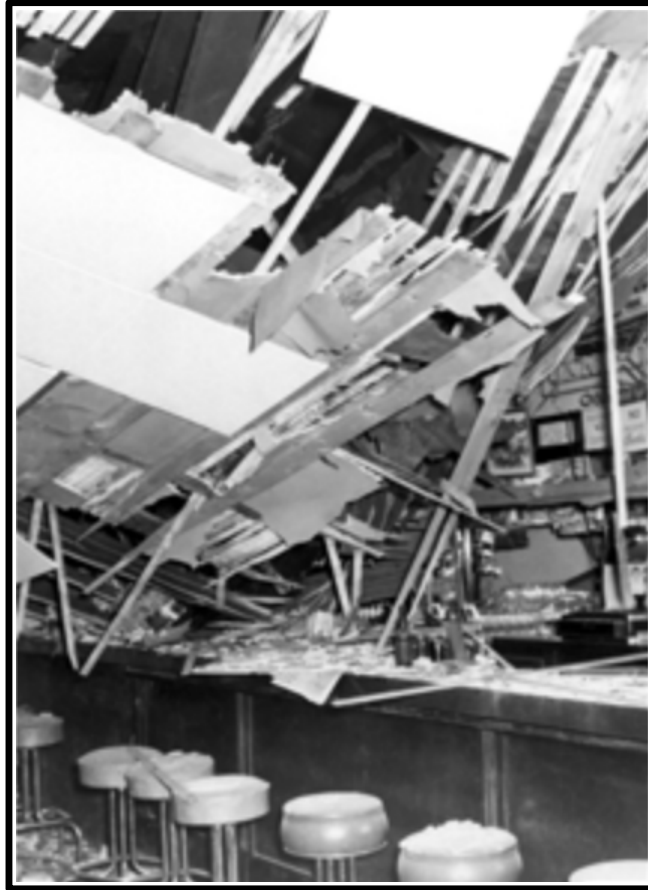
Inside Model Billiards in Logan, Utah, major damage occurred when the walls spread apart, allowing the roof to fall. Patrons were seated at the lunch counter, but no one was injured. Photo from Herald-Journal, Logan, UT.

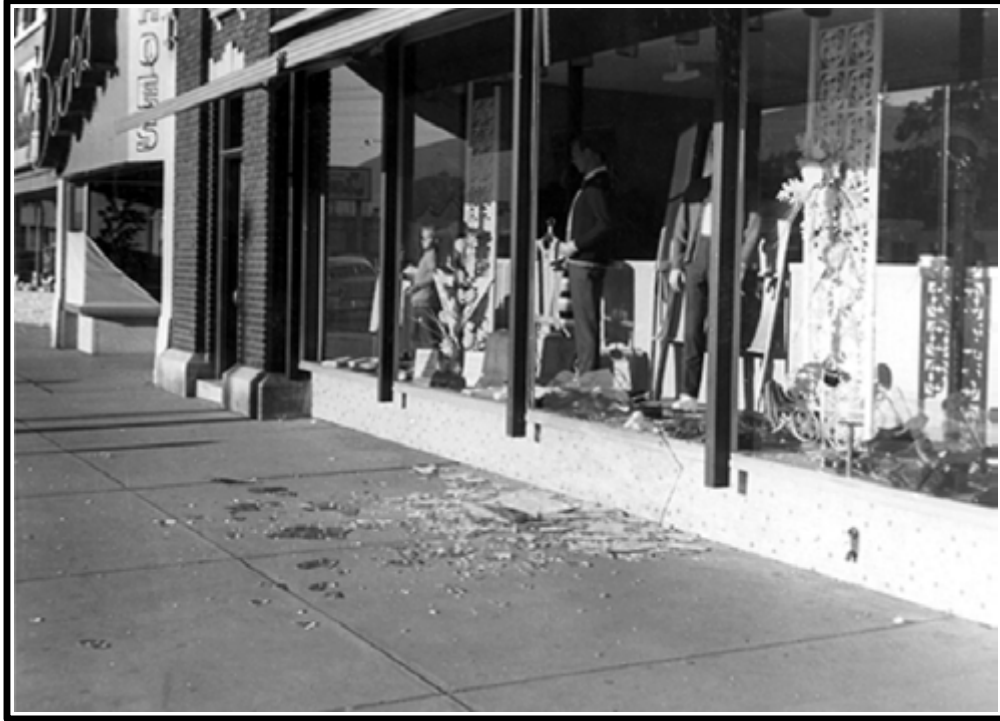
Many large plate glass windows were broken throughout Cache Valley. This is the Keith O'Brien store in downtown Logan, Utah. Photo from Herald-Journal, Logan, UT.

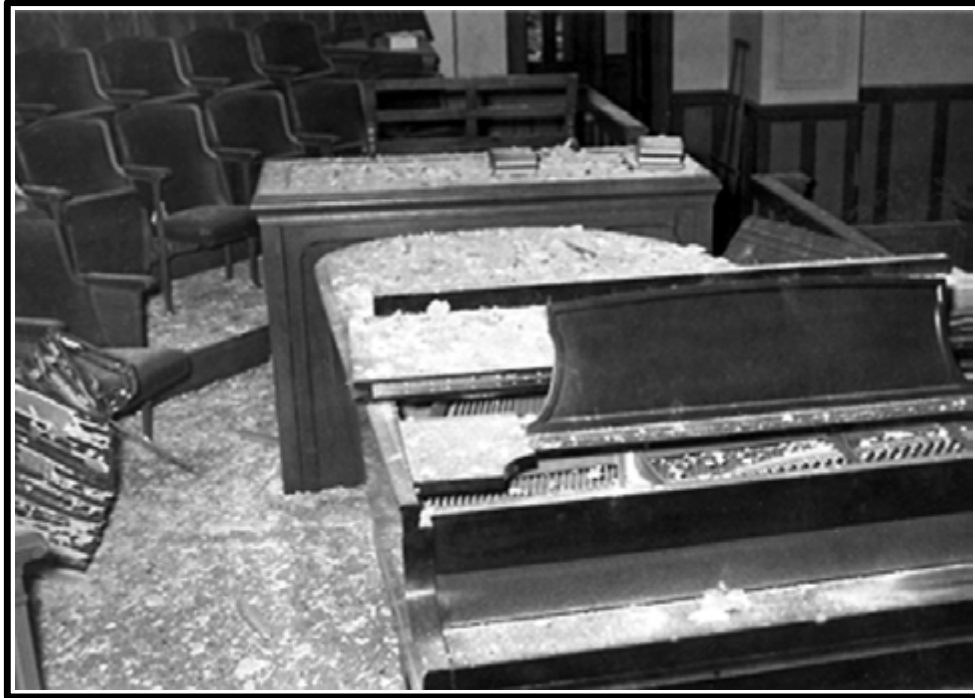
Plaster fell on the organ and the piano in the Richmond Tabernacle; Richmond, Utah (Latter-Day Saints church). The building itself suffered structural damage and was torn down. Photo from Herald-Journal, Logan, UT.
