Summary of Photographs

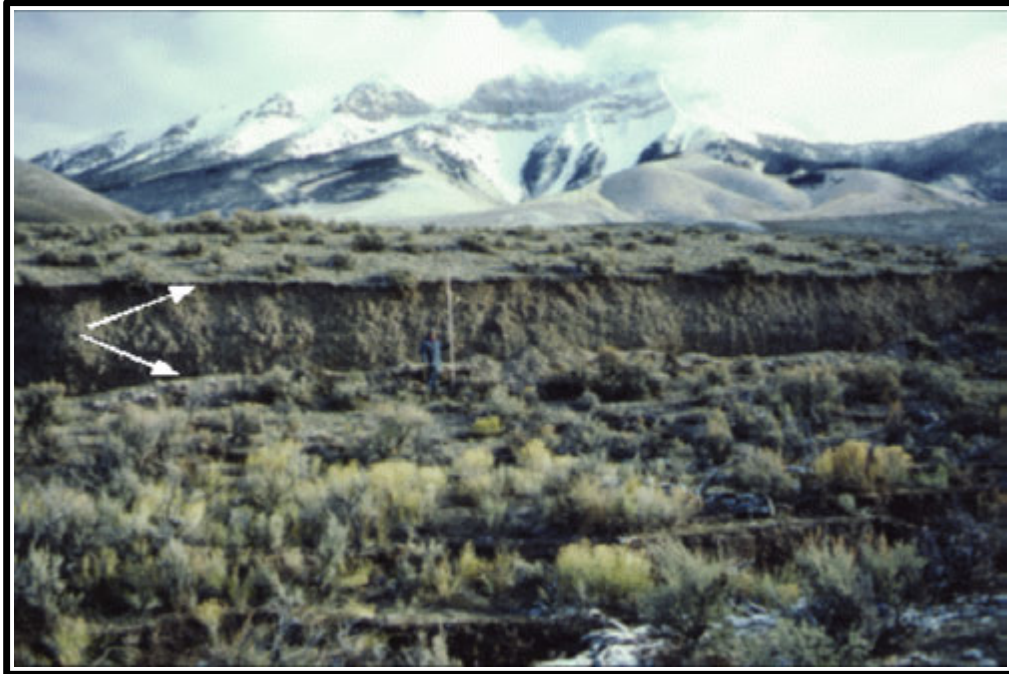
Earthquakes in the Intermountain West are a mountain-building process as rock moves vertically along a fault. Earthquakes typically occur repeatedly along the same faults. Arrows in this photo point out the new fault scarp face (~9 feet tall) created in the 1983 Borah Peak, ID earthquake. It is superimposed on an ancient fault scarp (vegetated, beveled area immediately above new scarp).

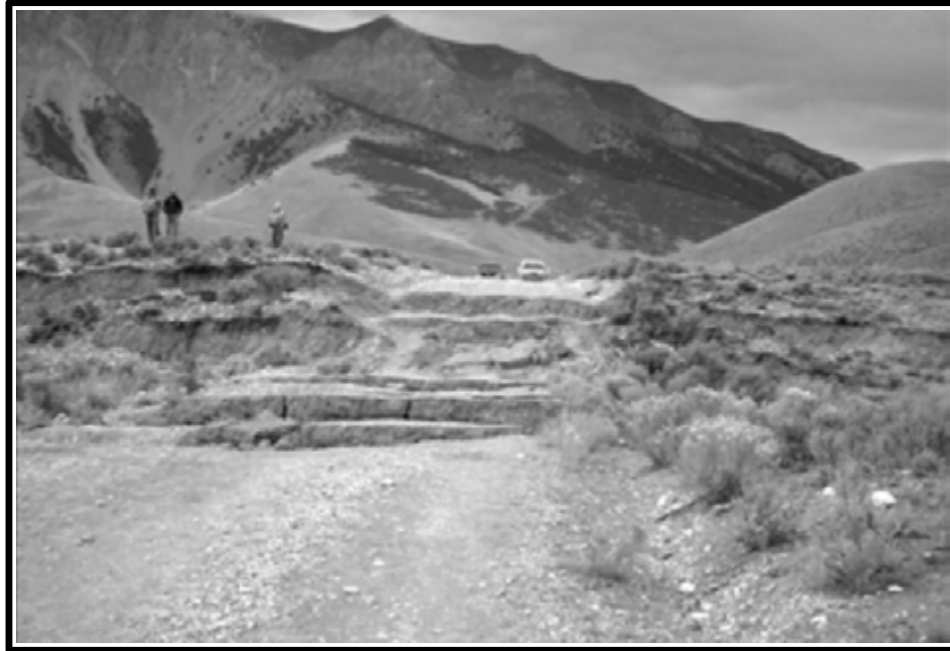
Luckily there were no buildings astride the new fault scarp. The only man-made structure affected was the Doublespring Pass Road.

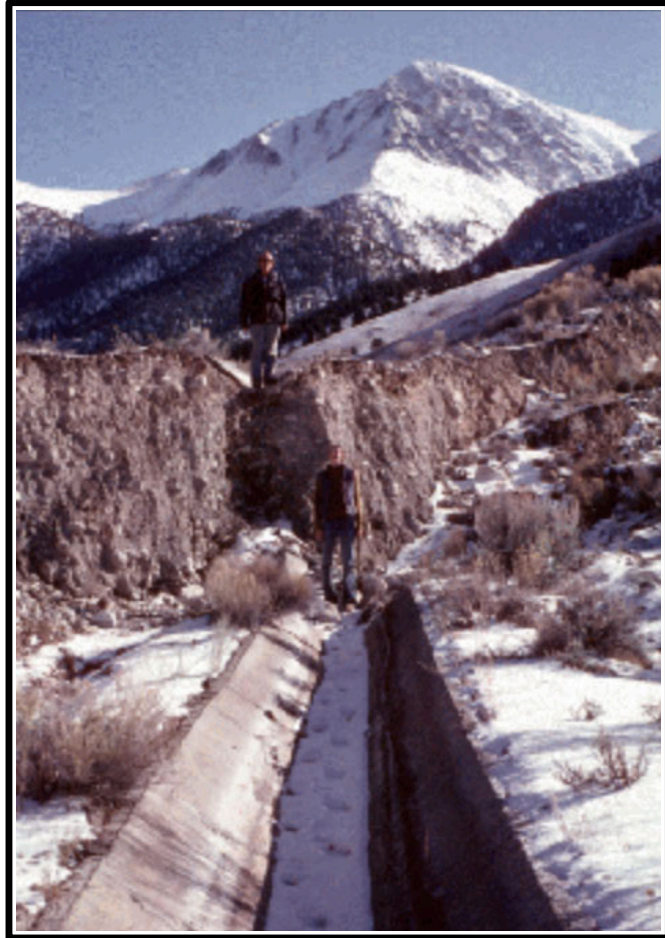
The direction of movement along the fault was predominantly vertical, but the broken drainage ditch shows that some lateral movement also occurred.

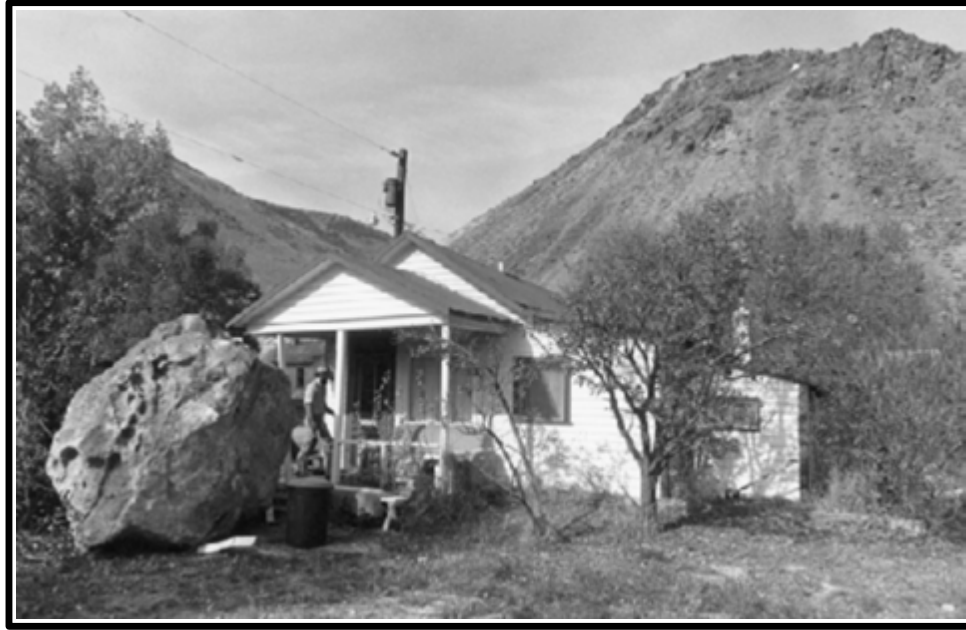
Close call! The people living in this house near the base of steep cliffs in Challis, Idaho, were very grateful that the ~20-ton boulder that fell during the earthquake came to rest "next to" rather than "on top of" their home.

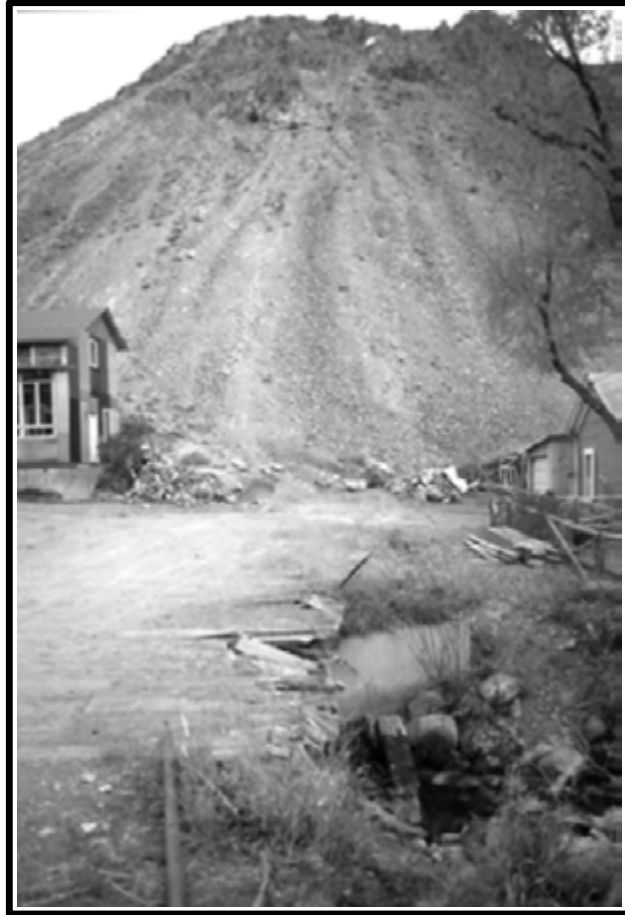
The ~20-ton boulder fell from near the top of this cliff, rolled and bounced between two houses, and smashed a small wooden bridge before coming to rest next to another home's front porch.

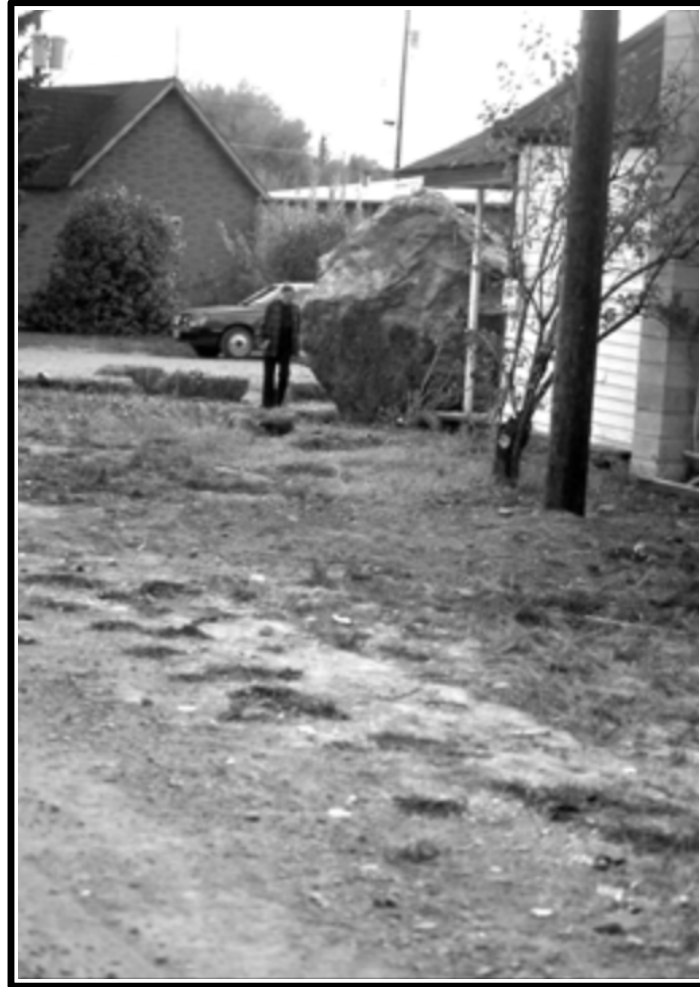
The boulder's path of travel can be traced by the "footprints" (pockmarks) it left on the ground before it came to rest next to the front porch of this home in Challis, Idaho.

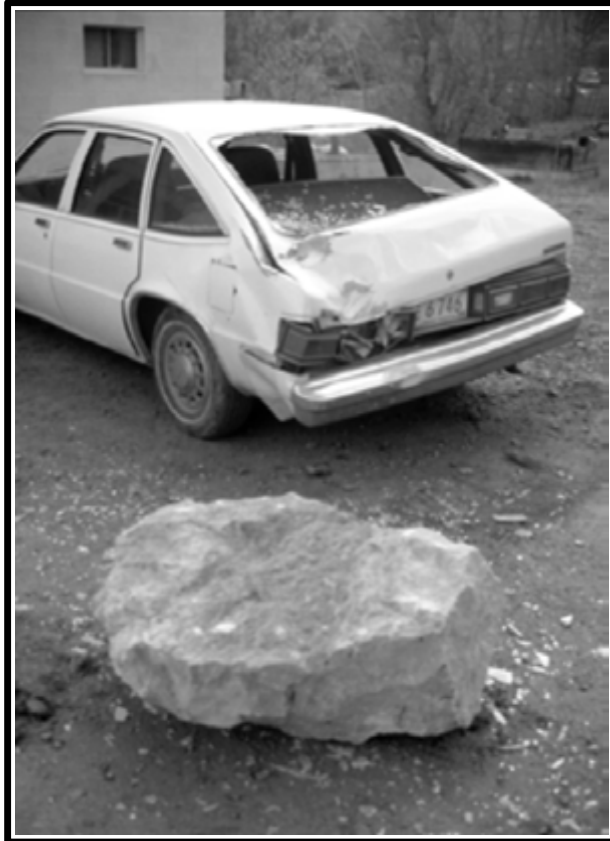
Two automobiles were damaged by boulders that fell in Challis, Idaho, during the earthquake.

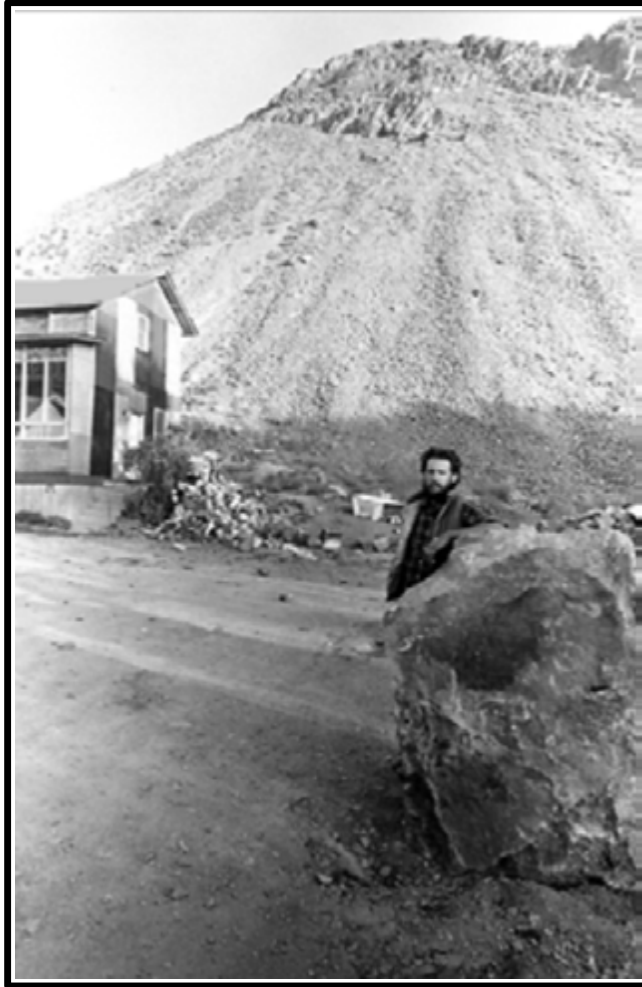
Homes built at the base of steep cliffs are at risk to rockfall--especially when the ground shakes in an earthquake. Luckily this large boulder missed the home of Robb Markley. Photo by Sue Villard, Challis, Idaho.

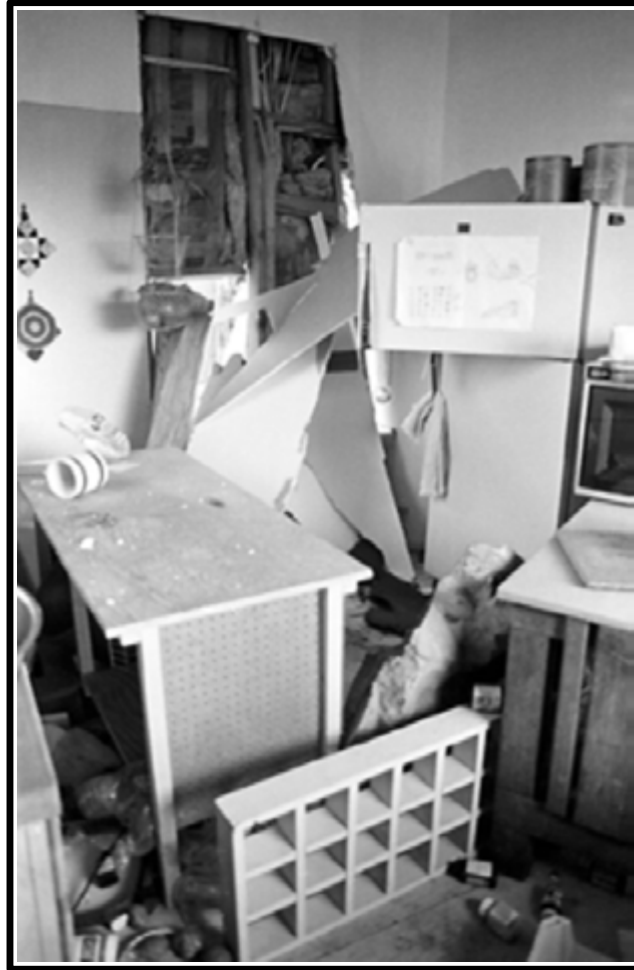
This 3-foot boulder did not miss (see in center of photo between cabinets). It crashed through the kitchen wall in the Robb Markley home in Challis, Idaho. Photo by Sue Villard, Challis, Idaho.

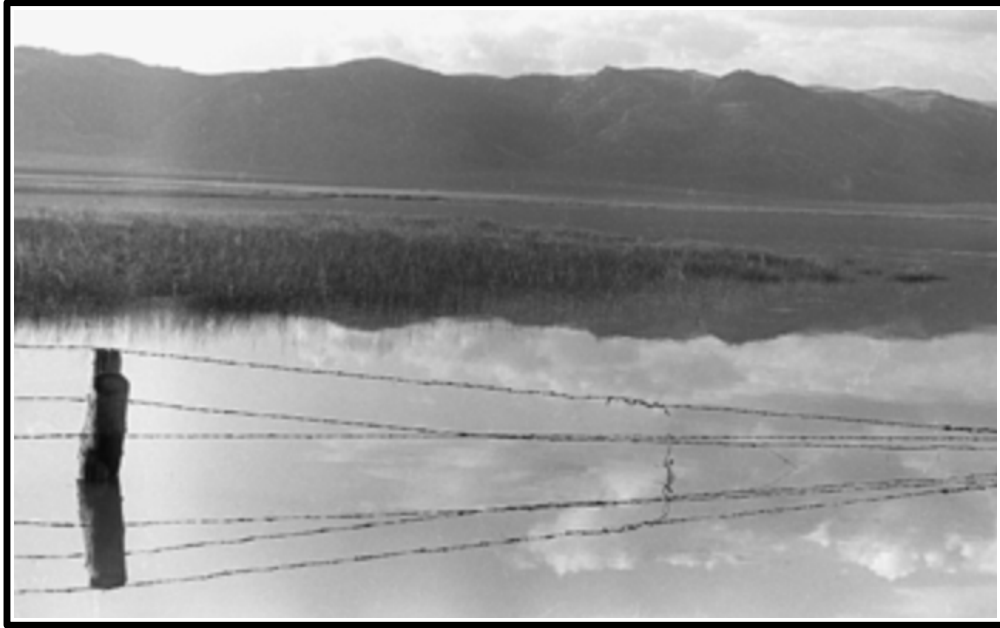
Acres of farmland were flooded near Chilly Butte due to the development of new springs. Photo by Sue Villard, Challis, Idaho.

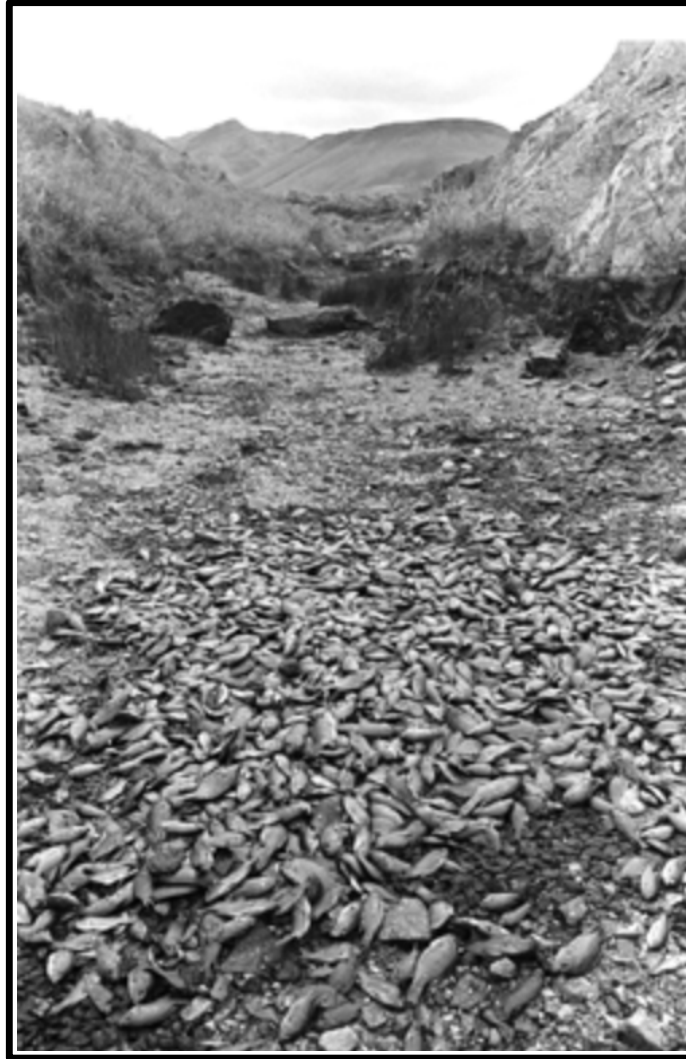
The warm water spring that served as the main source of water for the Will Ingram cattle ranch and for their catfish production project completely dried up during the earthquake. Photo by Sue Villard, Challis, Idaho.

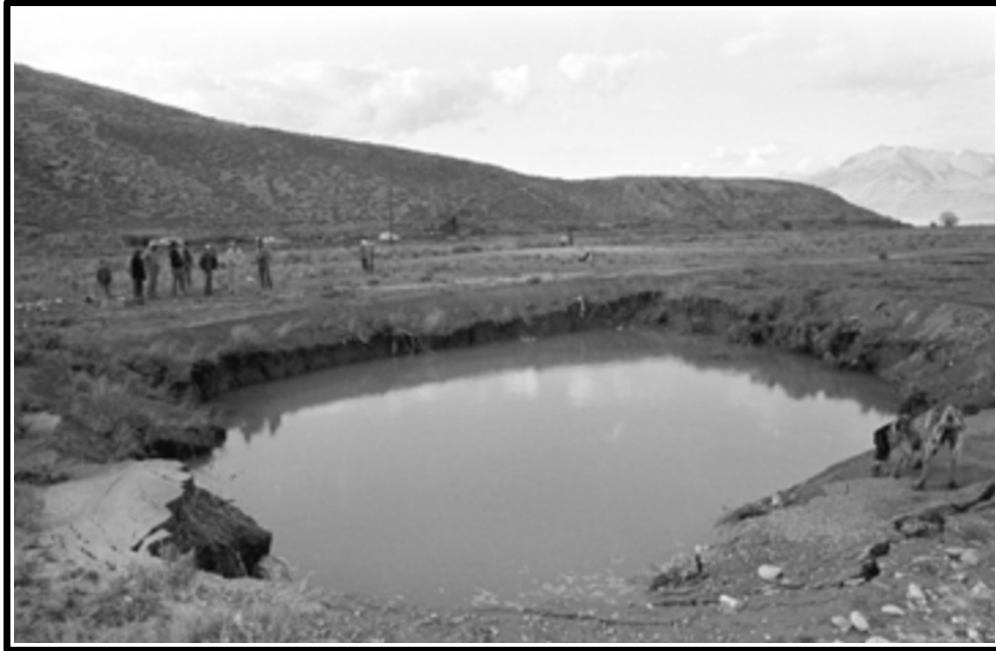
For 24 hours new artesian springs spurted water and sediment 15 to 20 feet into the air while eroding this crater near Chilly Butte. Photo by Sue Villard, Challis, Idaho.

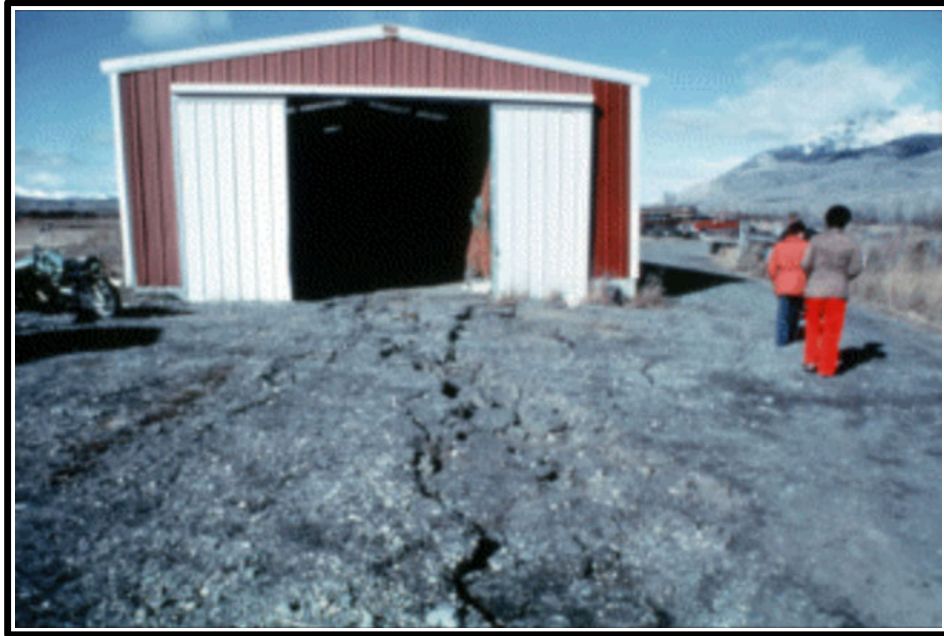
This steel-frame barn was pulled apart about 1 foot due to fissures caused by lateral spreading due to liquefaction of the soil.

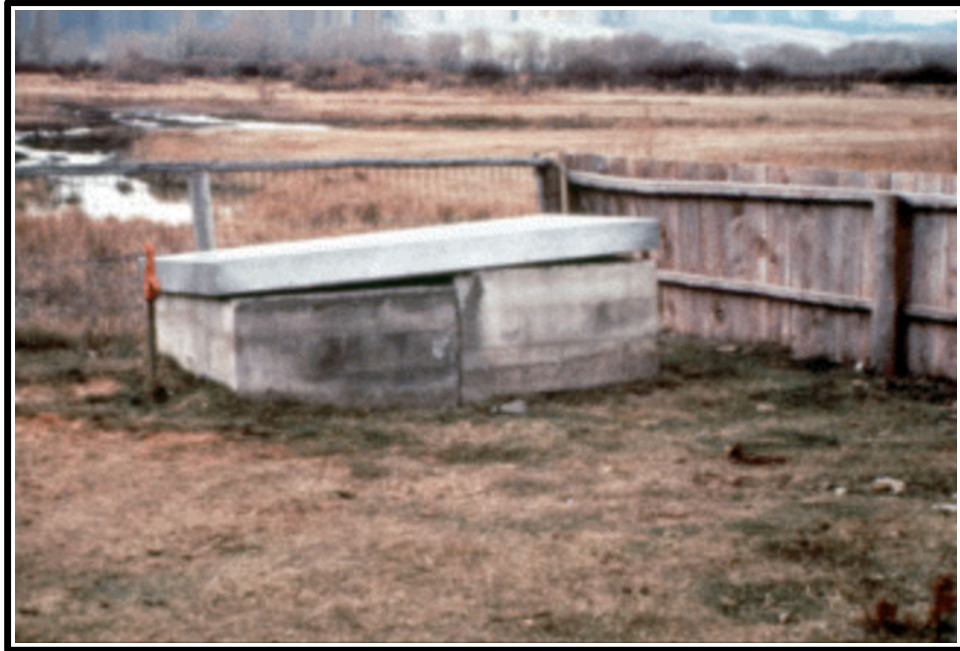
Buried light or hollow objects often float upwards when the surrounding soil liquefies during an earthquake. The concrete box on the right, housing a well pump, rose 3 inches due to liquefaction.

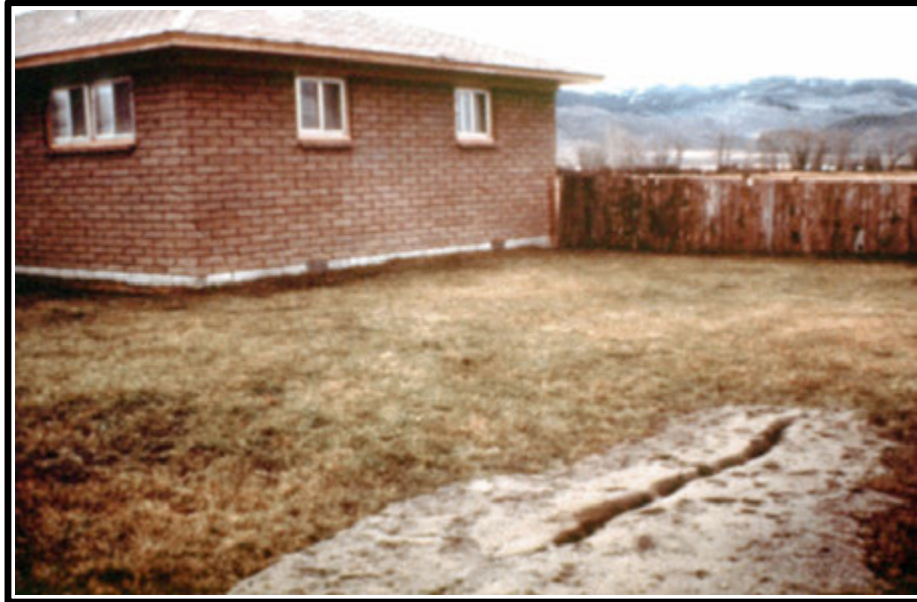
A gravelly deposit was left by a sand boil near this ranch house adjacent to Big Lost River. Sand boils are caused by soil liquefaction.

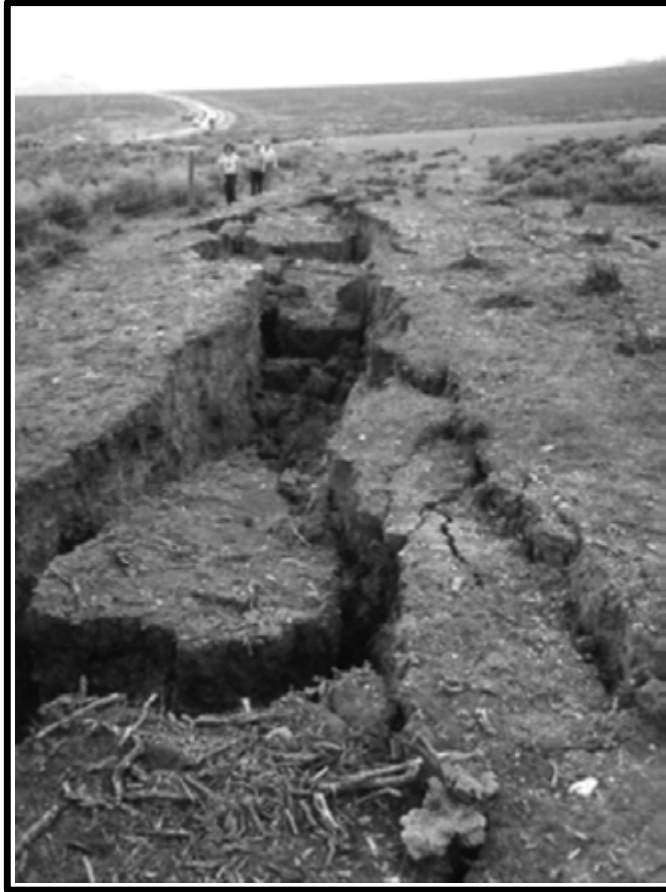
Lateral spreading caused by soil liquefaction caused fissures to form near Highway 93 in Custer County, Idaho.

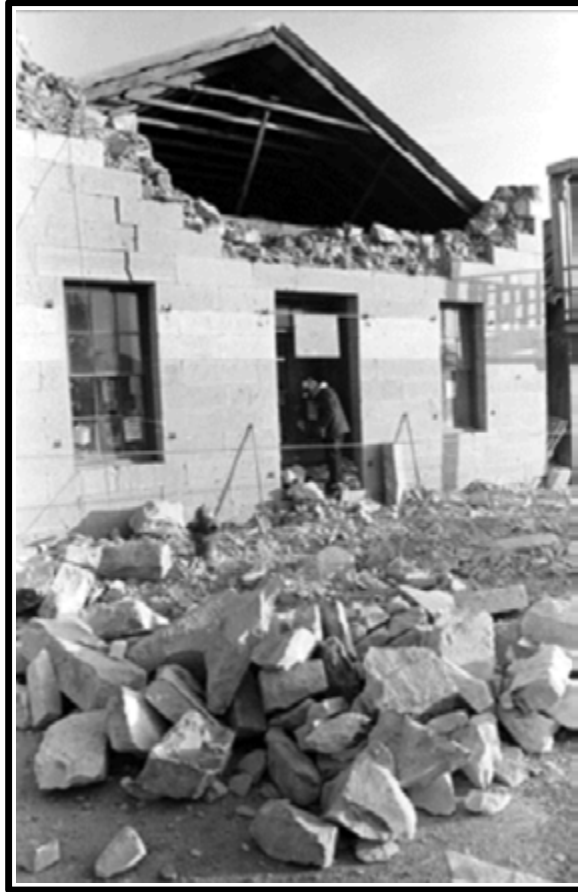
In Challis, Idaho, two young children died when the upper front of this old rock building collapsed onto the sidewalk as they walked to school. It's extremely important that we all learn to move away from buildings when we feel the ground shake. Photo by Sue Villard, Challis, Idaho.

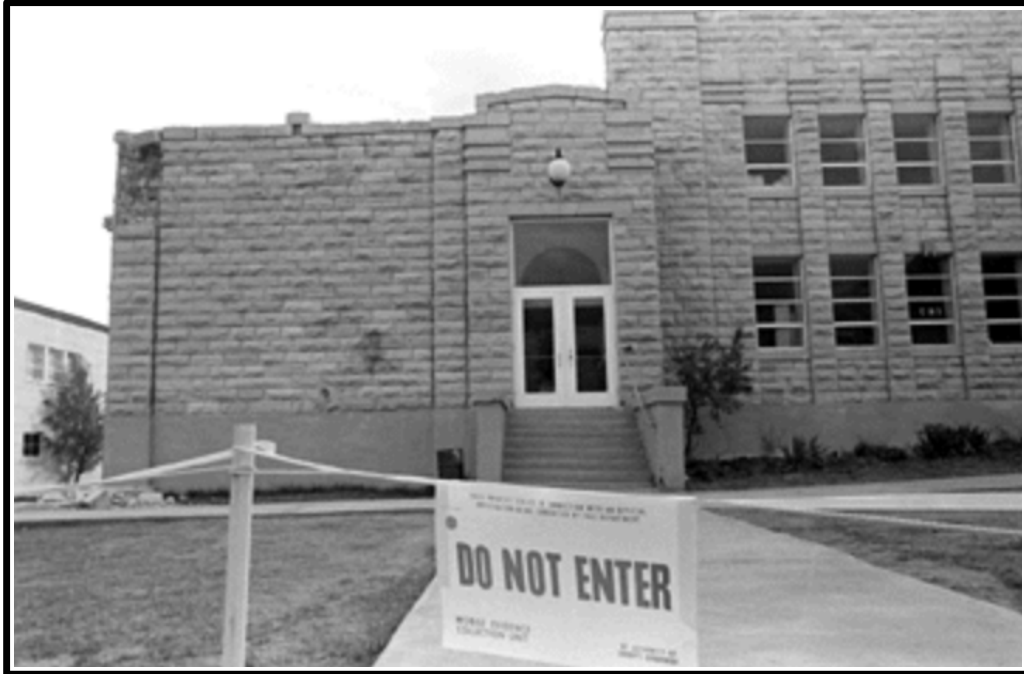
The entire stone front exterior of the old high school separated from the rest of the building, and the northeast corner crumbled. Its 360 junior high and high school students began attending classes at the newly-built high school and an elementary school. Photo by Sue Villard, Challis, Idaho.

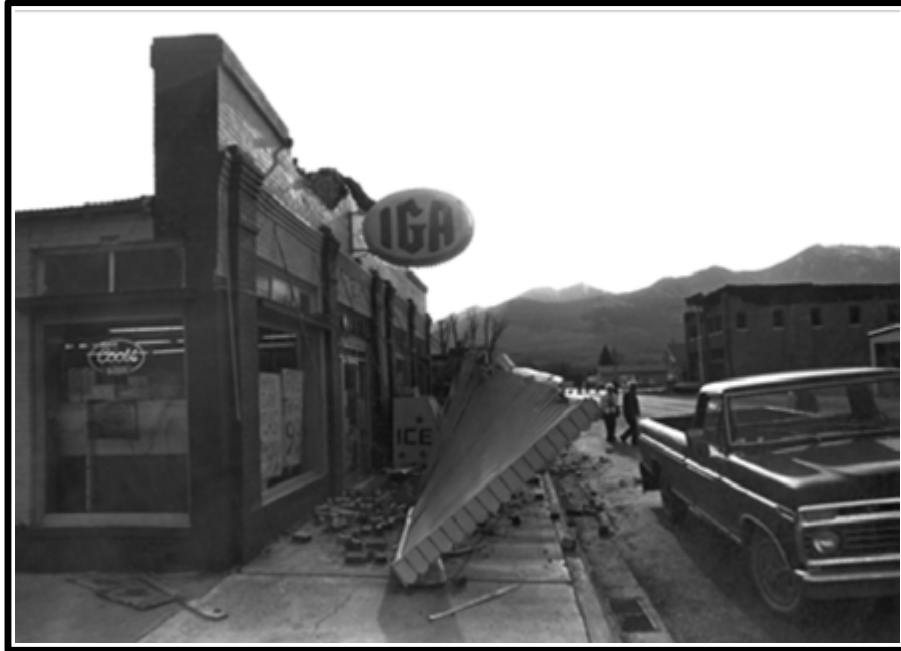
Luckily, no one was on this sidewalk in Mackay, Idaho, when the awning fell during the earthquake. This photo is a good reminder of how dangerous it may be to run outside while the ground is still shaking. Photo by Dave LaBelle.

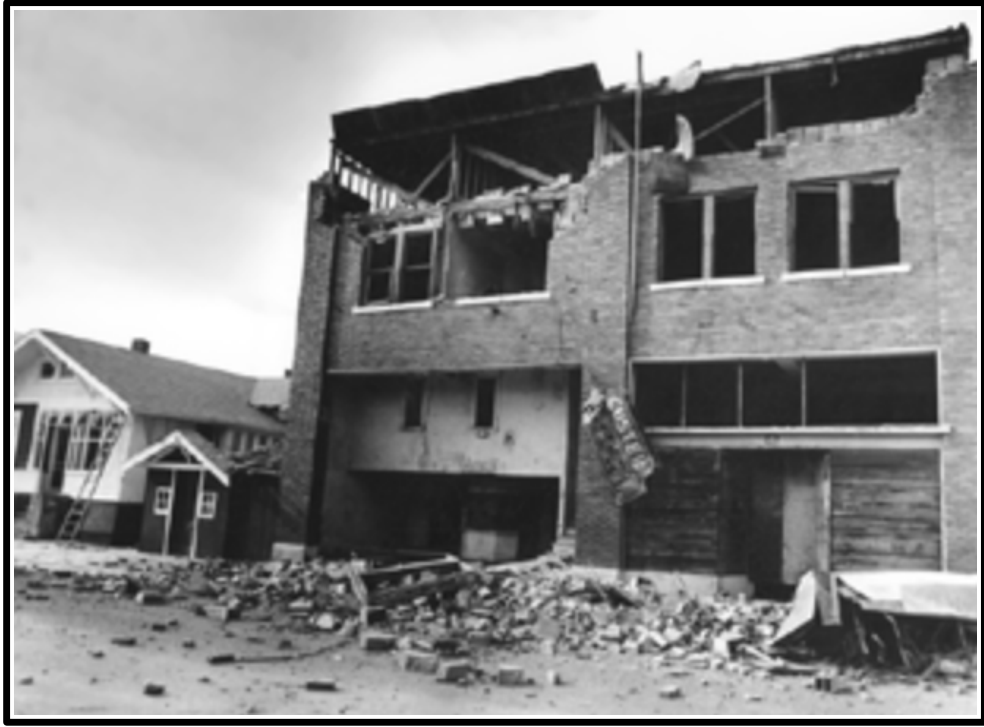
The old Custer Hotel was one of the buildings on Main Street in Mackay, Idaho, that was severely damaged. It was later torn down. Photo by O. Kasteler.

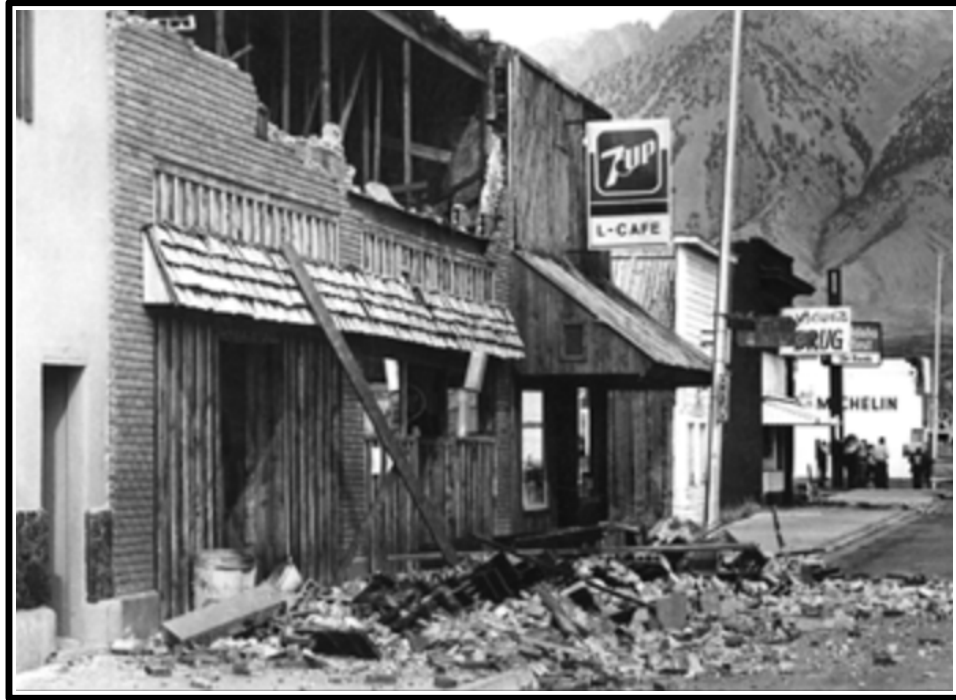
Mackay, Idaho's Main Street was hard hit by the ground shaking. According to Oval Caskay, mayor, 80% of the businesses in Mackay were adversely affected by the earthquake. Photo by O. Kasteler.

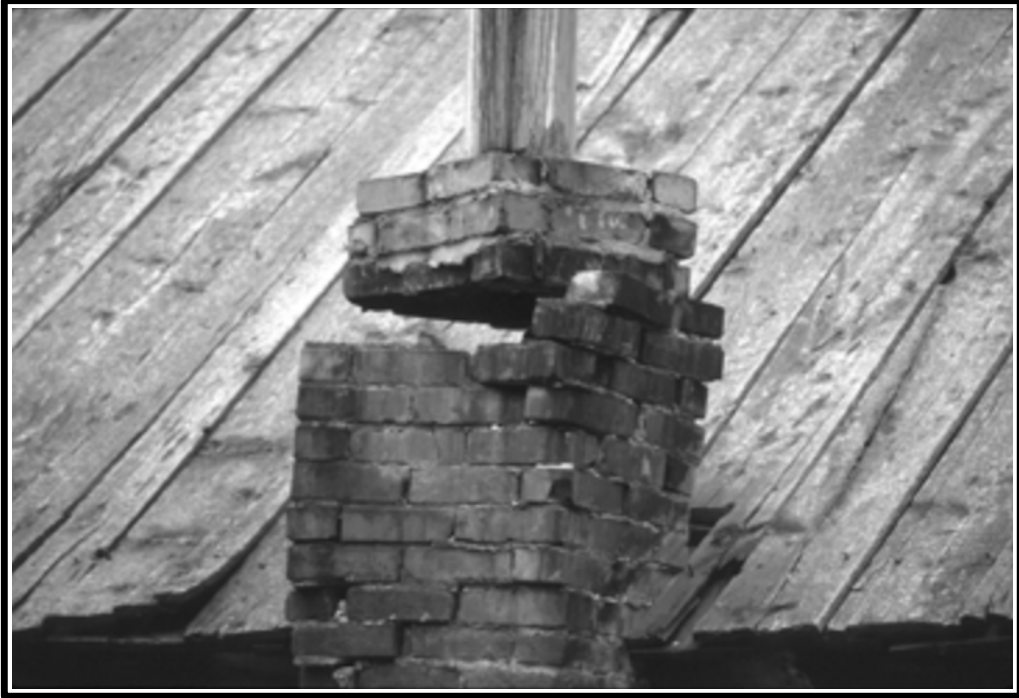
Most brick chimneys in Mackay, Idaho, fell or were severely damaged during the earthquake. Despite losing several bricks and being severely cracked, this chimney on the barbershop managed to stay in place, apparently defying gravity.

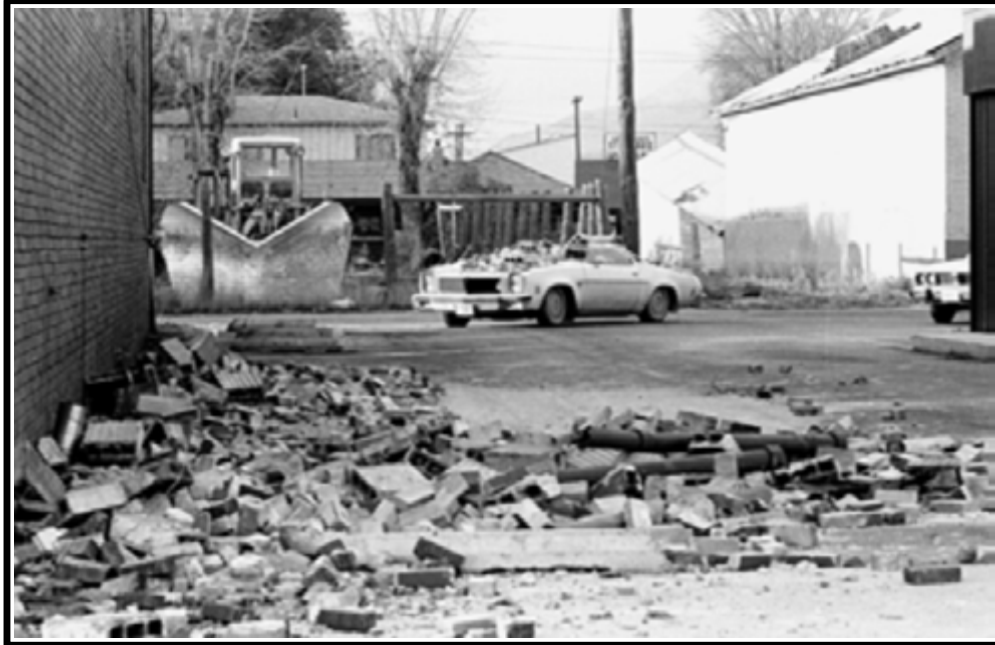
Eleanor Williams had just parked her car behind the Mackay Drug Store when the earthquake hit. The upper portion of the drugstore wall fell onto her car as she attempted to get out. She suffered a severely bruised leg. Photo by Sue Villard, Challis, Idaho.

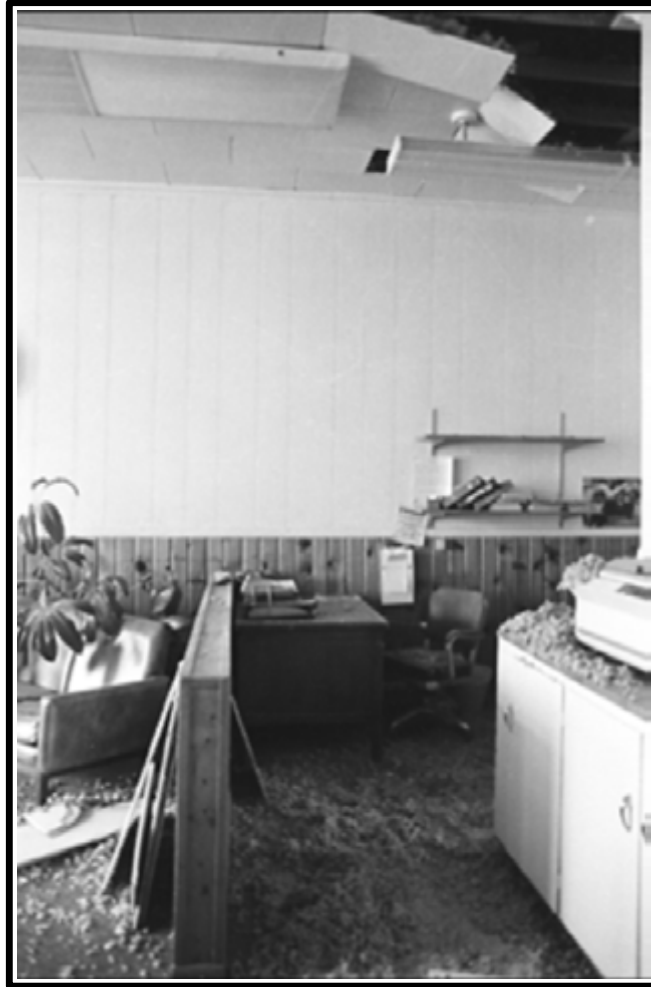
Interior damage to City Hall in Mackay, Idaho, does not appear to be severe. However, the building had to be razed due to structural damage. Photo by Sue Villard, Challis, Idaho.

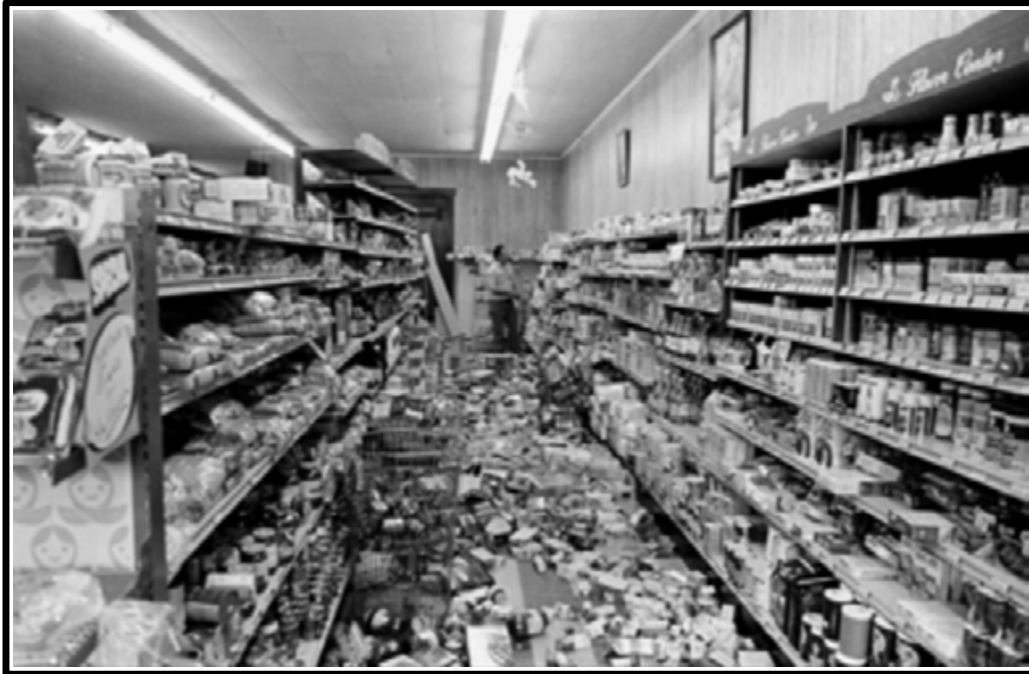
"Ivie's IGA Foodliner in Mackay was a mess of groceries that were strewn everywhere. This photo was taken after the cleanup crew had been working close to six hours, and the end was still not in sight." (Challis Messenger - Special Edition). Photo by Sue Villard, Challis, Idaho.

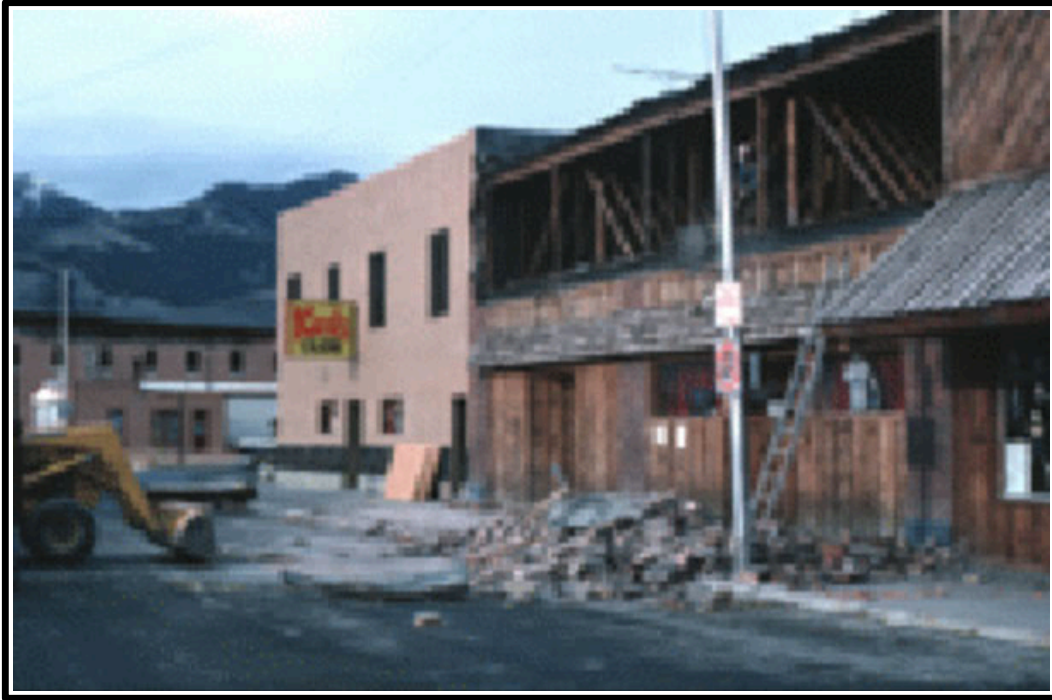
Members of Company A, 116th Engineer Battalion of the Idaho National Guard helped cleanup Mackay. By November 10, they had razed eight buildings on Main Street.

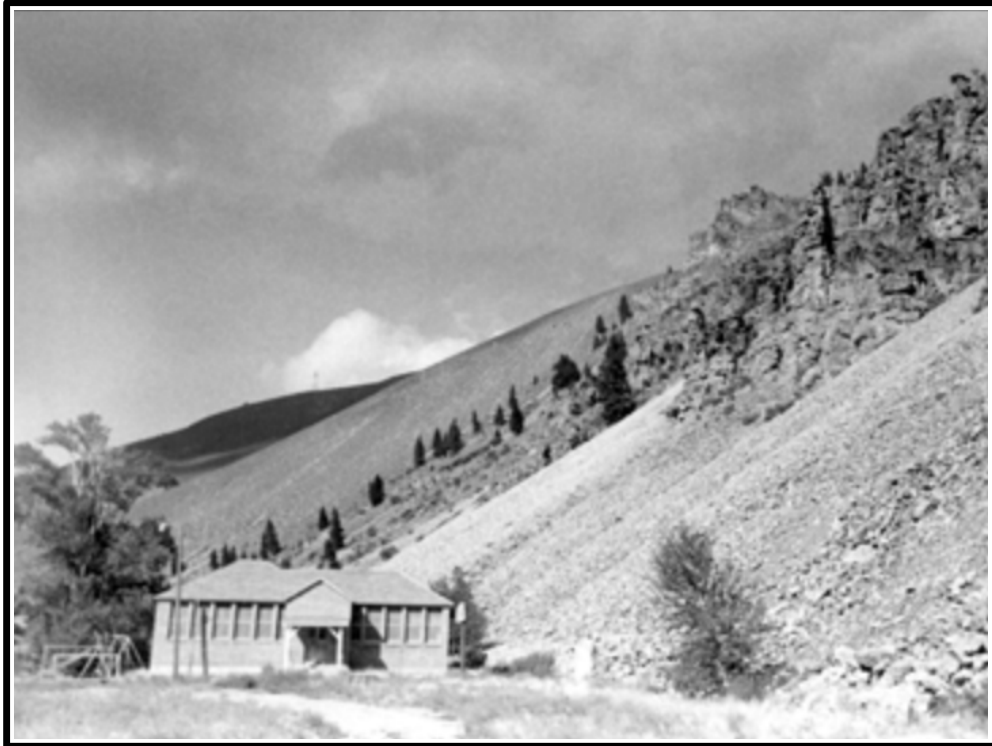
The Clayton Elementary School was abandoned as unsafe after the earthquake in 1983 that caused a 2 x 3 ft. boulder to fall and crash into its outer wall. School district patrons voted for a \$100,000 tax levy override to build a new school in a safer location. Photo by Sue Villard, Challis, Idaho.

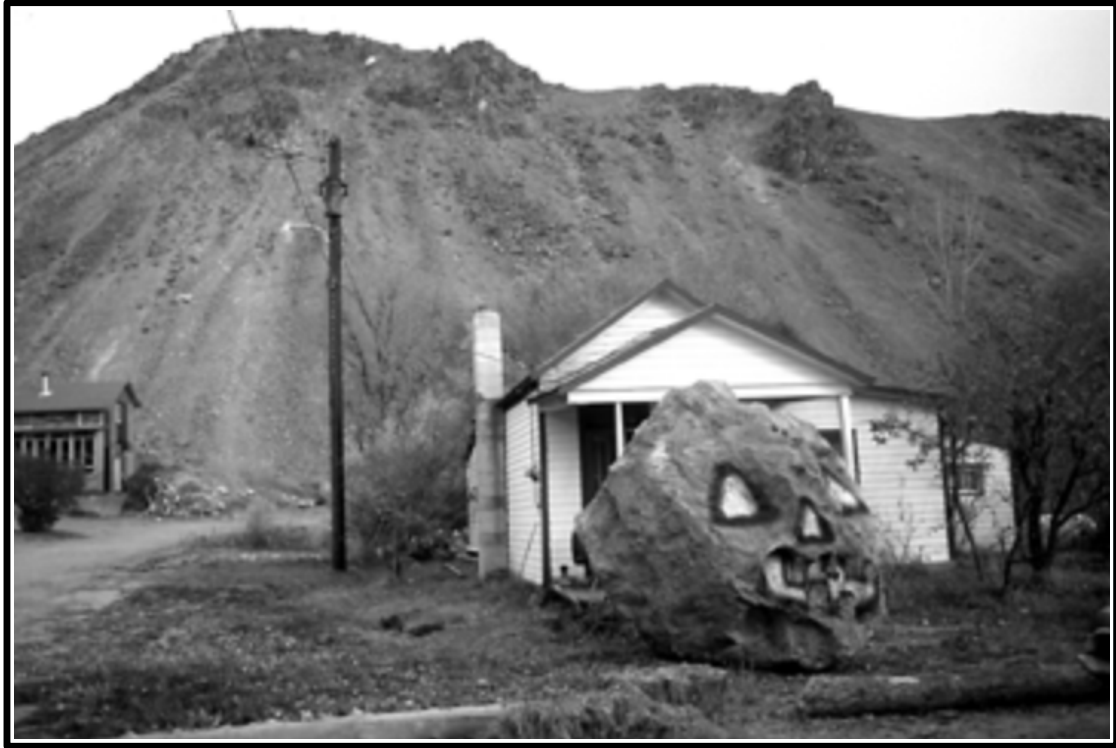
The earthquake occurred three days before Halloween. Georgia Smith exemplified "making the best of trouble" when she decorated this ~20-ton boulder that came to rest next to her home during the earthquake.
