## Summary of Photographs

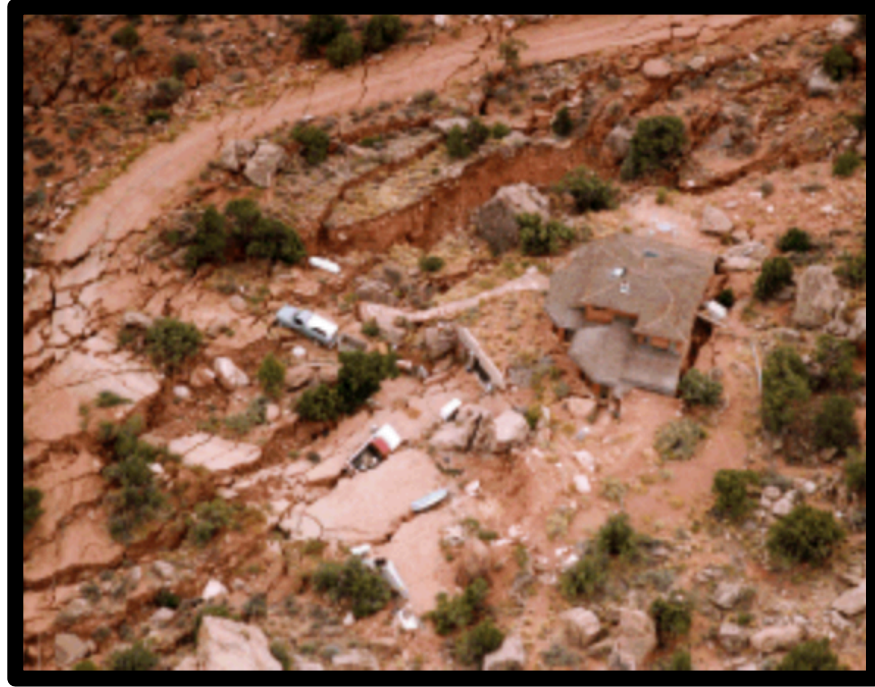
The couple living in this house was unable to use their vehicles to escape the landslide.

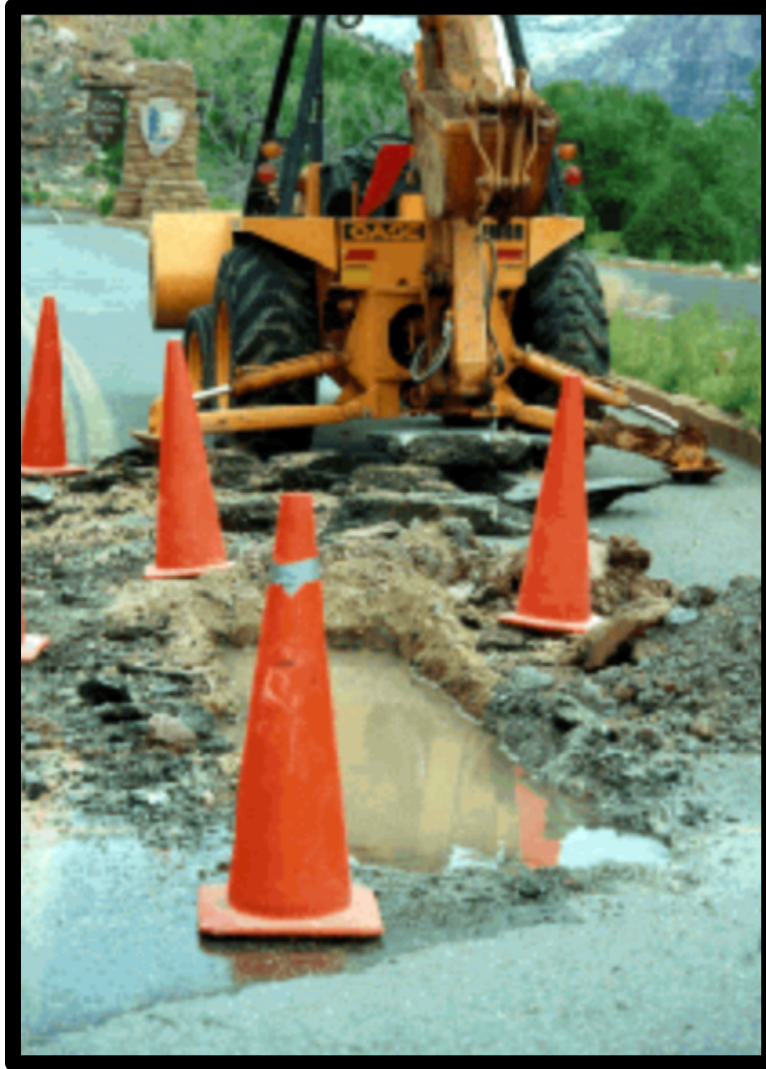
The water pipe broke just outside the entrance to Zion National Park.

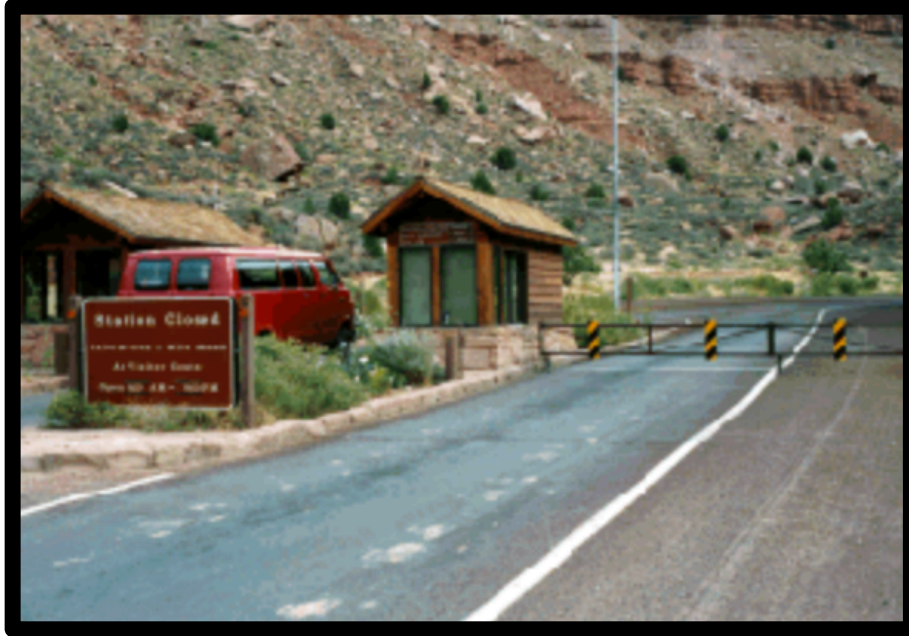
Zion National Park was closed for one day after the earthquake caused the large landslide and broke the water pipe just outside its southwest entrance.

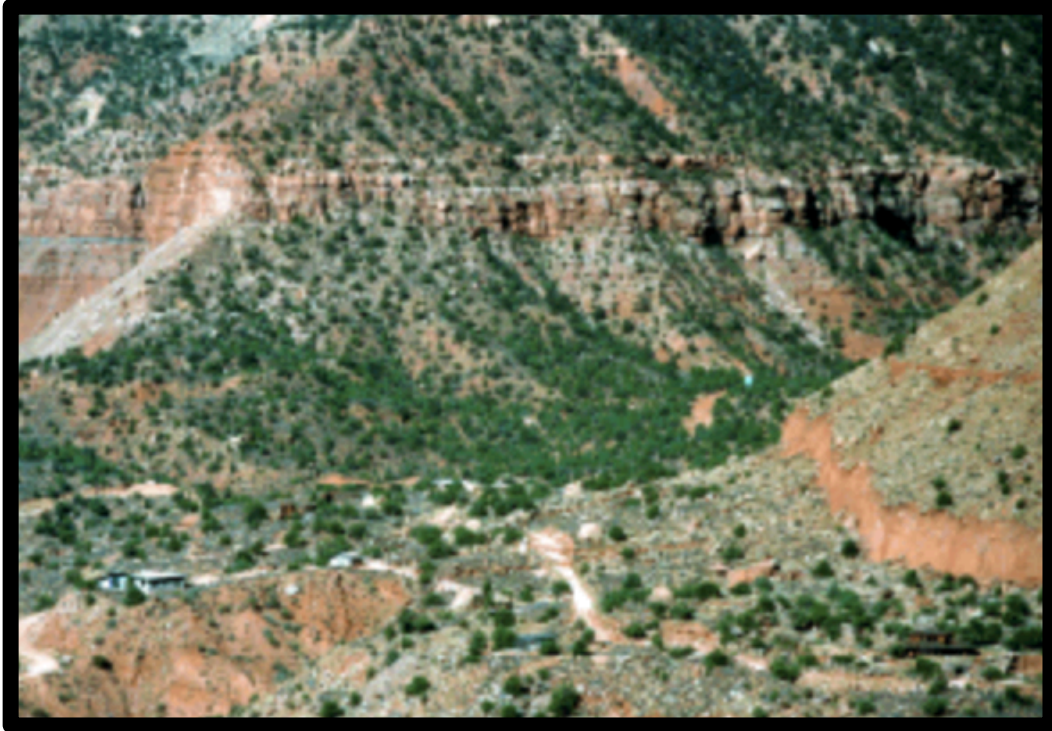
This view of the Springdale landslide is from the Watchman Trail in Zion National Park. The large landslide scarp (as high as 50 feet) is in the lower right corner of photo.

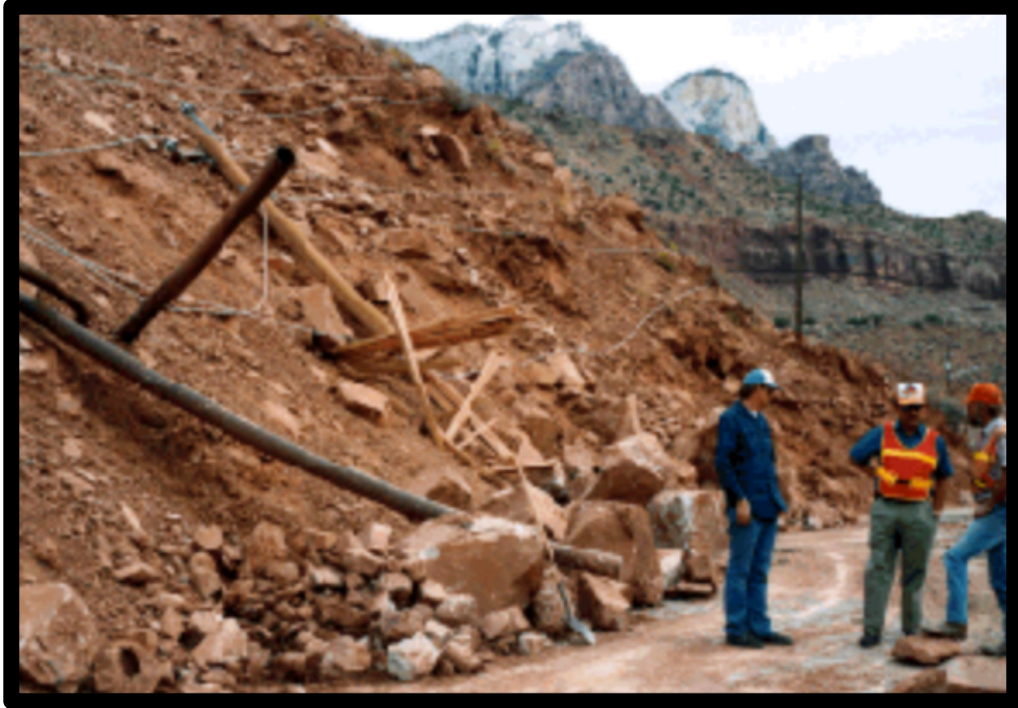
Utility poles along State Route 9 were turned to kindling by the steep bulging front (toe) of the landslide as it moved laterally several meters.

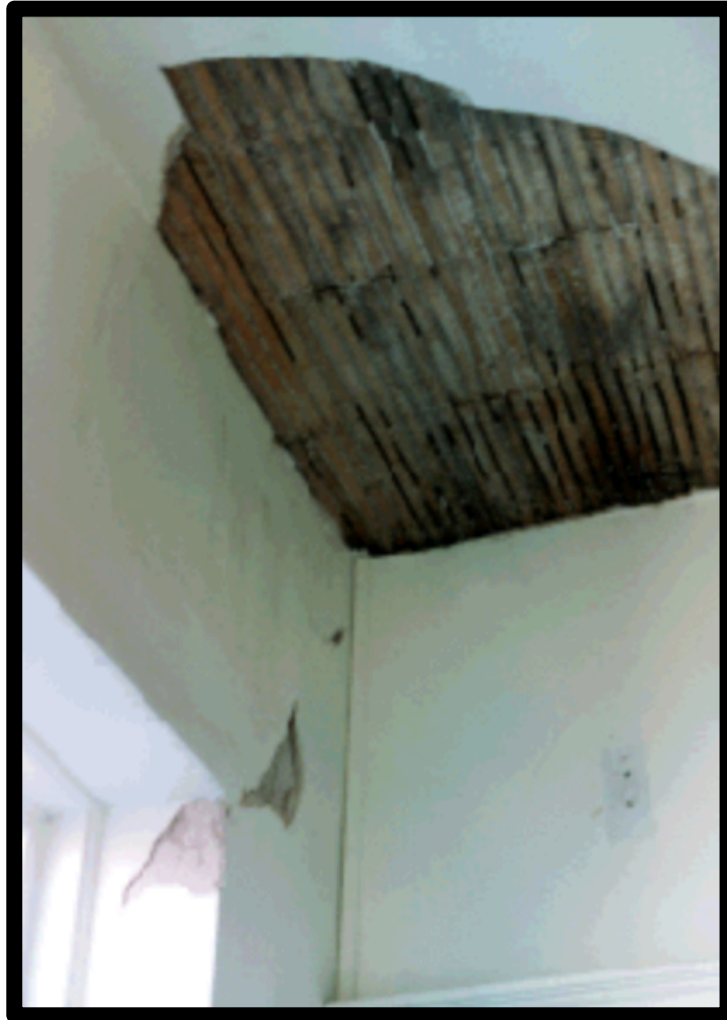
Plaster damage occurred in the women's restroom in the St. George Art Center in St. George, Utah. This building is a large, two-story building constructed of unreinforced masonry.

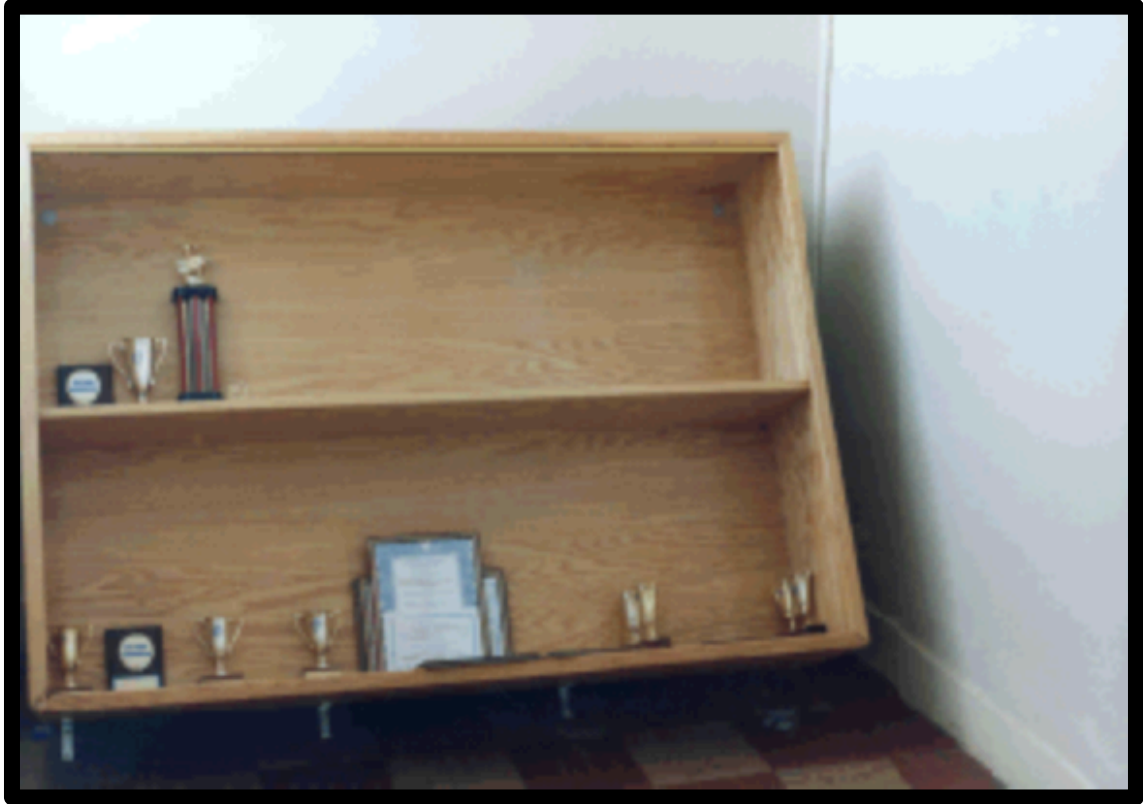
The trophy cabinet fell from the wall on the east staircase of the St. George Art Center.

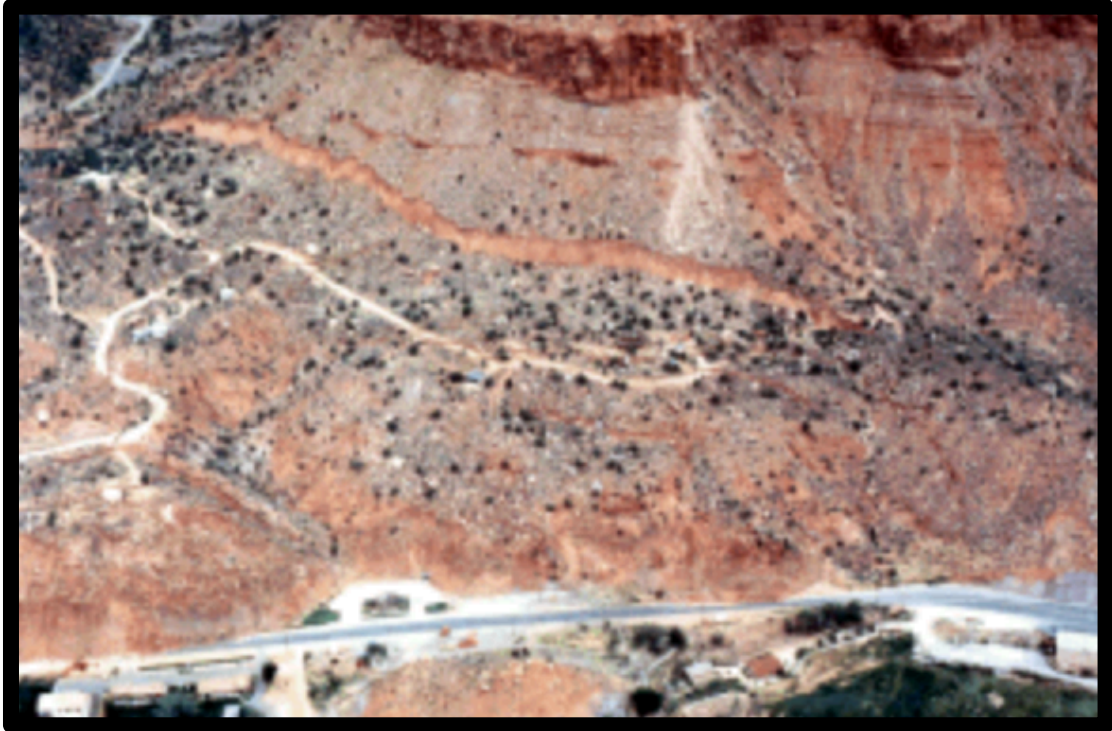
This aerial view to the north of the Balanced Rock Hills Subdivision landslide in Springdale, UT shows the landslide toe covering part of State Route 9 just outside the southwest entrance of Zion National Park. Notice the restaurant that is surrounded, but not touched, by the landslide. Photo by B.J. Solomon, Utah Geological Survey.

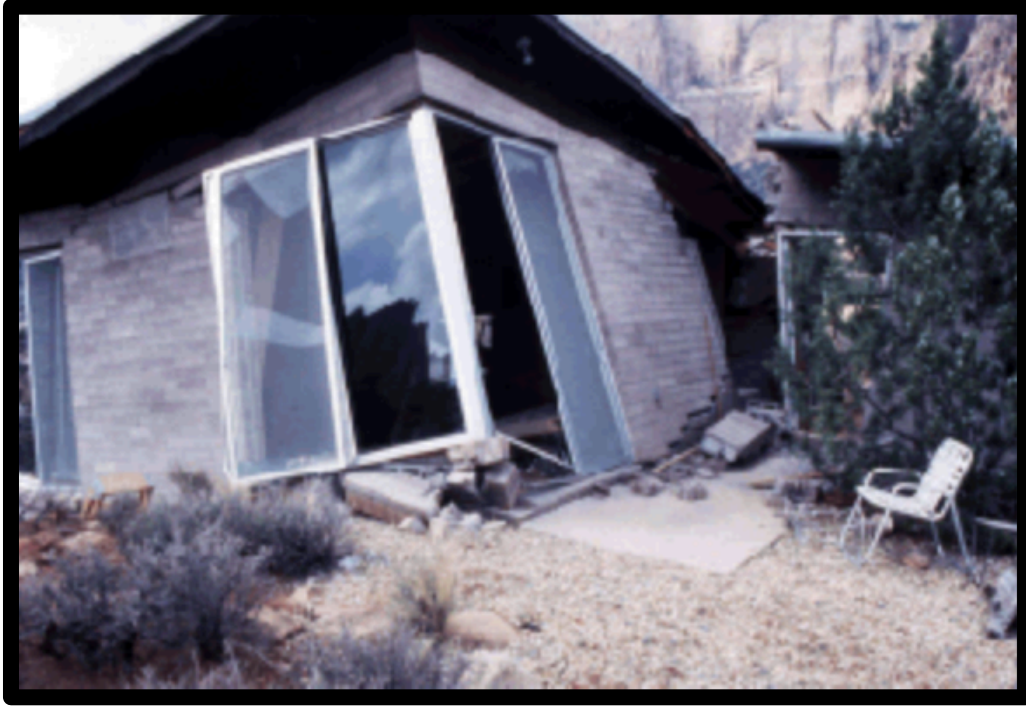
Balanced Rock Hills Subdivision was built on "slide hill" (name given the area by old-timers in the area). The earthquake, whose epicenter was 30 miles away, caused slide hill to slide again. This is one of three homes destroyed in the landsliding. No one was injured. Photo by B.D. Black, Utah Geological Survey.

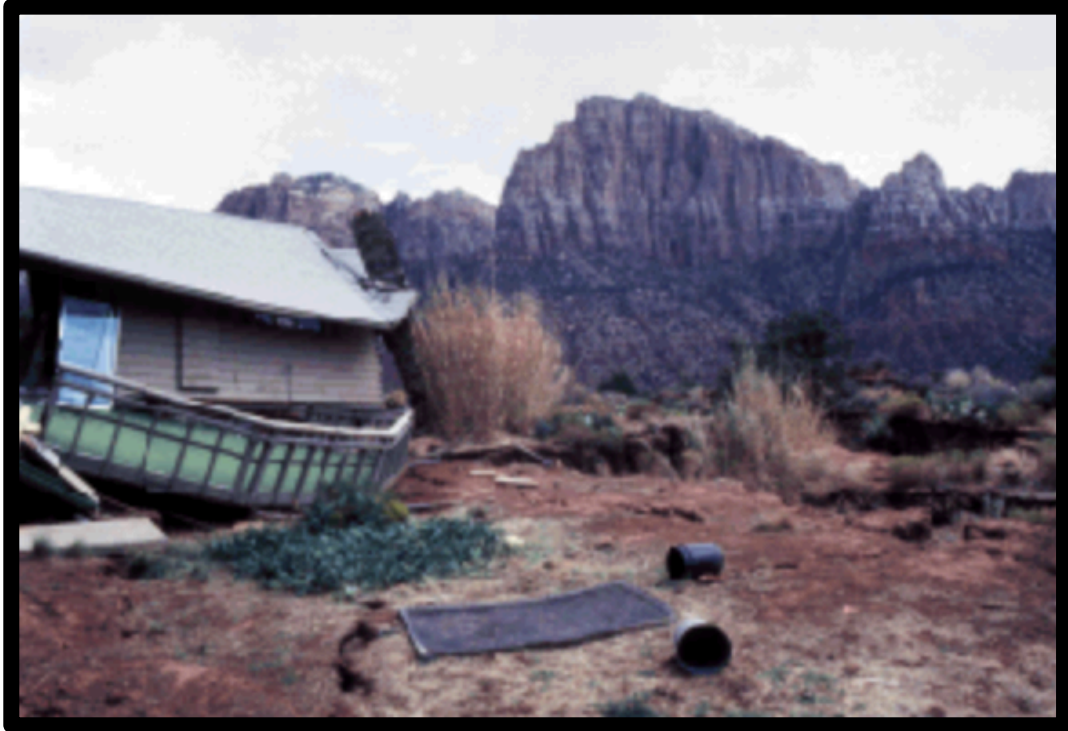
One of three homes destroyed when the hillside beneath them slide due to ground shaking. Photo by B.D. Black, Utah Geological Survey.

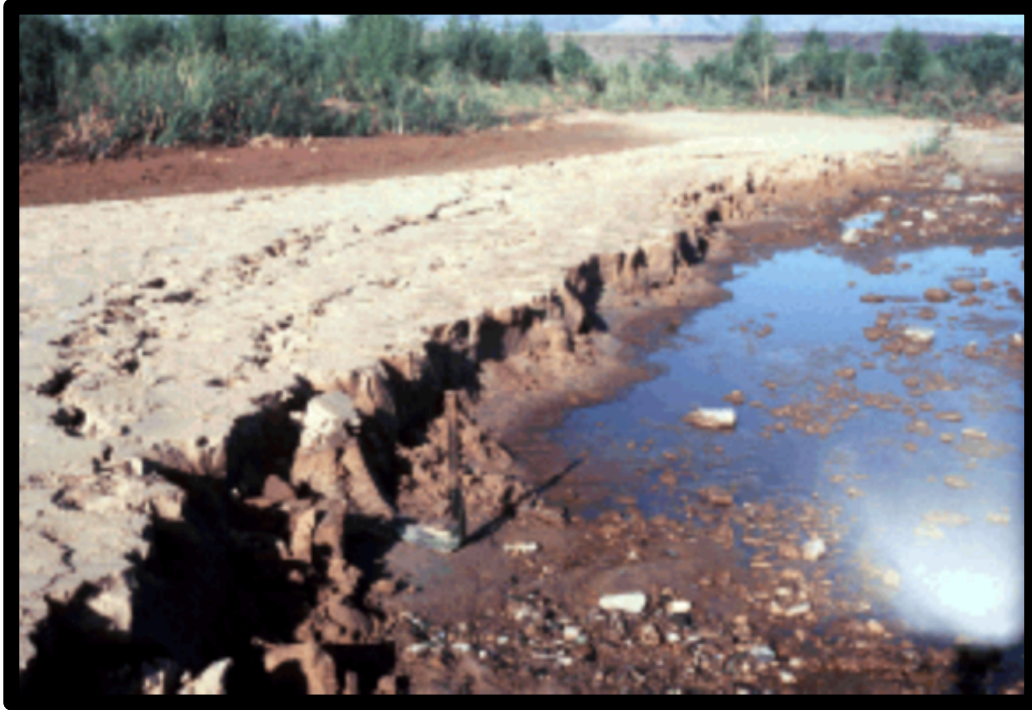
Lateral-spread cracks and caved stream banks resulted from liquefaction along the Virgin River near St. George, UT. Photo by W.E. Mulvey, Utah Geological Survey.

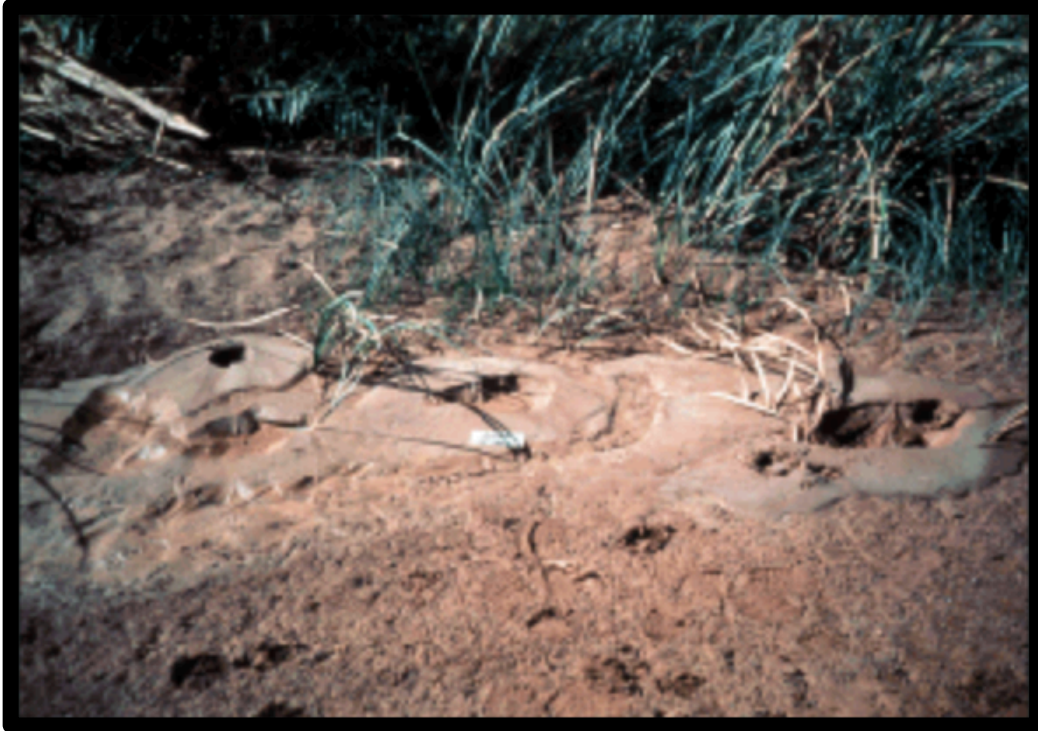
Sand blows resulted from liquefaction along the Virgin River near St. George, UT. Photo by M.A. Mabey, Oregon Department of Geology and Mineral Industries.

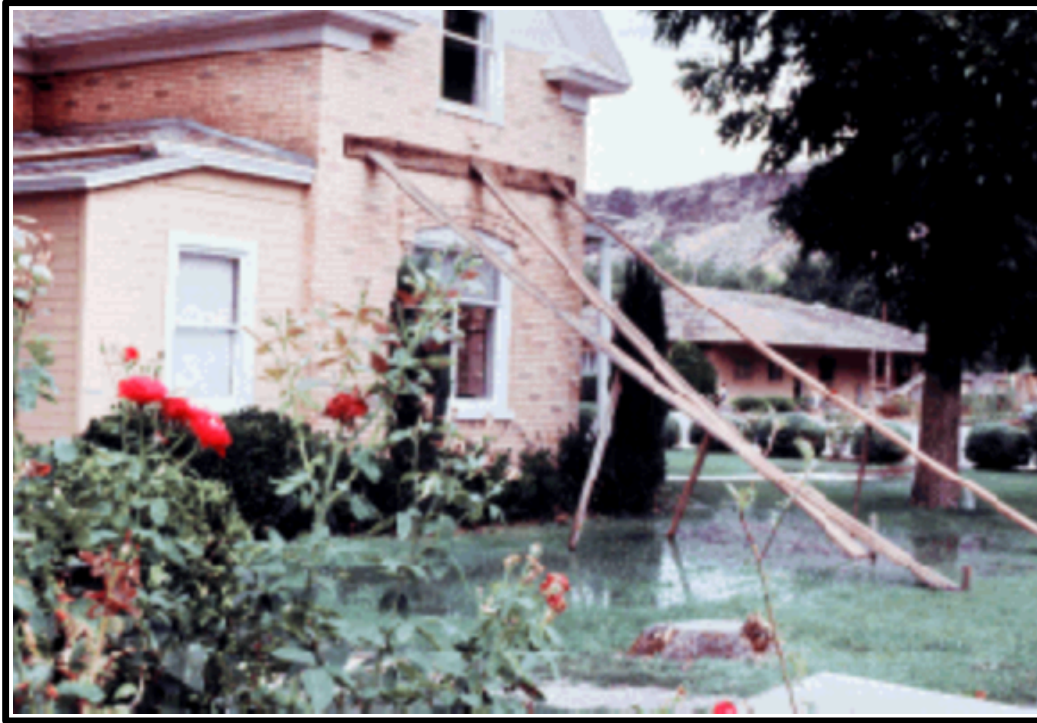
The historical "Stanworth home" in Hurricane, UT, was damaged by the ground shaking. "Chimneys were twisted and partially fell, the walls and foundation were severely cracked, and two walls partially separated from the first-story ceiling, necessitating bracing and eventually structural repair to prevent collapse." [quote from Olig, S.S. (1992). Ground shaking and modified Mercalli intensities, in *The September 2, 1992 M<sub>L</sub> 5.8 St. George Earthquake, Washington County, Utah*, G.E. Christenson (Editor), Utah Geological Survey Circular 88, p. 16. <https://ugspub.nr.utah.gov/publications/circular/C-88.pdf>] Photo by B.D. Black, Utah Geological Survey.
