Summary of Photographs

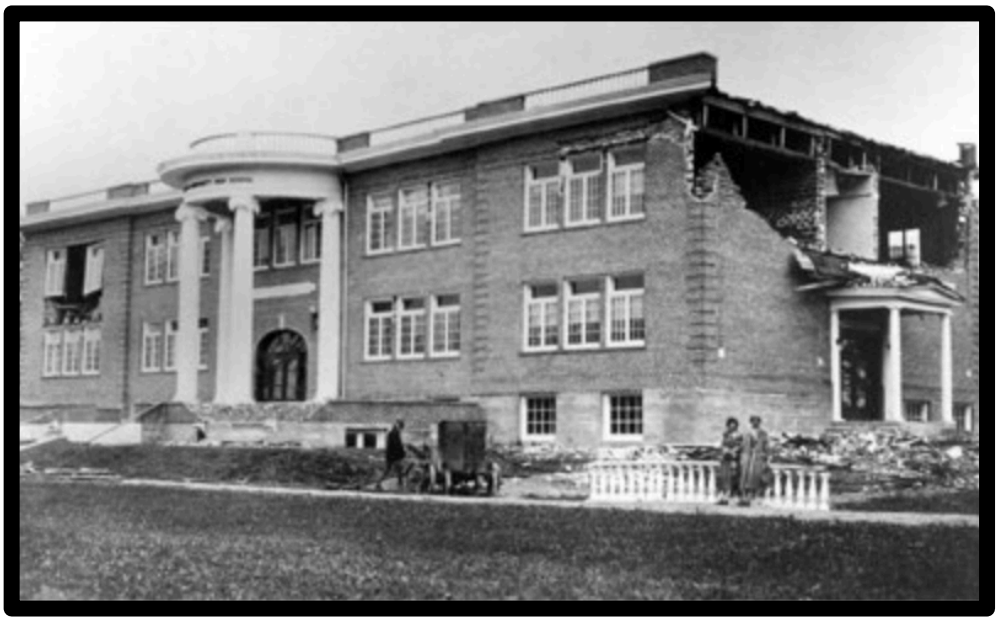
Brick wall and parapet fell from new Community High School in Manhattan, Montana. Photo by J.T. Pardee
